**REHOBOTH FORD DAM
WASHINGTON COUNTY, MISSOURI
NO 28727**

**PHASE 1 INSPECTION REPORT
NATIONAL DAM SAFETY INSPECTION**

RICHWOODS POND DAM
Washington County, Missouri
Missouri Inventory No. 30727

Phase I Inspection Report
National Dam Safety Program

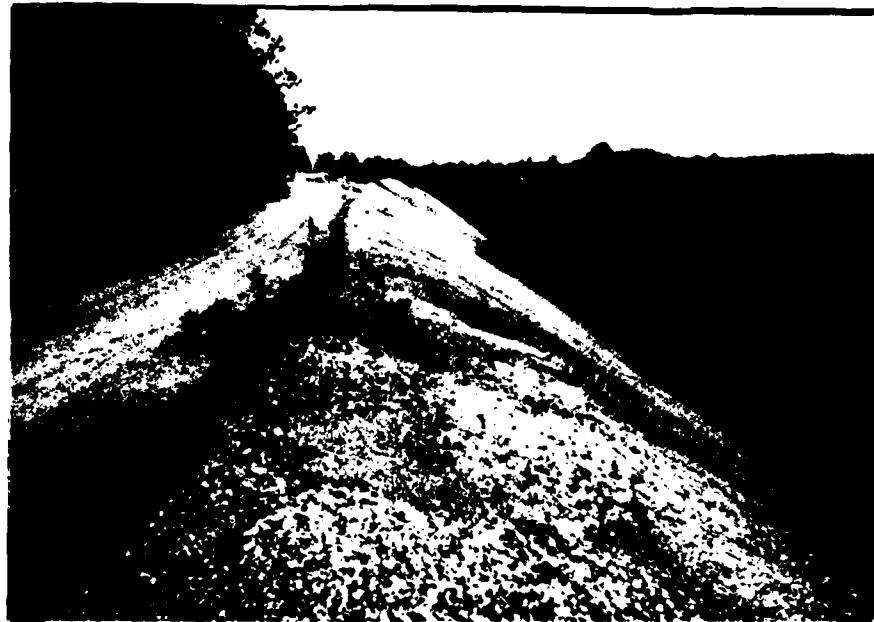
1. Roadway or crest of dam, looking northwest.
