WILDWOOD DAM
JACKSON COUNTY, MISSOURI
MO 20045

PHASE 1 INSPECTION REPORT NATIONAL DAM SAFETY PROGRAM

WILDWOOD LAKE DAM
JACKSON COUNTY, MISSOURI
MISSOURI INVENTORY NO. 20045

PREPARED BY:
BLACK & VEATCH
CONSULTING ENGINEERS
KANSAS CITY, MISSOURI

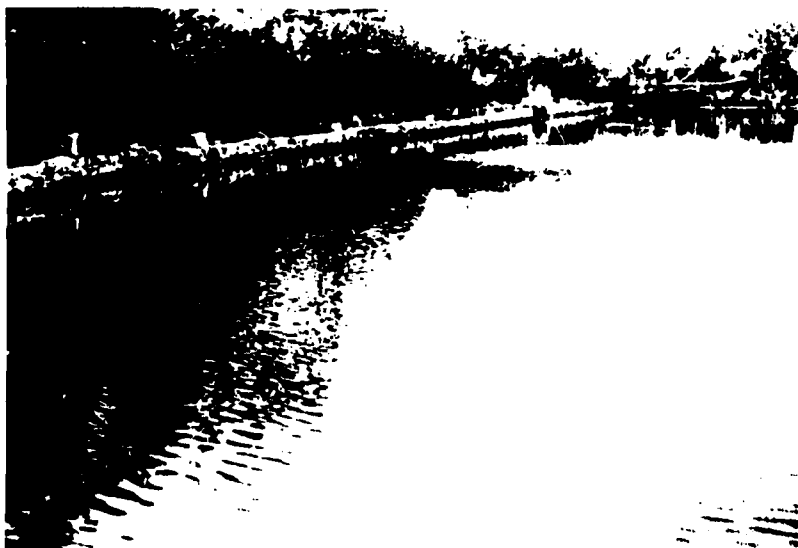
PHOTO 2: UPSTREAM FACE OF DAM (LOOKING SOUTH)
