WEATHERBY DAM
PLATTE COUNTY, MISSOURI
MO. 10690

PHASE 1 INSPECTION REPORT NATIONAL DAM SAFETY PROGRAM

SEPTEMBER 1978

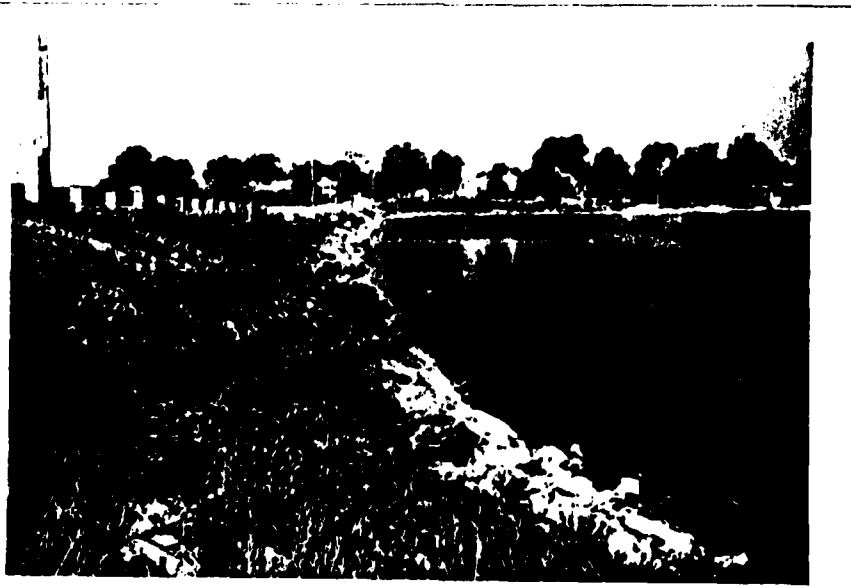
(1) The movement of riprap on the upstream face exposes the embankment material to wave action.

PHOTO 1: Upstream Face of Dam (Looking West)

(4) Additional erosion protection should be added on the upstream slope in the areas of riprap movement. This protection is needed to prevent erosion of the embankment material due to wave action.

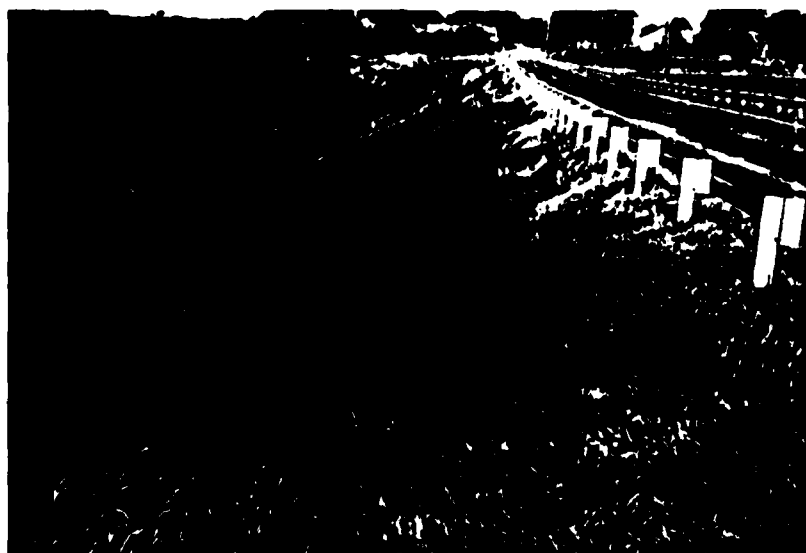
(2) Small trees and brush are a potential seepage hazard, prevent inspection of the slope, and provide animal habitat.

PHOTO 2: Downstream Face of Dam (Looking West)

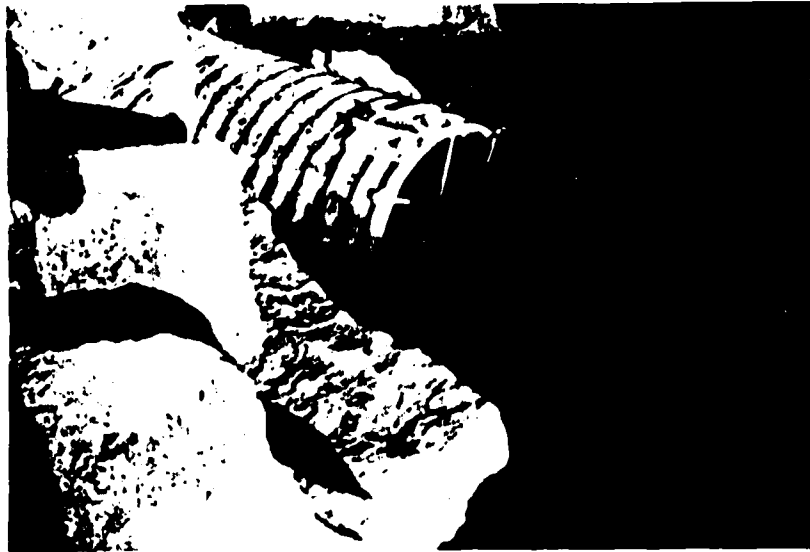
The 24-inch diameter lake drawdown pipe and gate well appeared to be in good condition at the time of inspection. The pipe runs through the upper portion of the embankment where it spills onto the concrete discharge apron. The operator handle was missing; thus, the gate could not be checked for operation. No water was discharging through the outlet culvert at the time of inspection.

PHOTO 3: Inlet of 24-inch Diameter Outlet Pipe
