PERRY CITY DAM

ROLLS COUNTY, MISSOURI

PHASE I INSPECTION REPORT
NATIONAL DAM SAFETY PROGRAM

JANUARY 1979

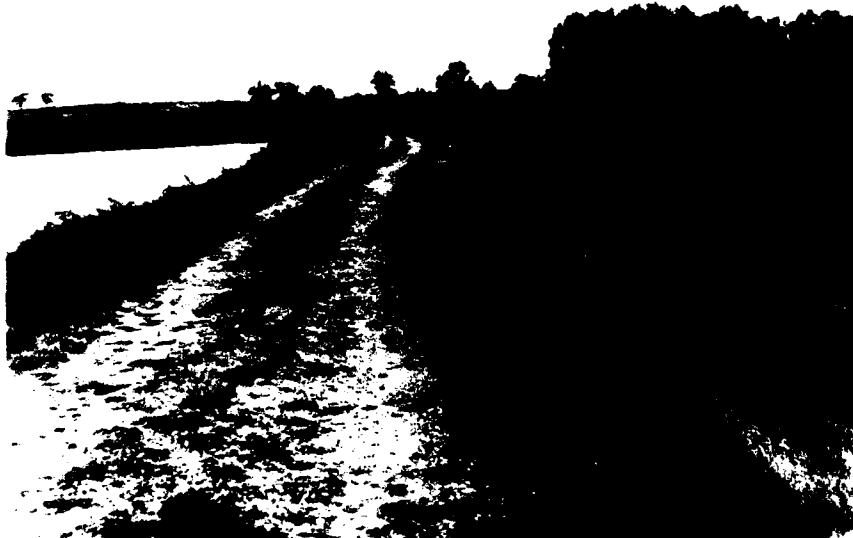
Photo 1 - View along crest of dam taken near right abutment.
