CADET NO. 1 DAM  
WASHINGTON COUNTY, MISSOURI  
MO 30704

# PHASE 1 INSPECTION REPORT NATIONAL DAM SAFETY PROGRAM

SUBJECT: Cadet No. 1 Dam (MC 30704) Dam Phase I Inspection  
Report

Name of Dam	Cadet No. 1 Dam
State	Missouri
County	Washington
Stream	Offstream from unnamed Mill Creek Tributary
Date of Inspection	10 April 1979

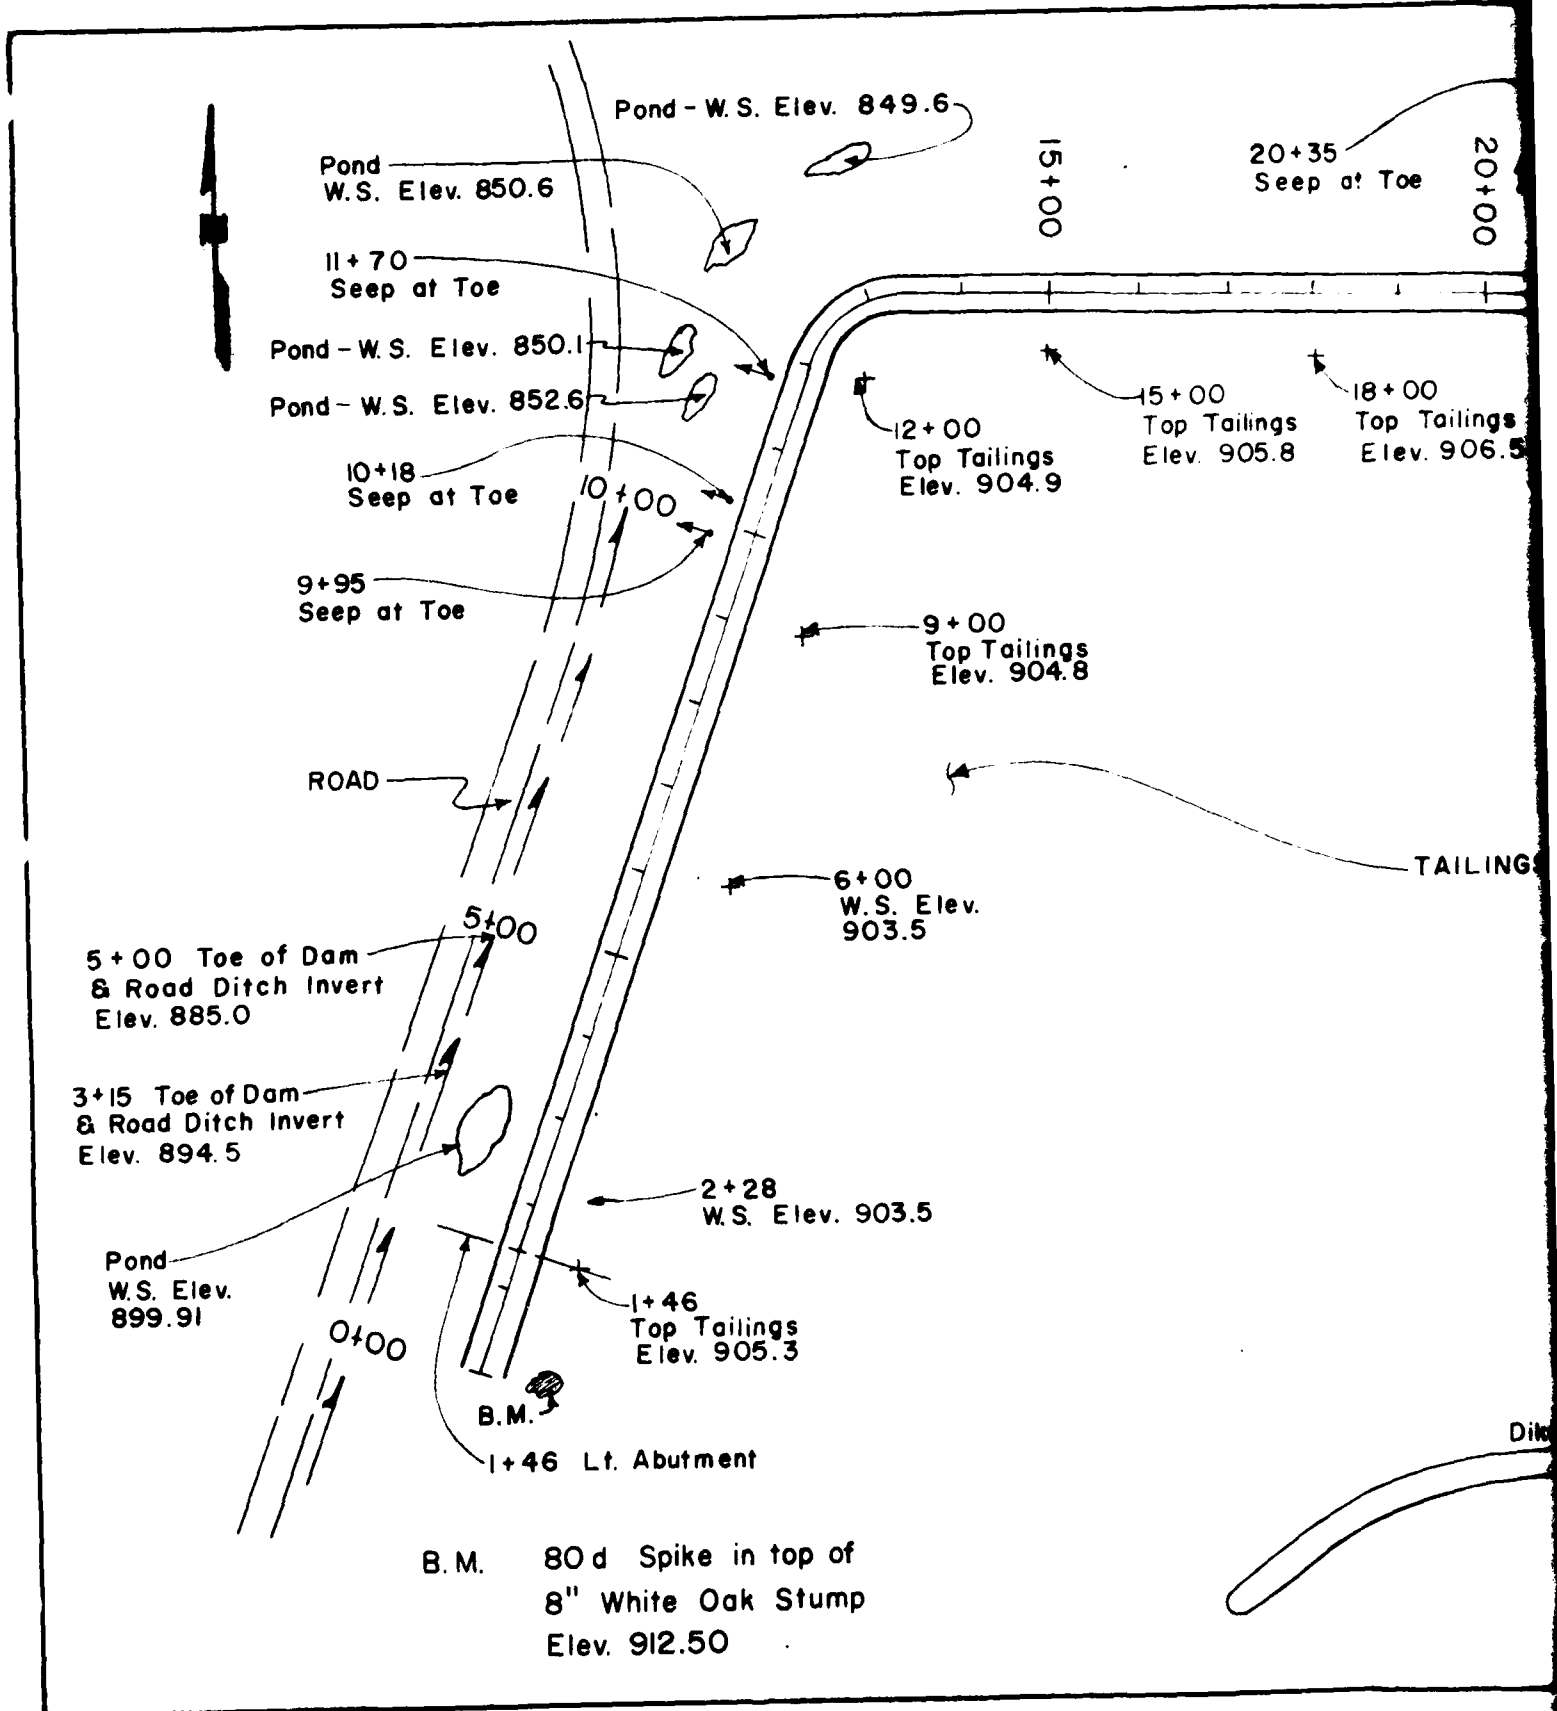
c. Dam. The plan of the dam is shown on Plate 3; a profile and sections are presented on Plates 4, 5, and 6. Little vegetation is growing on the slopes of the dam. Some trees were buried during the dam enlargement process, and these were exposed in places on the downstream slope of the dam.
