**DRESSER NO. 4 DAM
WASHINGTON COUNTY, MISSOURI
MO 30474**

**PHASE I INSPECTION REPORT
NATIONAL DAM SAFETY PROGRAM**

JUNE 1979

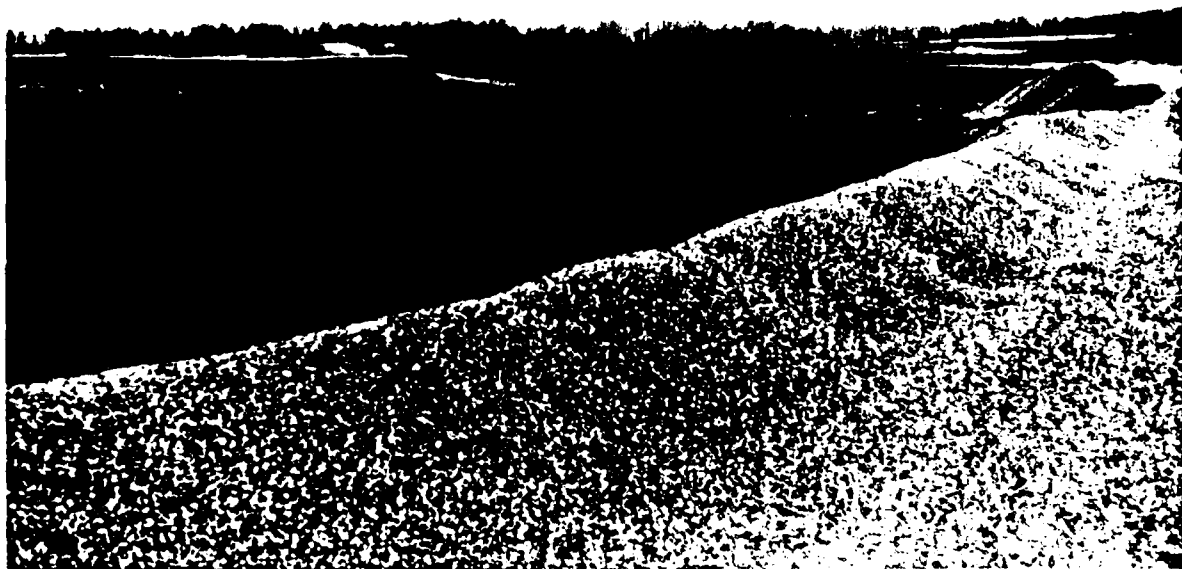
VIEW THROUGH BREACH AT NORTH
END OF IMPROVEMENT OF
DRESSER NO. 4 DAM

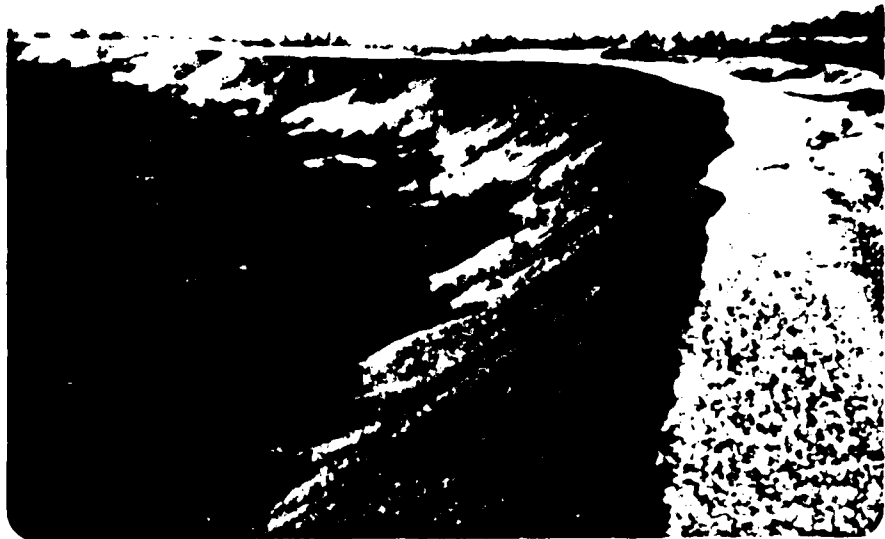
No detrimental settlement, depressions, sinkholes or animal burrows were observed in the embankment. Several cracks that paralleled the embankment alignment were noted on the crest of the northwest section (see Photo No. 4). Locally, these cracks were 2 inches wide and 2 to 3 feet deep at a minimum. No vertical displacement was observed. Vertical scarps about 2 feet high on the upstream face of the northwest portion of the dam were evident (see Photo No. 5).

The slope facing the impoundment at the northwest section of the dam appears to be unstable. Cracks in the dam crest and the scarps which may have resulted from previous slide activity are indications of slope instability. As long as the impoundment remains inactive and cannot retain water, the consequences of slope instability toward the impoundment would not appear to be serious.
