J.M. KIRCHER DAM

CASS COUNTY, MISSOURI

MO 31075

PHASE 1 INSPECTION REPORT NATIONAL DAM SAFETY INSPECTION

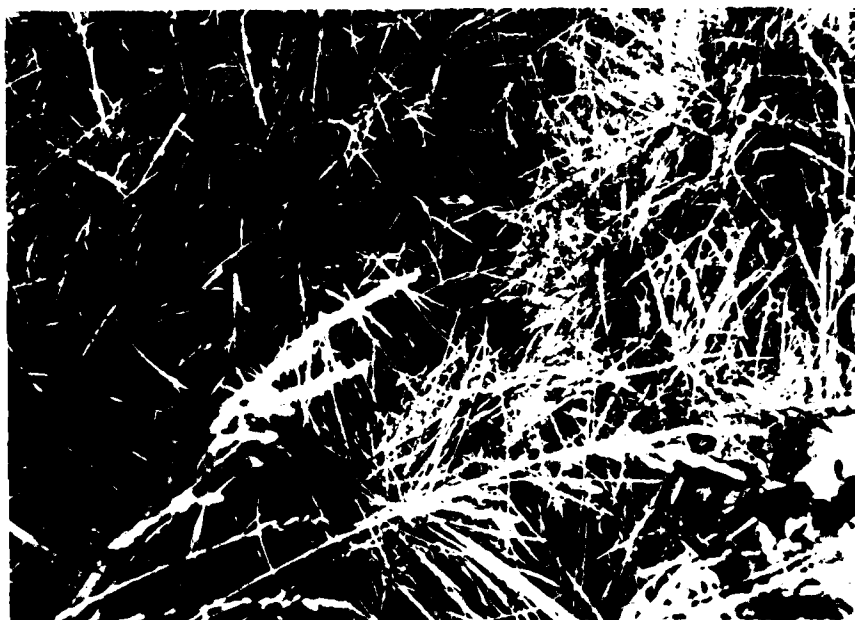
One small tree (6 inch diameter) and various brush in the channel spillway have been allowed to grow. A few small animal burrows exist on the embankment. If these deficiencies are unchecked, they could lead to deterioration of the dam embankment.

PHOTO 11: LOOKING AT ANIMAL BURROW
(Note 35-mm film box approx. 1 1/2" by 2 1/2")
