**HAAKE LAKE DAM
CASS COUNTY, MISSOURI
MO 20379**

**PHASE 1 INSPECTION REPORT
NATIONAL DAM SAFETY INSPECTION**

MARCH 1979

BLACK & VEATCH
CONSULTING ENGINEERS
KANSAS CITY, MISSOURI

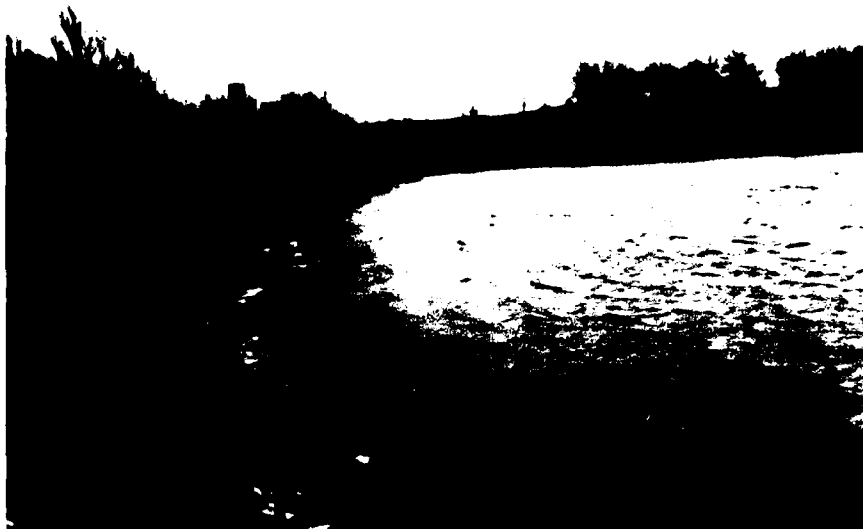
b. Dam. The inspection team observed the following items at the dam. No surface cracks or unusual movement of the embankment were found. A large animal burrow was found in the upstream face of the dam near the center. The depth of the burrow was unknown. There was no problem of sloughing or erosion of the embankment or abutment slopes. There was no riprap on the upstream face of the dam, but no problem of erosion was sighted. Growth of brush and trees was moderate to heavy on the downstream slope of the embankment. Two points of seepage were noticeable near the toe of the dam about 150 feet from the right abutment. These spots were wet, but there was no visible flow from them. Seepage was also detected in the left abutment downstream of the dam and right of the emergency spillway. Water was flowing from this spot at a rate of approximately two gallons per minute. The lake level at the time of the inspection was at full pool elevation. There was a small amount of flow over the principal spillway. The downstream embankment slope appears excessively steep and the stability criteria set forth in the guidelines probably will not be met.

PHOTO 1: UPSTREAM FACE OF DAM LOOKING EAST

(1) Further animal burrowing in the upstream face of the embankment should be prevented and the holes should be filled in with properly compacted material. Burrowing animals (muskrats and ground squirrels) have been responsible for piping failures in a number of small earth dams. If willows or other brush grow at the water line, muskrats will dig under them because the roots reinforce the opening of the hole and also hide its existence.

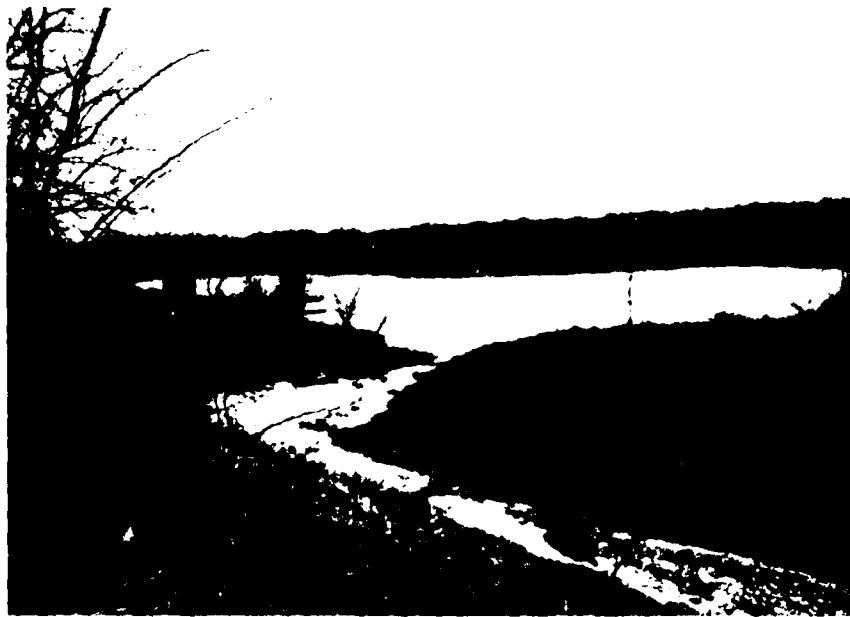
(1) The principal spillway is in good condition with no evidence of significant erosion or obstructions at the time of the inspection.

PHOTO 9: PRINCIPAL SPILLWAY LOOKING UPSTREAM
