**RICHWOODS MINE 'B' MILL DAM
WASHINGTON COUNTY, MISSOURI
MO. 31404**

**PHASE 1 INSPECTION REPORT
NATIONAL DAM SAFETY INSPECTION**

Name of Dam	Richwoods Mine "B" Mill Dam
State Located	Missouri
County Located	Washington
Stream	Unnamed Tributary of Ditch Creek
Date of Inspection	3 June 1980

PHASE I INSPECTION REPORT
NATIONAL DAM SAFETY PROGRAM
RICHWOODS MINE B MILL DAM - INVENTORY NO. 31404

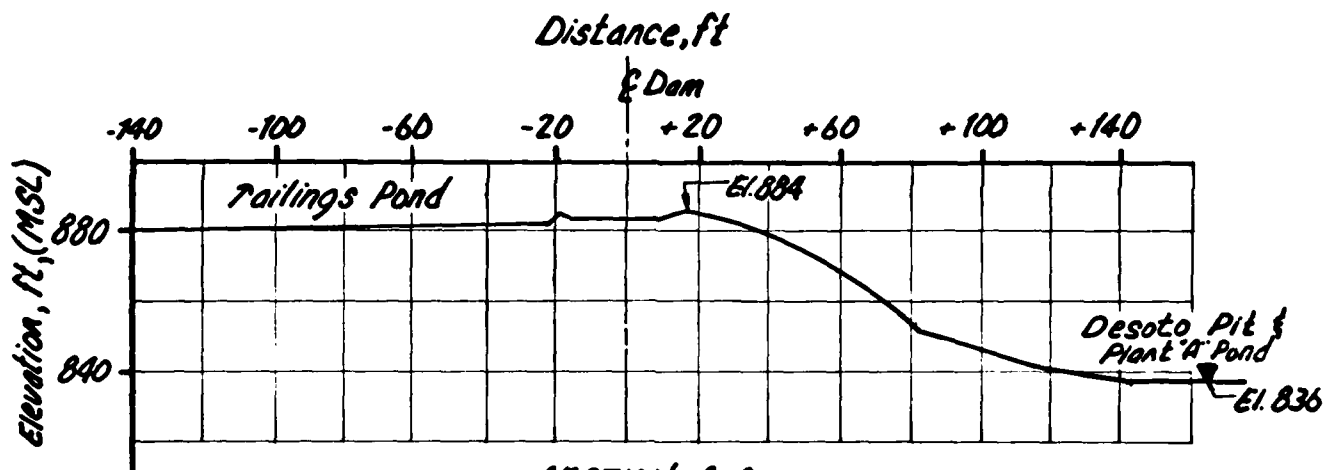
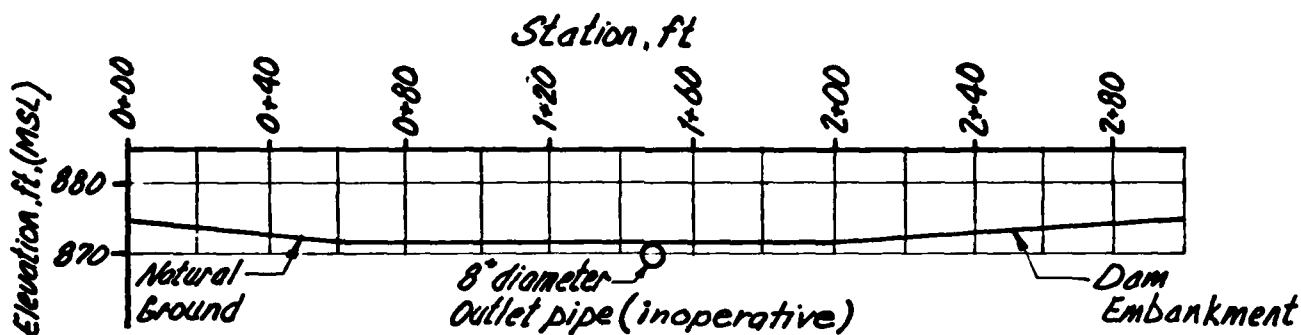
Fig. 3B

- a. General. Dam was inspected on 3 June 1980 without the owner's representative present. This inspection indicated the dam is in an unsatisfactory condition.
- b. Dam. The Richwoods Mine B Mill Dam consists of coarse tailings locally referred to as "chat". This material is sandy gravel and sand (GW, SW). It is cohesionless and can be easily eroded. The material is end-dumped on the crest of the dam by trucks. Compaction is limited to truck traffic. Slopes on the dam generally are at the angle of repose for this material, 33 to 35 degrees. A 40 degree slope angle was measured on portions of the maximum section (Fig. 3B).

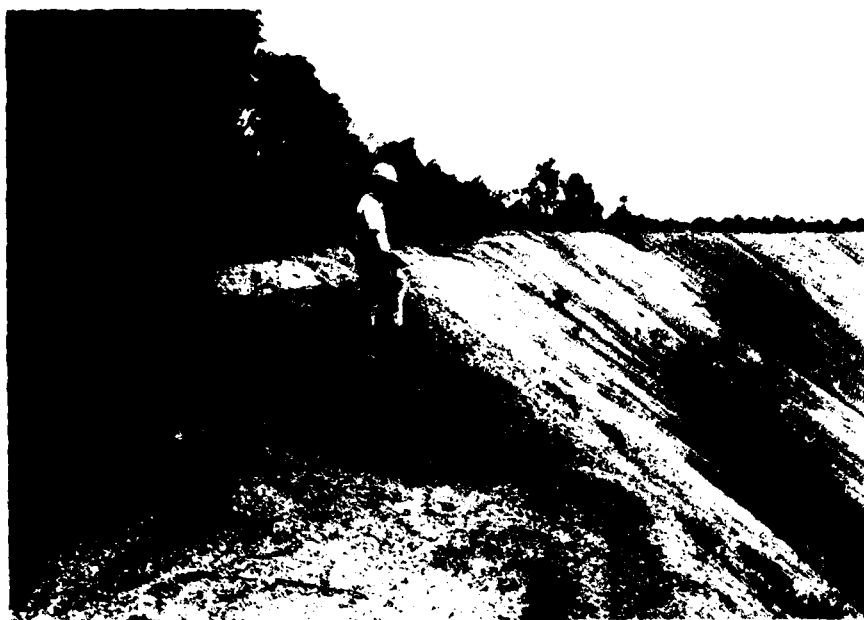
1. End dumped tailings used to construct dam. Looking north along crest.

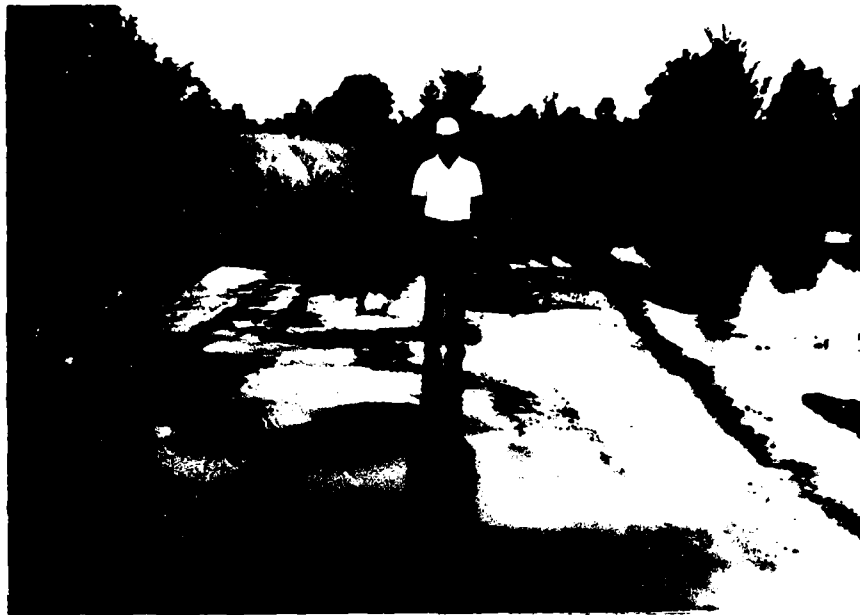
Richwoods Mine B Mill Dam is approximately 3700 ft long and borders the impoundment area on the north, east and south. It is approximately 48 ft high at the maximum section. There is no designed spillway for this dam. A low area at the southwest end of the embankment acts as an informal spillway. An 8 in. diameter pipe crosses beneath the road along the south side of the reservoir and is the only outlet structure identified. The pipe has corroded to the point of being inoperative. Some overflow from the reservoir flows across the road at approximately the same location as the pipe. The lowest point controlling overflow is elevation 872 ft MSL on the road (see Photo 7). Elevations on the dam crest vary from 884 ft to 872 ft MSL.

No maintenance is apparently performed on the operating facilities. The outlet pipe buried under the overflow section of the embankment has deteriorated through corrosion to the point of being inoperative.

7. Overflow crossing road. Reservoir to right. Looking west. Discharge pipe in background to right.

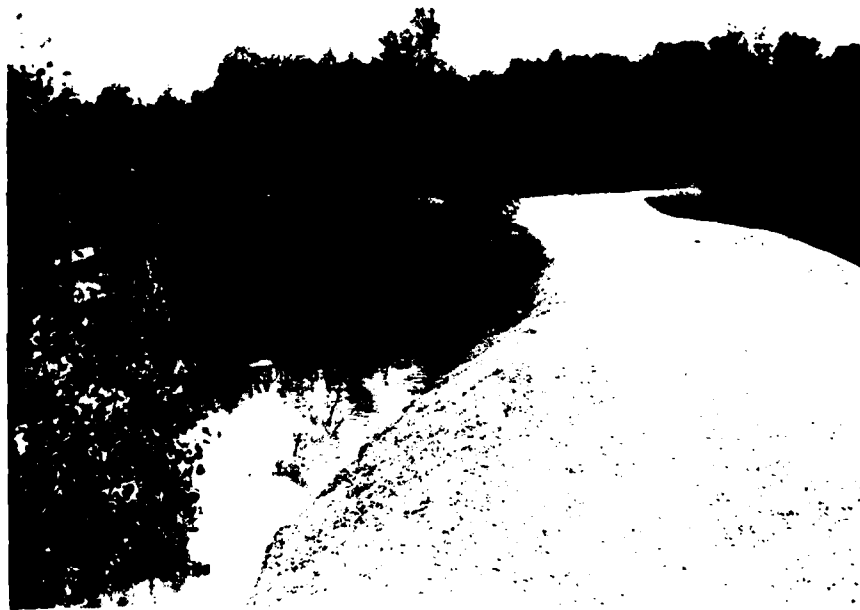
8. Dike along north side of impoundment, showing $1\frac{1}{2}$ to 2 feet freeboard.
