**STAR MINE DAM
WASHINGTON COUNTY, MISSOURI
MO 31005**

**PHASE 1 INSPECTION REPORT
NATIONAL DAM SAFETY INSPECTION**

STAR MINE DAM
Washington County, Missouri
Missouri Inventory No. 31005

Phase I Inspection Report
National Dam Safety Program

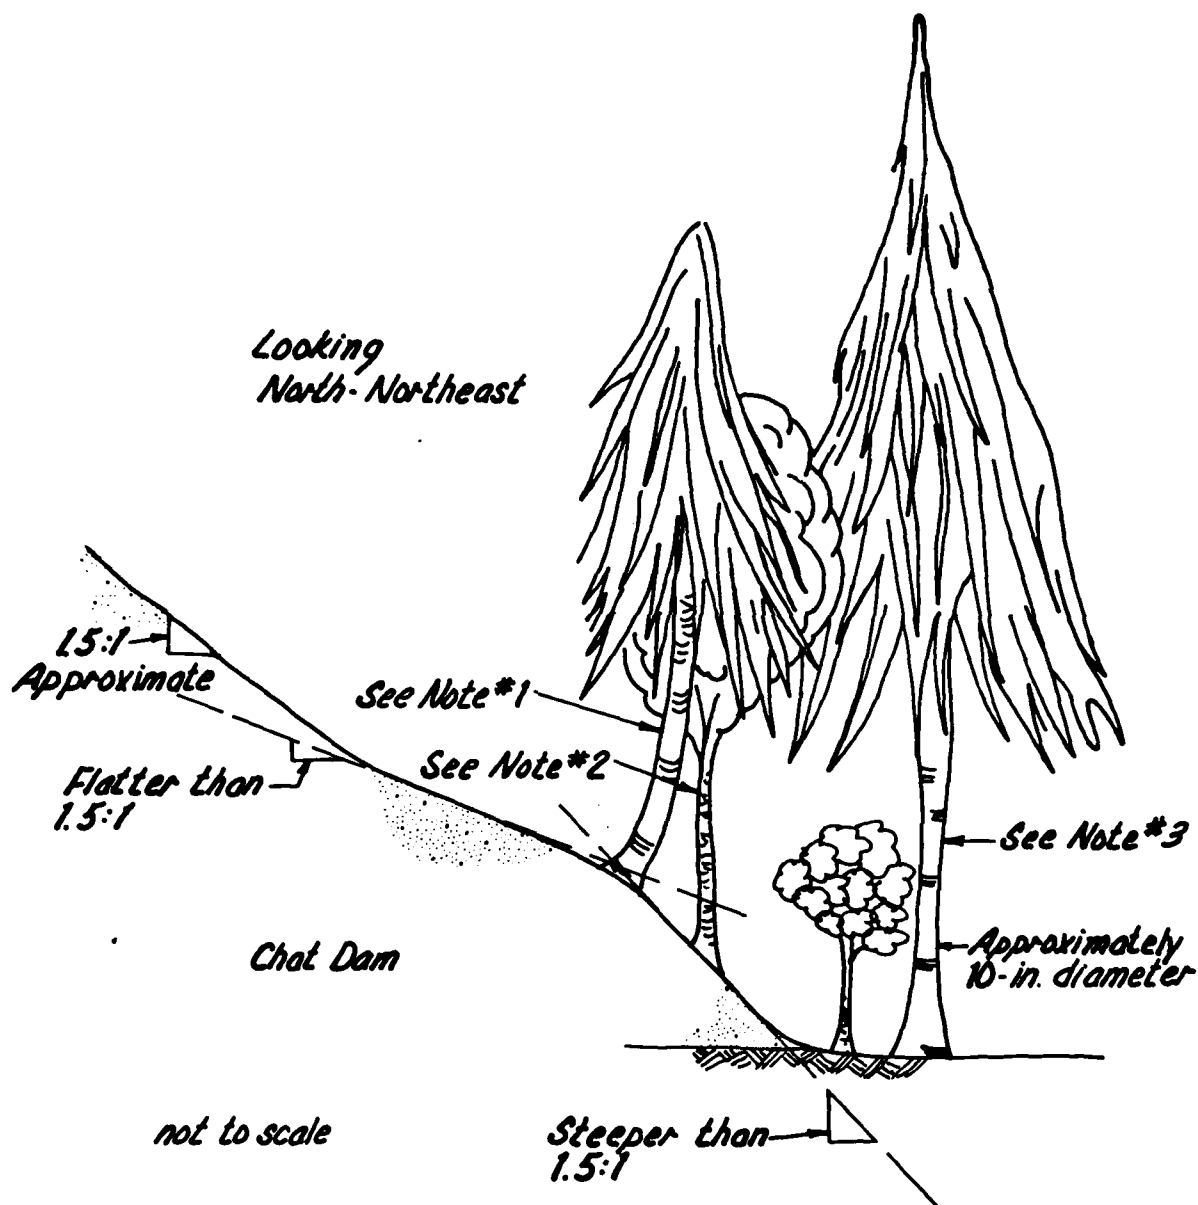
TOE OF SLOPE INDICATING MOVEMENT	
STAR MINE DAM	
MO 31005	Fig. 5

1. Older trees on bulge are curved.
2. Younger trees on bulge are unaffected.
3. Both older and younger trees are unaffected at toe of Dam.

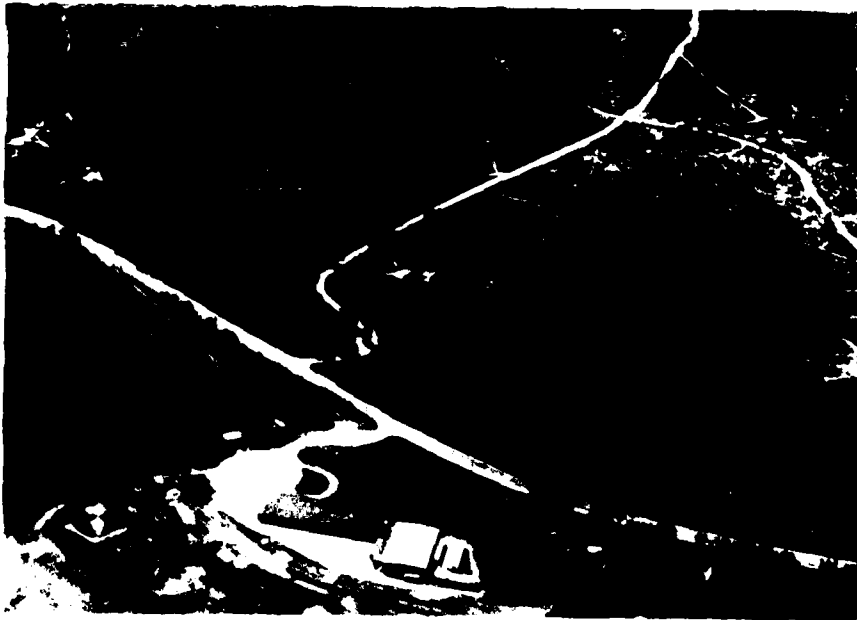
2. Downstream hazard - school; looking west.

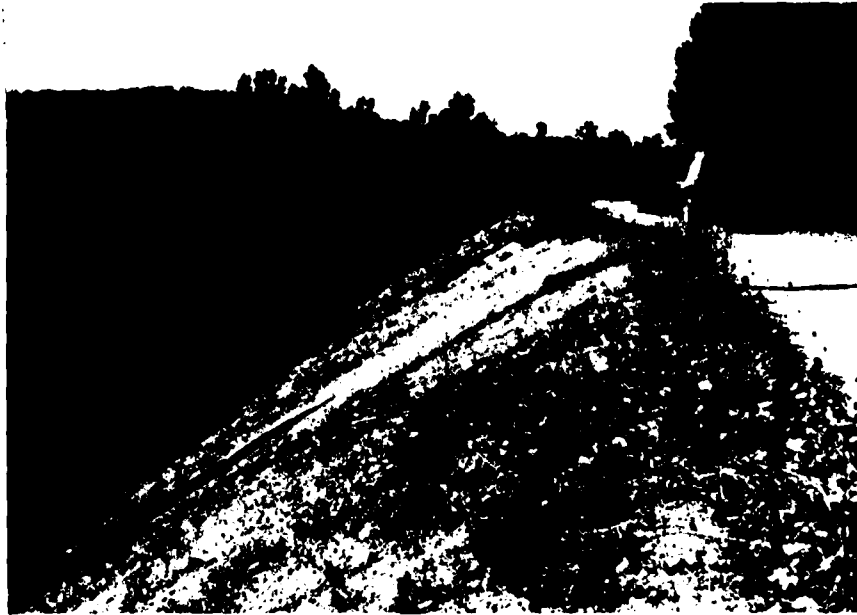
The crest of the dam had depressions or broad swales that would indicate that the embankment had settled (Photos 3 and 5). Without prior monitoring of the dam, however, this cannot be confirmed. One small possible slump scarp was noted on the downstream side of the dam crest. It is only a few inches deep and may possibly be a rut from vehicular traffic rather than a slump scarp (Photo 6).

Local settling of the dam crest seems to have occurred but does not appear to pose a safety hazard at this time.

3. Crest alignment, slope irregularities and vegetation of Star Mine Dam.
