**SOMETHING GREEN A DAM  
WASHINGTON COUNTY, MISSOURI  
MO 30720**

**SOMETHING GREEN B DAM  
WASHINGTON COUNTY, MISSOURI  
MO 30719**

**PHASE 1 INSPECTION REPORT  
NATIONAL DAM SAFETY INSPECTION**

**SEPTEMBER 1980**

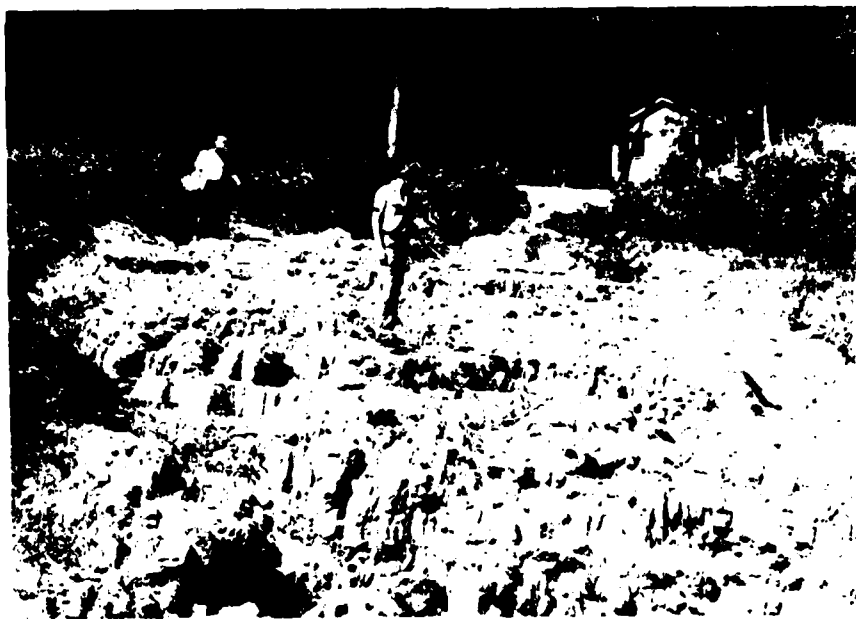
2. Discharge channel eroded to bedrock, Eminence Dolomite. Note erosion of channel walls. Dam is to the right. Looking southwest.

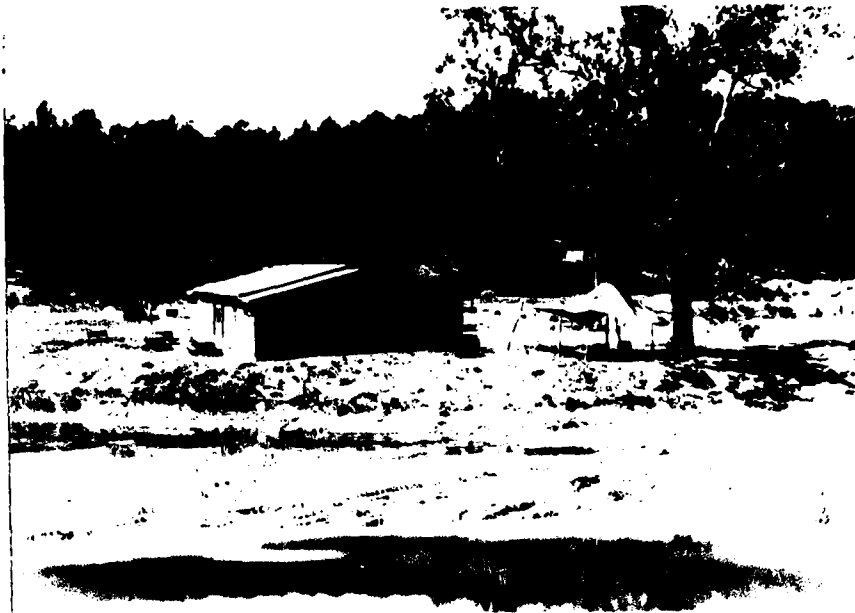
5. Community recreation center downstream of dam. Looking southeast across drainage.
