LAKE HANNIBAL ESTATES UPPER DAM

RALLS COUNTY, MO.

MO 11185

**PHASE 1 INSPECTION REPORT
NATIONAL DAM SAFETY PROGRAM**

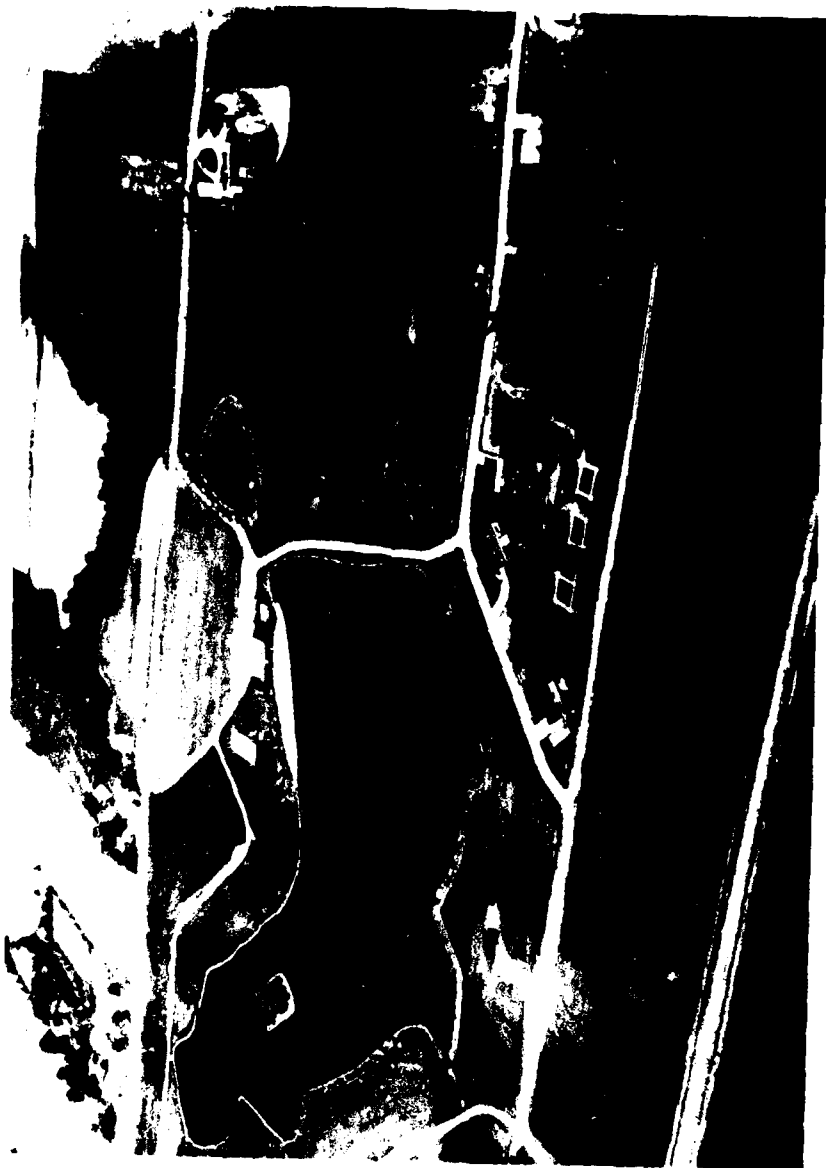
PHOTO NO. 1 - OVERVIEW

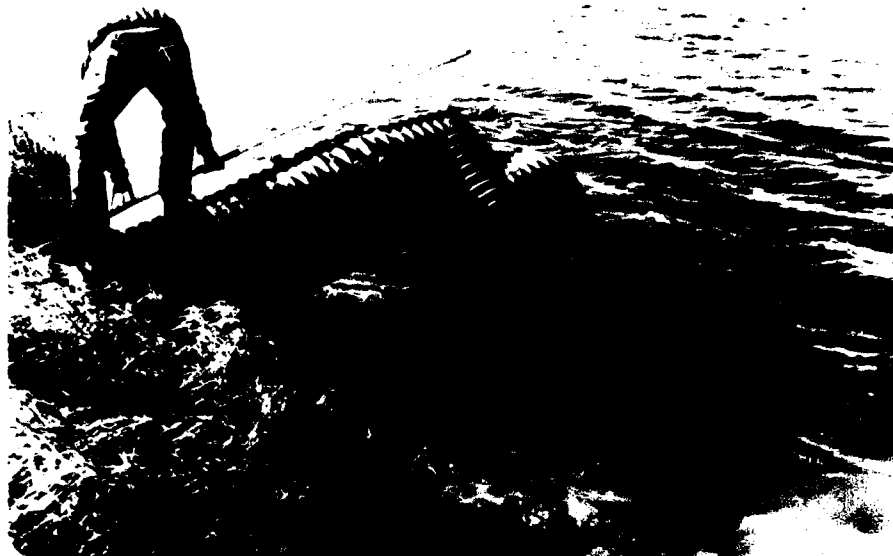
Rotation of the "gooseneck" type inlet to its highest invert elevation of 99.0 would result in the spillways not being able to pass the 10-year flood without overtopping the dam. Failure of the spillways to pass the 10-year flood would change the classification of the dam from Unsafe-Non-emergency to Unsafe-Emergency.

- (a) Inlet Structure. The "gooseneck" type inlet is constructed of 24-inch diameter corrugated metal pipe and is attached to the inlet end of the conduit by a 24-inch length corrugated metal pipe band with manually tightened bolts. The effective invert elevation of the inlet can be raised by loosening the bolts and rotating the inlet. The "gooseneck" type inlet is shown in Photo No. 6.

- (a) Inlet Structure. The 24-inch corrugated metal pipe spillway was designed with a conventional uncontrolled hooded inlet (Plate C-3). A manually controlled "gooseneck" type inlet was added to the inlet end of the spillway in lieu of the hood inlet. This inlet can be manually rotated to provide control over the elevation of the normal pool. The inlet was open and free, and no deterioration of the metal structure was apparent. Photos 5 and 6 show the inlet of the principal spillway.

PHOTO NO. 6 - PRINCIPAL SPILLWAY INLET WITH ADJUSTABLE HOOD.

- (4) Measures should be taken to assure that the elevation of the invert of the principal spillway inlet does not exceed 97.0.
- (5) Maintenance of the vegetation on the embankment and emergency spillway is excellent and should be continued.
- (6) A trash rack should be installed on the principal spillway inlet to help in keeping the spillway open.
- (7) Periodic inspections of the dam should be made and recorded as part of this project file.

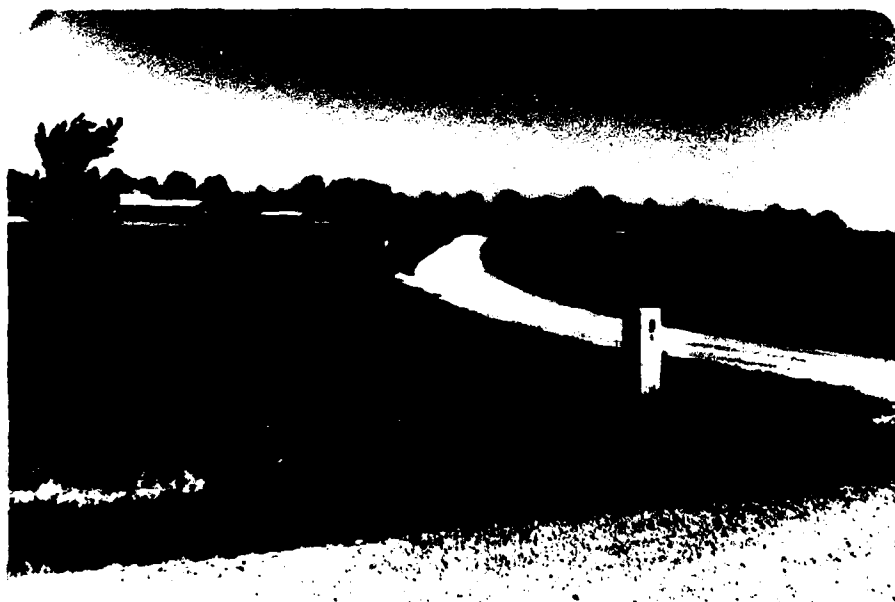
- (2) Crest. The crest is well graveled and serves as an access road for the development. No cracks or serious erosion were observed on the crest. The profile of the crest, shown on Plate C-2, Appendix C, shows a distinct hump in the crest with top elevation of 102.2 for a distance of 50 feet± either side of the principal spillway (comparable to settled elevation of 102 shown on Plate C-3). The remainder of the dam is below the settled top elevation shown on Plate C-3 with a low elevation of 100.3 at the extreme left (stations 0+00 to 0+50) and 100.2 at station 6+00 on the extreme right at the left edge of the emergency spillway. There was no evidence that would indicate that the dam has been overtopped. Photos 3, 8 and 9 show the crest.

PHOTO NO. 9 - CREST FROM RIGHT END.

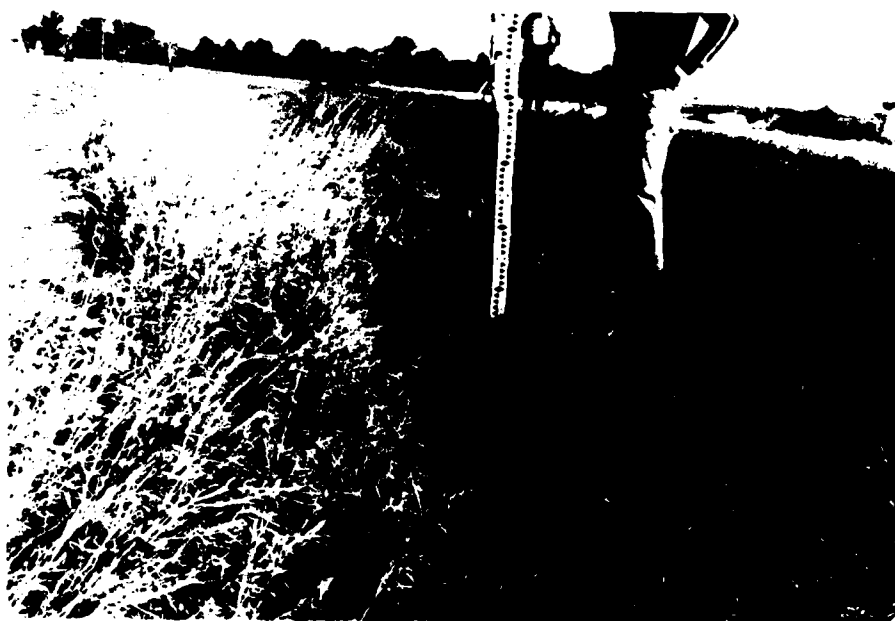
- (1) Upstream Slope. The upstream slope is well vegetated. No cracks or deformations were observed. Some erosional damage was observed on the slope extending 2 or 3 feet vertically above present lake level. Some of the eroded areas had been stabilized with small size riprap. One active erosional area was observed between stations 5+00 and 5+25. This area has cut into the face about 8 feet horizontally and has a vertical scarp about 2 feet deep. Mr. Hulse reported that he places riprap whenever the erosion becomes significant and that he plans to repair this area in the near future. The slope of the upstream embankment, as determined during the inspection, is 1V on 5H as compared to 1V on 3H as shown on Plate C-8. There was no evidence to indicate that an upstream berm was constructed. Photos 2 and 10 show the upstream face, and Photo No. 11 shows the active erosional area.

The dam is mowed regularly and is neat and clean in appearance. Maintenance of the upstream slope is reportedly done as needed. One eroded spot (station 5+00 - 5+25) needs to be repaired in the near future.

PHOTO NO. 11 - EROSION AREA ON RIGHT UPSTREAM FACE.

Maintenance of this structure is generally good. Prevention and/or repair of erosion on the upstream slope should be done on a regular basis rather than waiting until it becomes serious.

- (3) Erosion damage on the upstream slope should be repaired and measures taken to stabilize the slope.
 - (4) The presence of bends in the principal spillway inlet and the absence of a trash rack may result in the blockage of the spillway by debris resulting in a reduced spillway capacity.
