**GARMS LAKE DAM**

**CAPE GIRARDEAU COUNTY, MISSOURI**

**MO 31218**

**PHASE 1 INSPECTION REPORT  
NATIONAL DAM SAFETY PROGRAM**

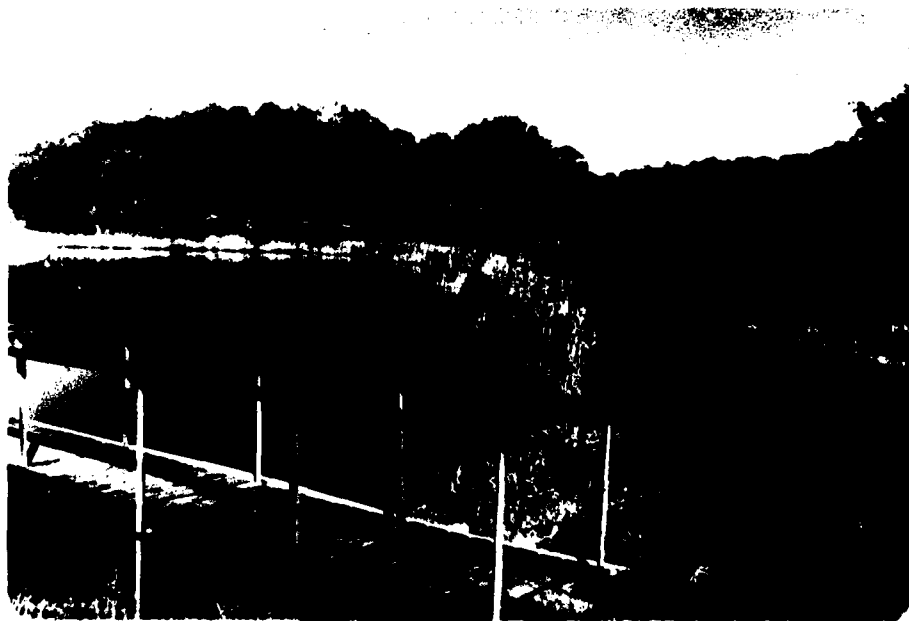
- (2) Upstream Slope. The upstream slope is well covered with adapted grasses from the crestline down to near the waterline. Cattails are growing at the waterline along the entire length of the dam. A few small trees and some brush are also growing on the slope. There was no significant erosion observed on the upstream slope. There were no cracks, slides, slumps, deformations or rodent holes. The upstream slope is shown in Photo No. 3.

PHOTO NO. 3 - UPSTREAM SLOPE TAKEN FROM THE RIGHT END.

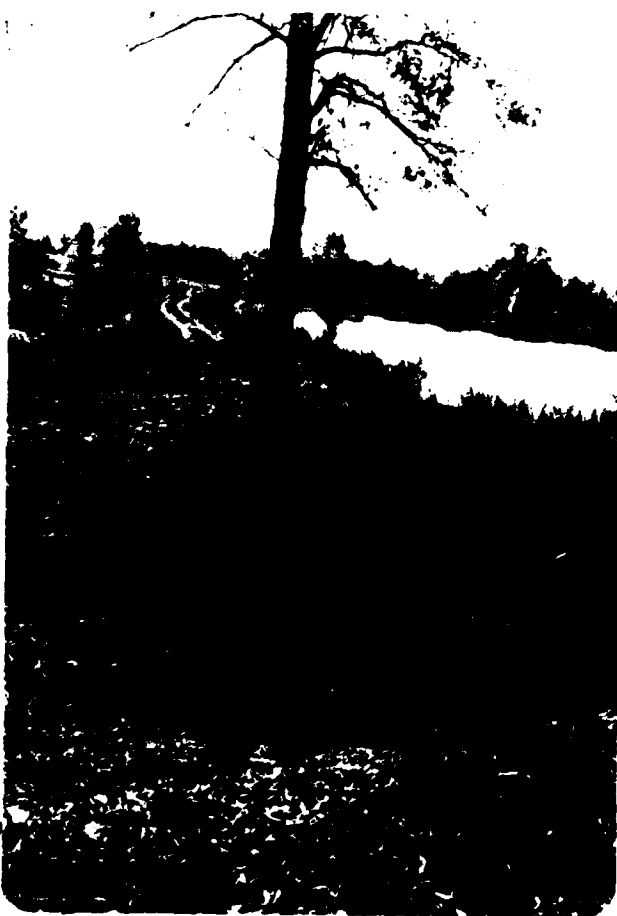
PHOTO NO. 5 - CREST LOOK-  
ING OVER THE SPILLWAY CUT.

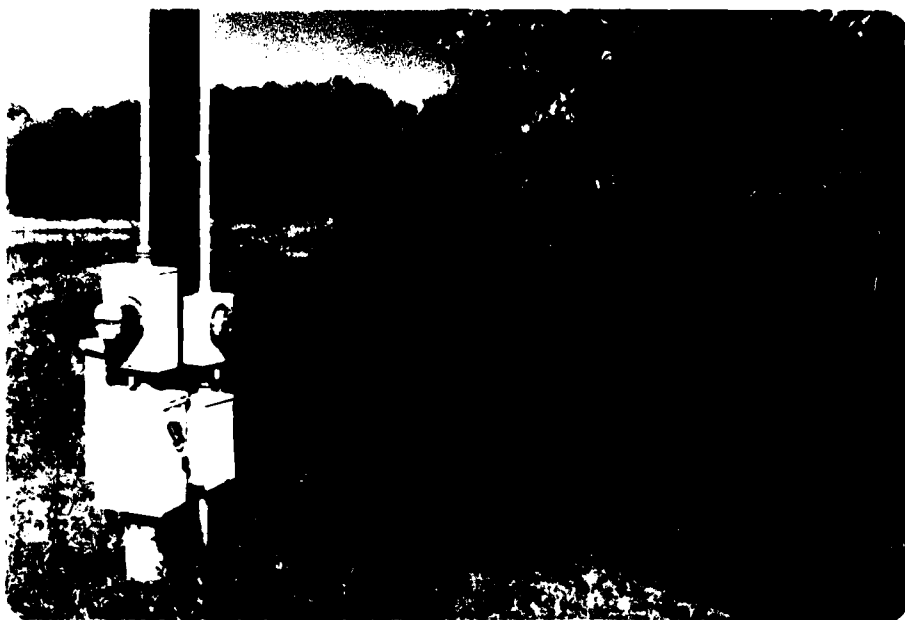
PHOTO NO. 6 - DOWNSTREAM SLOPE FROM THE RIGHT END.

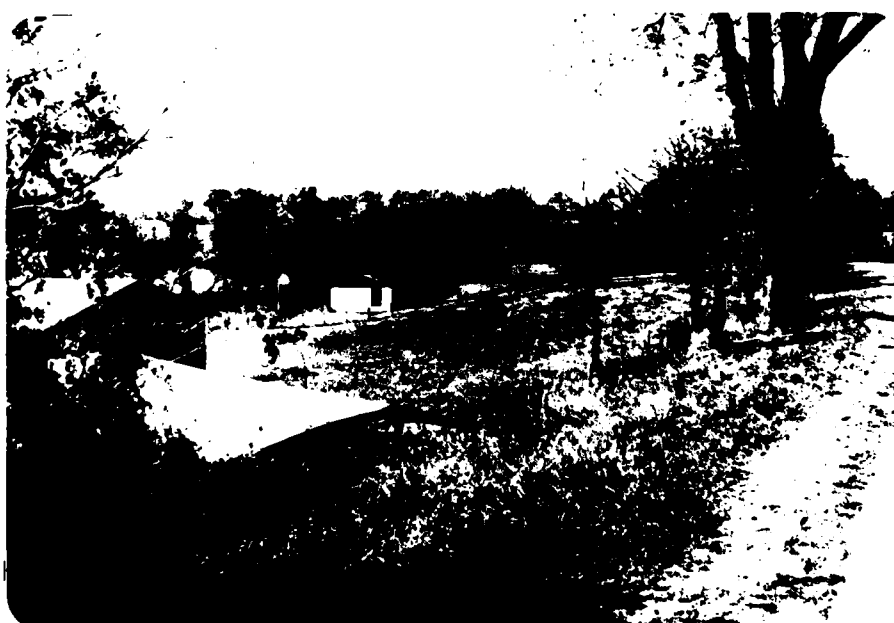
PHOTO NO. 19 - DWELLING AT 0.8 MILE BELOW THE DAM. THE DWELLING IS APPROXIMATELY 25 FEET ABOVE THE CREEK BED.
