**KEHR'S MILL TRAIL LOWER DAM  
ST. LOUIS COUNTY, MISSOURI  
MO 11277**

**PHASE 1 INSPECTION REPORT  
NATIONAL DAM SAFETY PROGRAM**

**NOVEMBER 1980**

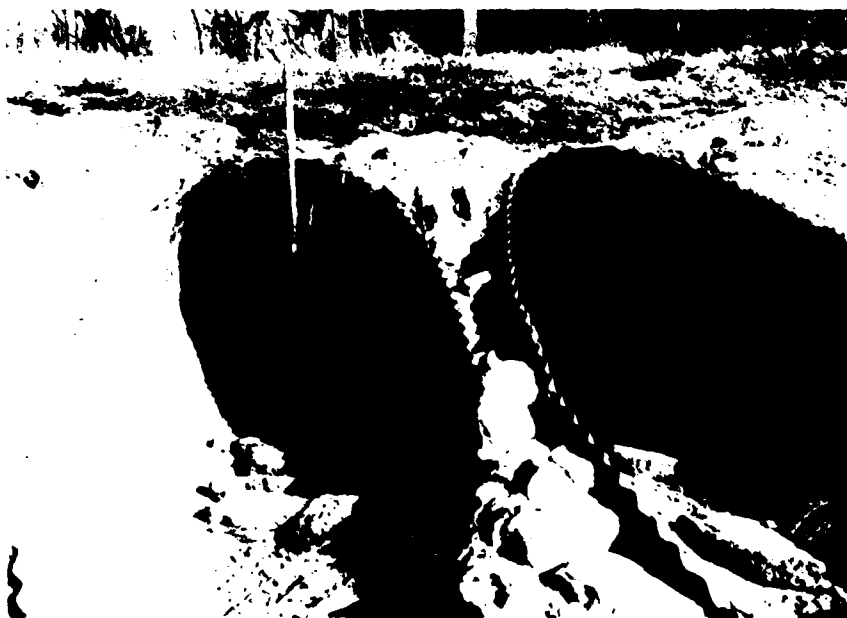
(1) The spillway appears to be in good condition. The lake level at the time of the inspection (El. 504.4) was below the spillway pipe inlet invert. There was an accumulation of debris at the pipe inlet (Photos 7 & 8) and trees were beginning to develop at the outlet (Photos 9 & 10) which could reduce the capacity of the spillway pipes. The channel downstream of the spillway was grown up with trees and brush but should not effect the capacity of the spillway.

PHOTO 8: INLET TO SPILLWAY PIPES

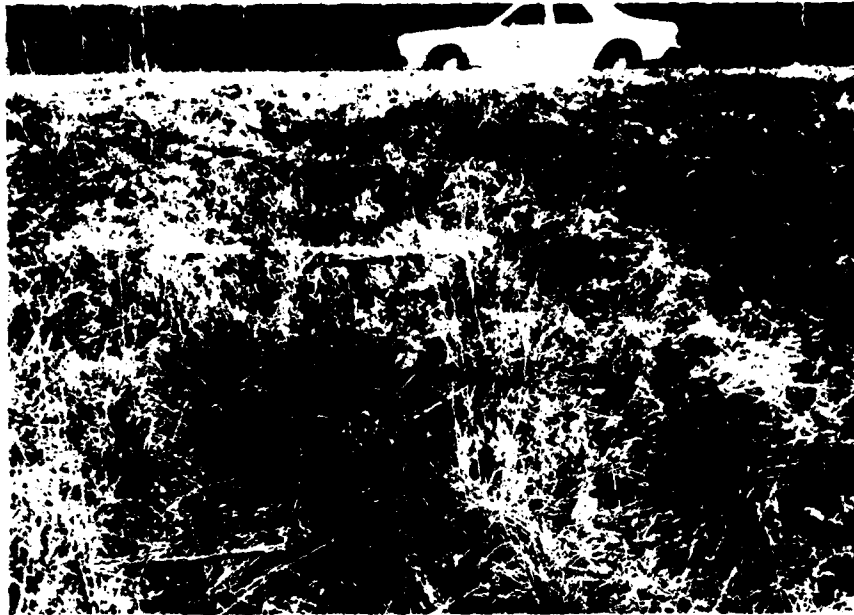
PHOTO 13: EROSION ON UPSTREAM FACE OF DAM

The erosion on the upstream and downstream faces of the embankment and on the right abutment should be repaired and a suitable ground cover should be established for erosion protection. Riprap protection should be provided to reduce the potential for wave induced erosion.
