DOVE LAKE DAM

COLE COUNTY, MISSOURI

**PHASE 1 INSPECTION REPORT
NATIONAL DAM SAFETY PROGRAM**

PHASE I INSPECTION REPORT
NATIONAL DAM SAFETY PROGRAM

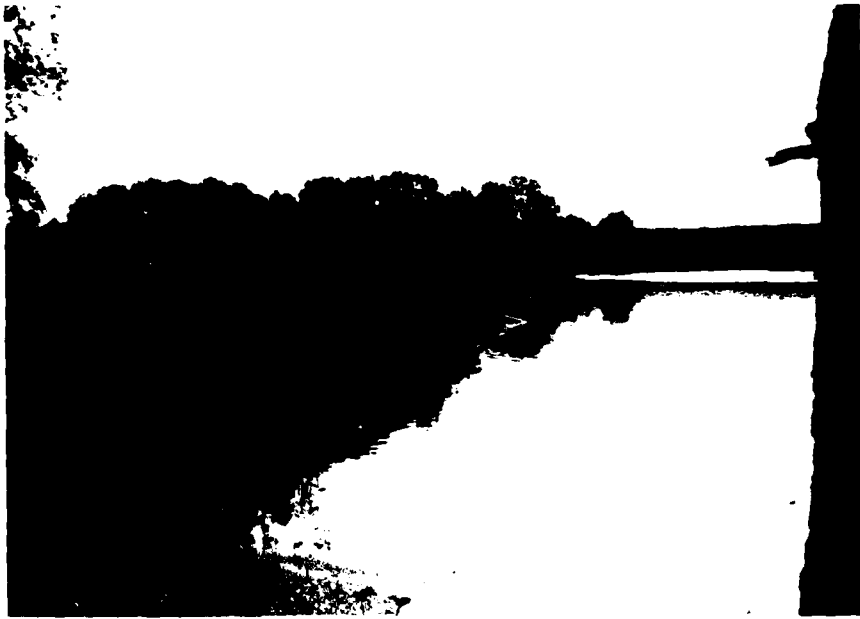
PHOTO 1: UPSTREAM FACE OF DAM LOOKING EAST

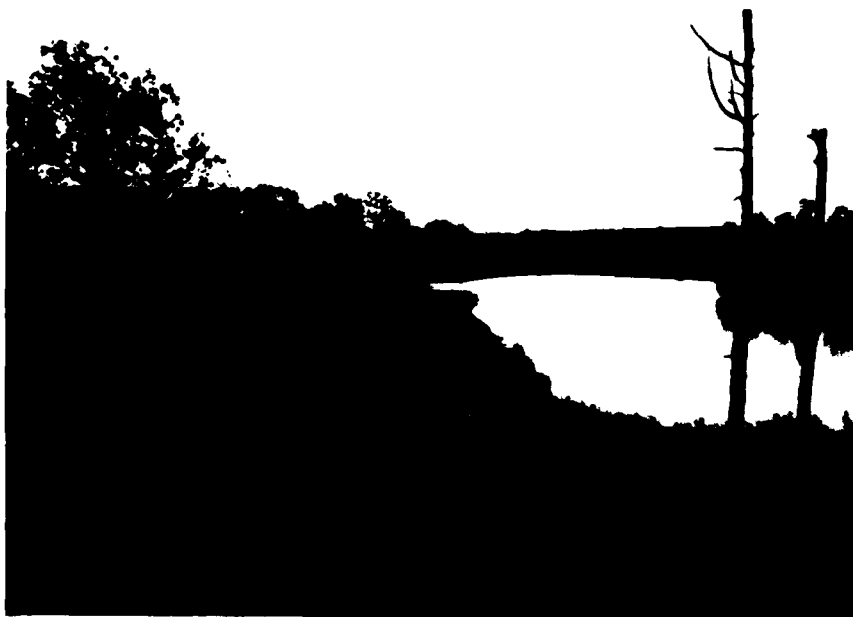
PHOTO 4: CREST OF DAM LOOKING EAST

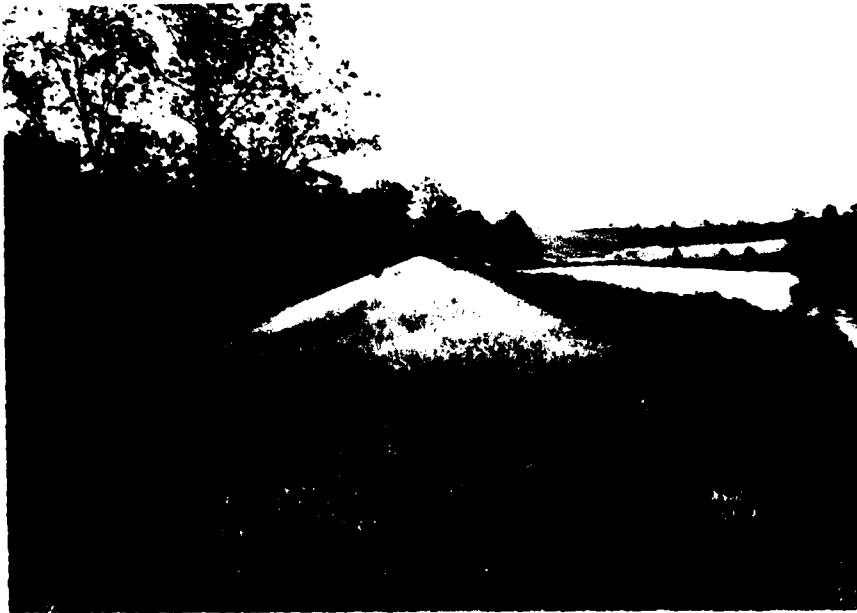
PHOTO 6: DOWNSTREAM SLOPE OF DAM LOOKING EAST

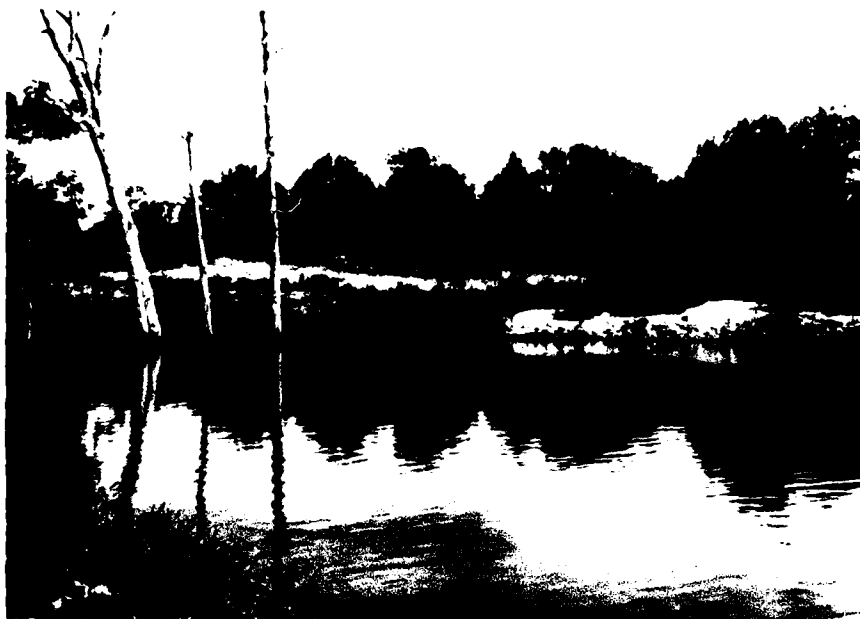
PHOTO 11: APPROACH TO EMERGENCY SPILLWAY
