GUTHRIE LAKE DAM
CALLAWAY COUNTY, MISSOURI
MO. 10990

**PHASE I INSPECTION REPORT
NATIONAL DAM SAFETY PROGRAM**

Name of Dam: Guthrie Lake Dam, Missouri Inv. No. 10990
State Located: Missouri
County Located: Callaway
Stream: McKinney Creek
Date of Inspection: June 4, 1980

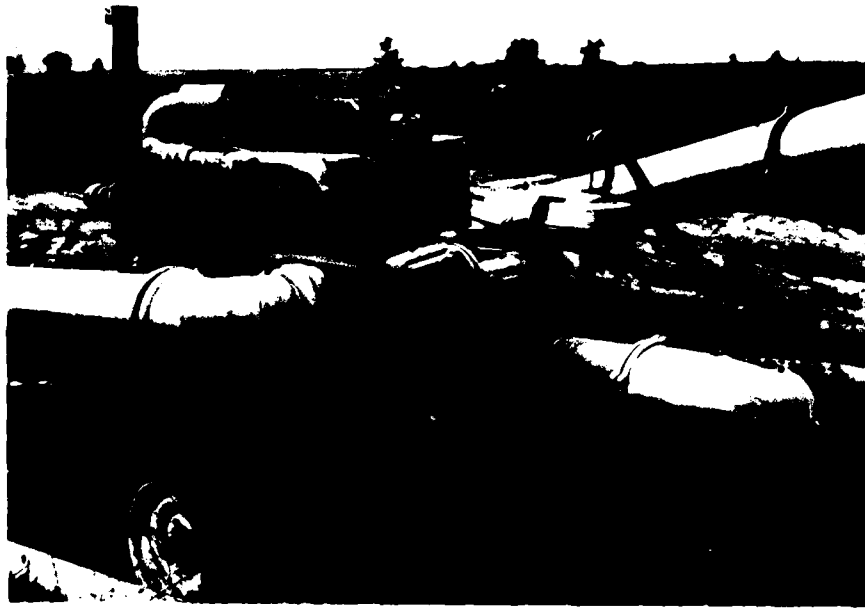
Photo 11

No low-level outlets or outlet works were provided for this dam; however, a portable, diesel powered, centrifugal pump is used at the damsite (see Photo 11). The pump is used to pump water from the reservoir to a central pivot irrigation sprinkler system on the reservoir rim. According to Mr. Guthrie, the pump has a capacity of 1,100 gallons per minute (gpm). The pump was last used during the summer of 1979.

There are no low-level outlets or outlet works provided for this dam. However, a portable, diesel-powered centrifugal pump, which cannot be considered an appurtenant structure, is used at the damsite. The pump is operable and is capable of draining the reservoir, according to Mr. Guthrie. The pump was last used during the summer months of 1979.

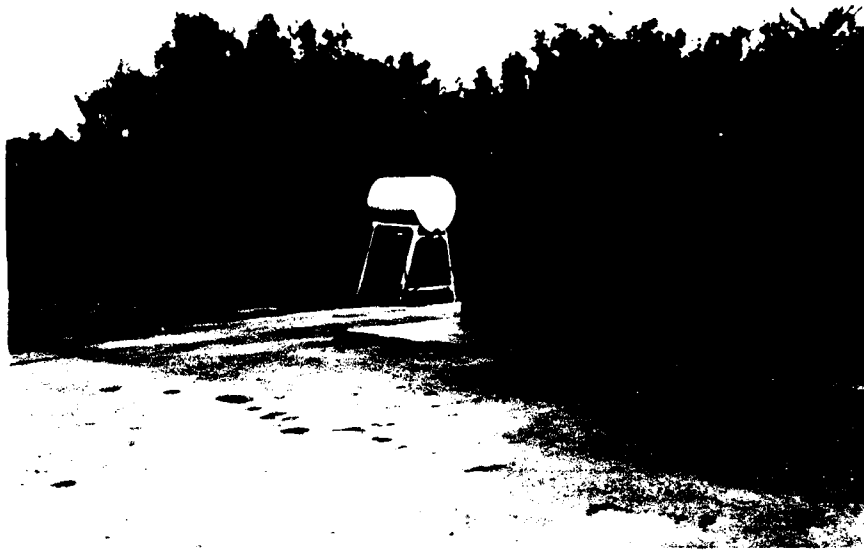
Photo 13

The dam has been classified as having a "high" hazard potential in the National Inventory of Dams, on the basis that in the event of failure of the dam or its appurtenances, excessive damage could occur to downstream property, together with the possibility of the loss of life. From a visual inspection of the downstream area, our findings concur with this classification. There are twelve dwellings, a commercial building, a bank, a Post Office, a U.S. highway (U.S. 54), and an Interstate highway (I-70) crossing within the estimated damage zone, which extends approximately three miles downstream of the dam (see Photos 13 and 14).
