ROCKWOOD HILLS LAKE DAM

TANEY COUNTY, MISSOURI

# PHASE 1 INSPECTION REPORT NATIONAL DAM SAFETY PROGRAM

JANUARY, 1981

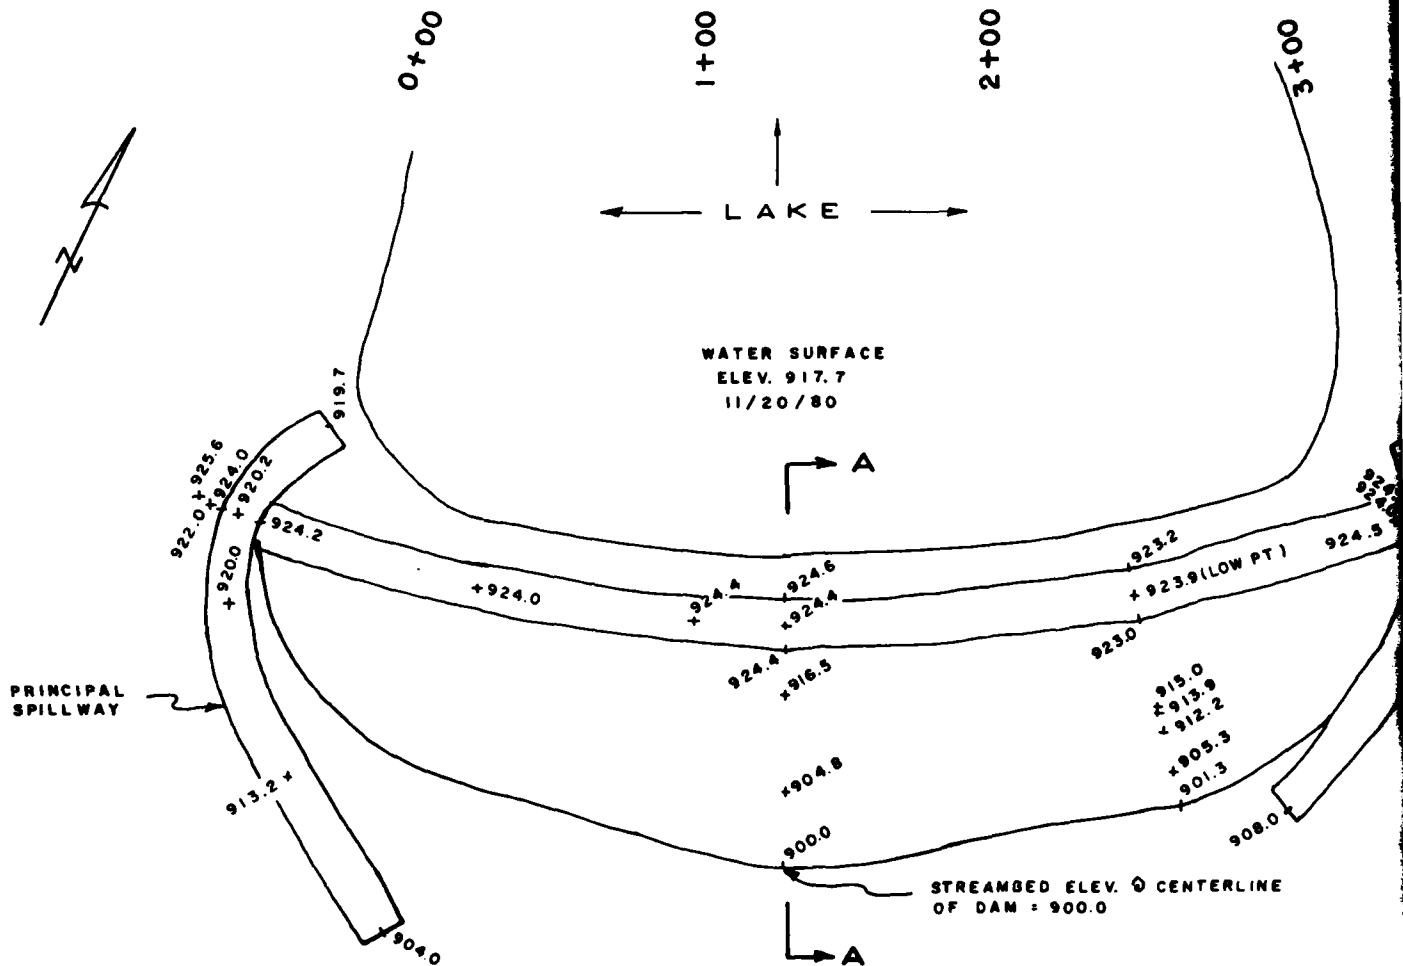
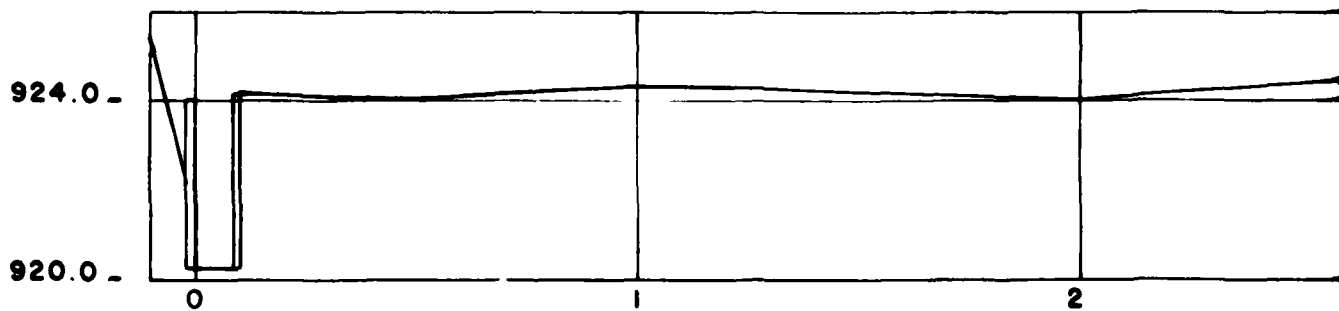
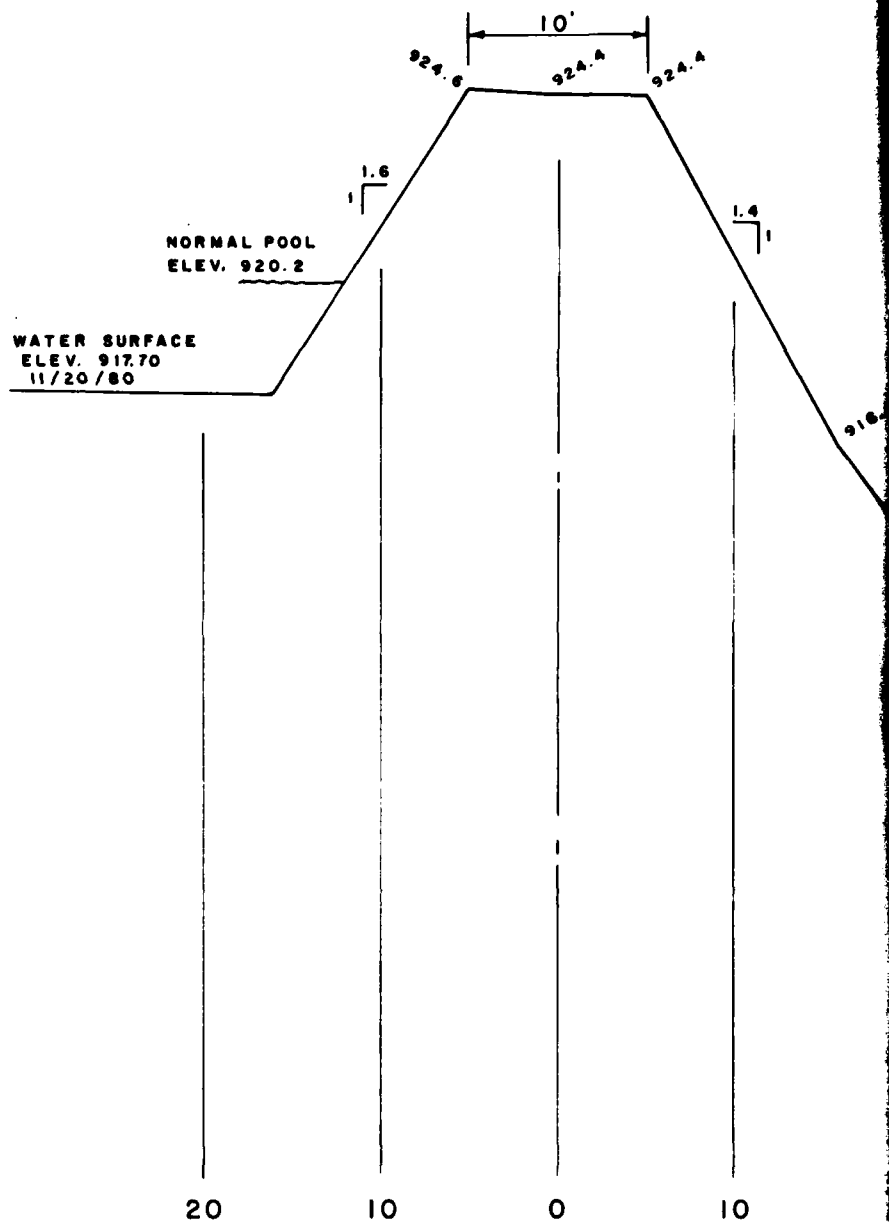
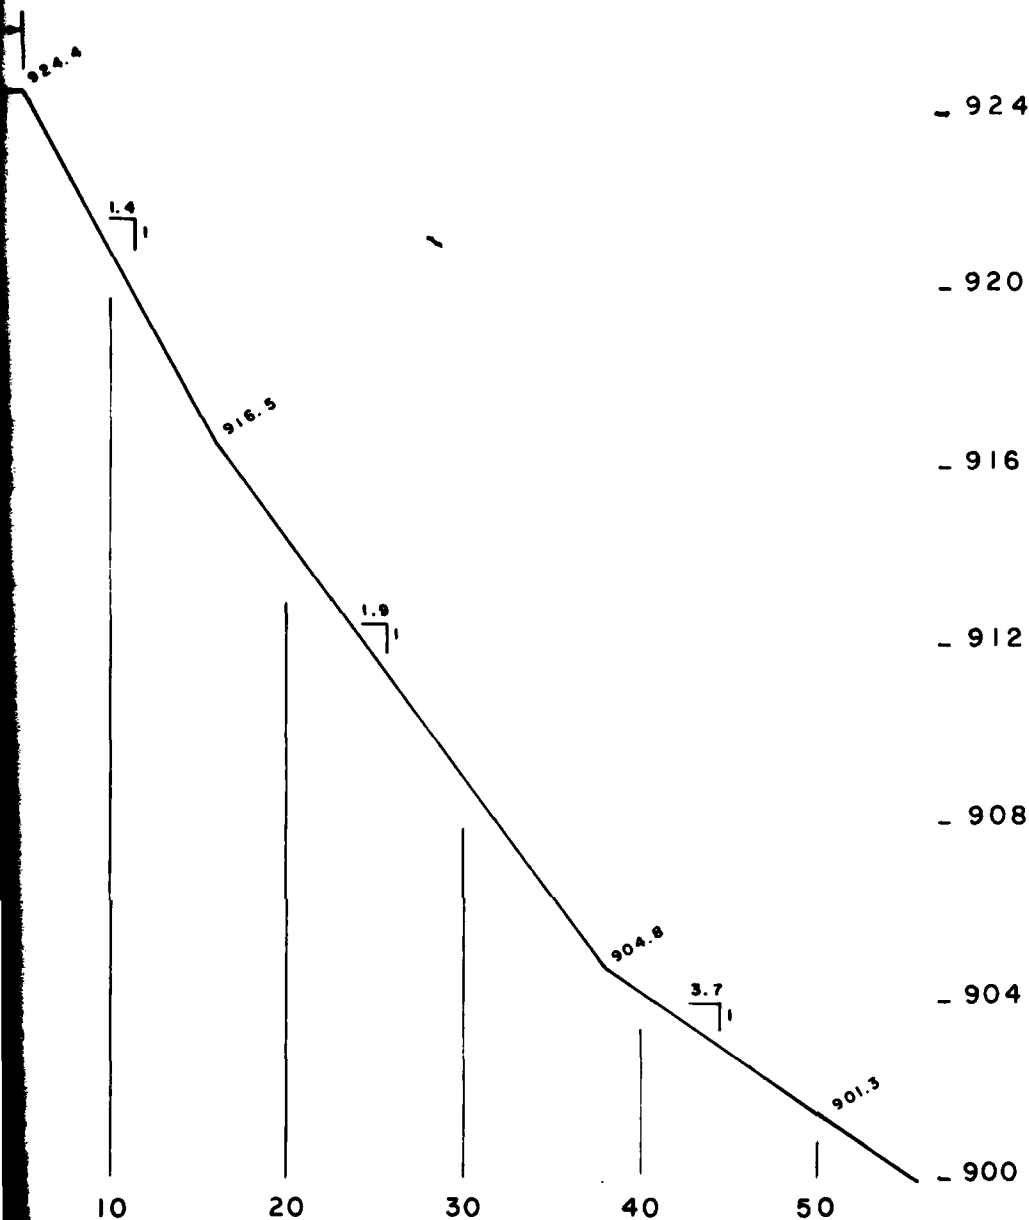
SHEET 3, APPENDIX A

Rockwood Hills Lake Dam is an earth fill structure approximately 25 ft high and 260 ft long at the crest. The appurtenant work consists of a 9 ft wide concrete chute principal spillway at the west abutment and an 8 ft wide concrete emergency spillway at the east abutment.
