HOLDEN WATER SUPPLY DAM

JOHNSON COUNTY, MISSOURI

MO 20532

PHASE 1 INSPECTION REPORT NATIONAL DAM SAFETY PROGRAM

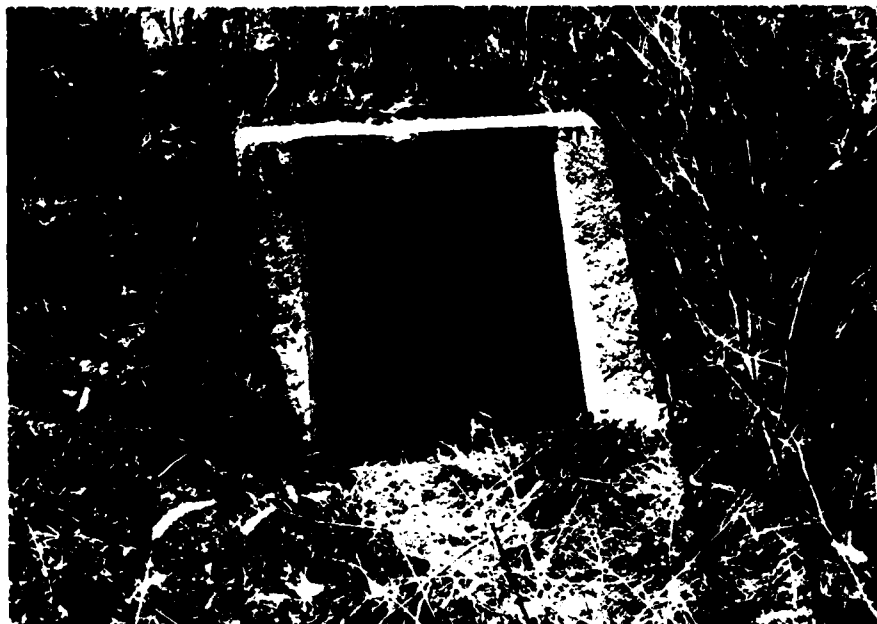
There was no evidence that a maintenance program was in effect. Unmowed grass was observed on both faces of the dam. No trees were observed on the embankment. An 8-inch outlet to the toe drain system

was observed to be dry. Many small animal burrows were observed in the embankment. There was no evidence of seepage through the embankment at the time of inspection.

PHOTO 13: OUTLET FROM TOE DRAIN SYSTEM
