SWEETWATER DAM (NO NAME 251)  
JEFFERSON COUNTY, MISSOURI

MISSOURI INVENTORY NO. 30436

PHASE I INSPECTION REPORT  
NATIONAL DAM SAFETY PROGRAM

DATE OF INSPECTION: 15 December 1978

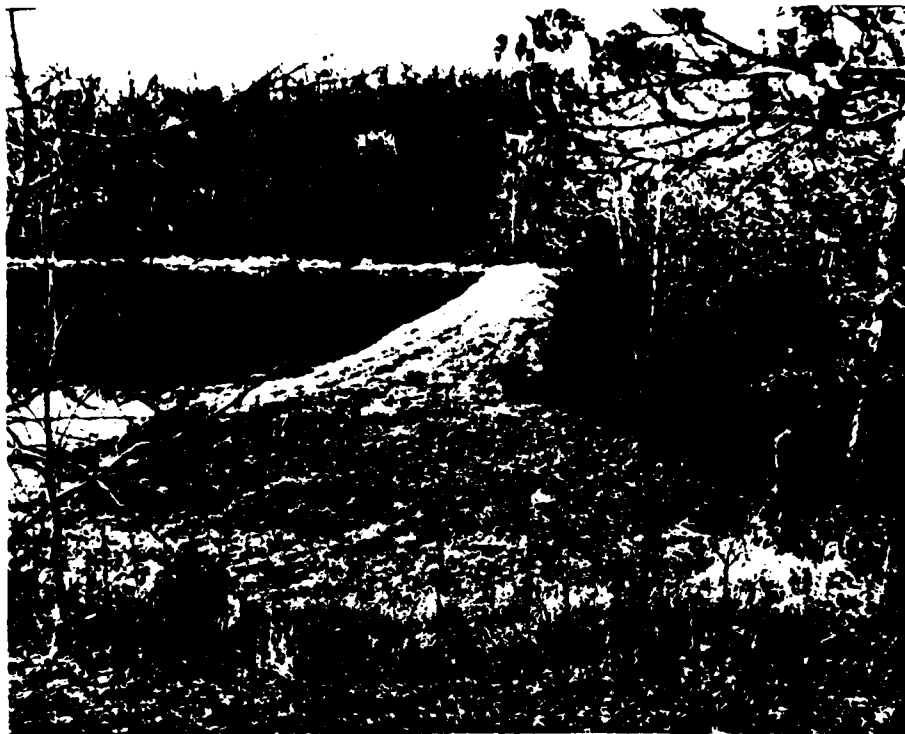
As shown on Photos 1 through 6, the downstream slope of the dam and the left spillway area has not been maintained as evidenced by the heavy brush and tree growth. Also, the scour hole and ditch downstream of the spillway at the right abutment has not been repaired (see paragraph 3.1c).

PHOTO 1 TOP OF DAM (RIGHT SPILLWAY IN FOREGROUND. SCOUR HOLE BEGINS IN FRONT OF MAN AT RIGHT OF PHOTO.)

(1) Repair scour hole and ditch which have been eroded downstream of the spillway at the right abutment, and take corrective measures to prevent reoccurrence of this problem.

(3) Remove all trees and bushes growing on the embankments of the dam and in the left spillway approach channel and in both spillway exit channels. Removal of the stumps and roots of large trees should be done only under the direction and guidance of an engineer experienced in the design and construction of dams. Indiscriminate clearing could jeopardize the safety of the dam. Potential exists for other deficiencies such as rodent holes to be found after the trees and brush have been removed. Establish a grass or ground cover in those areas after the trees and brush have been removed and any rodent holes found have been filled.
