ARMY ENGINEER DISTRICT MEMPHIS TN  
NATIONAL DAM SAFETY PROGRAM, TURKEY CREEK DAMS (MO 31101, MO 31--ETC(U)  
AUG 79 J L ANDERSON, H L SMITH, R O SMITH

14. MONITORING AGENCY NAME & ADDRESS (If different from Controlling Office) (1) National Dam Safety Program. Turkey Creek Dams (MO 31101, MO 31108, MO 31109, MO 31602), Mississippi - Kaskaskia - St. Louis Basin, Wayne County, Missouri. Phase I Inspection Report.		12. REPORT DATE (11) August 1979

PHASE I INSPECTION REPORT  
NATIONAL DAM SAFETY PROGRAM  
TURKEY CREEK DAMS

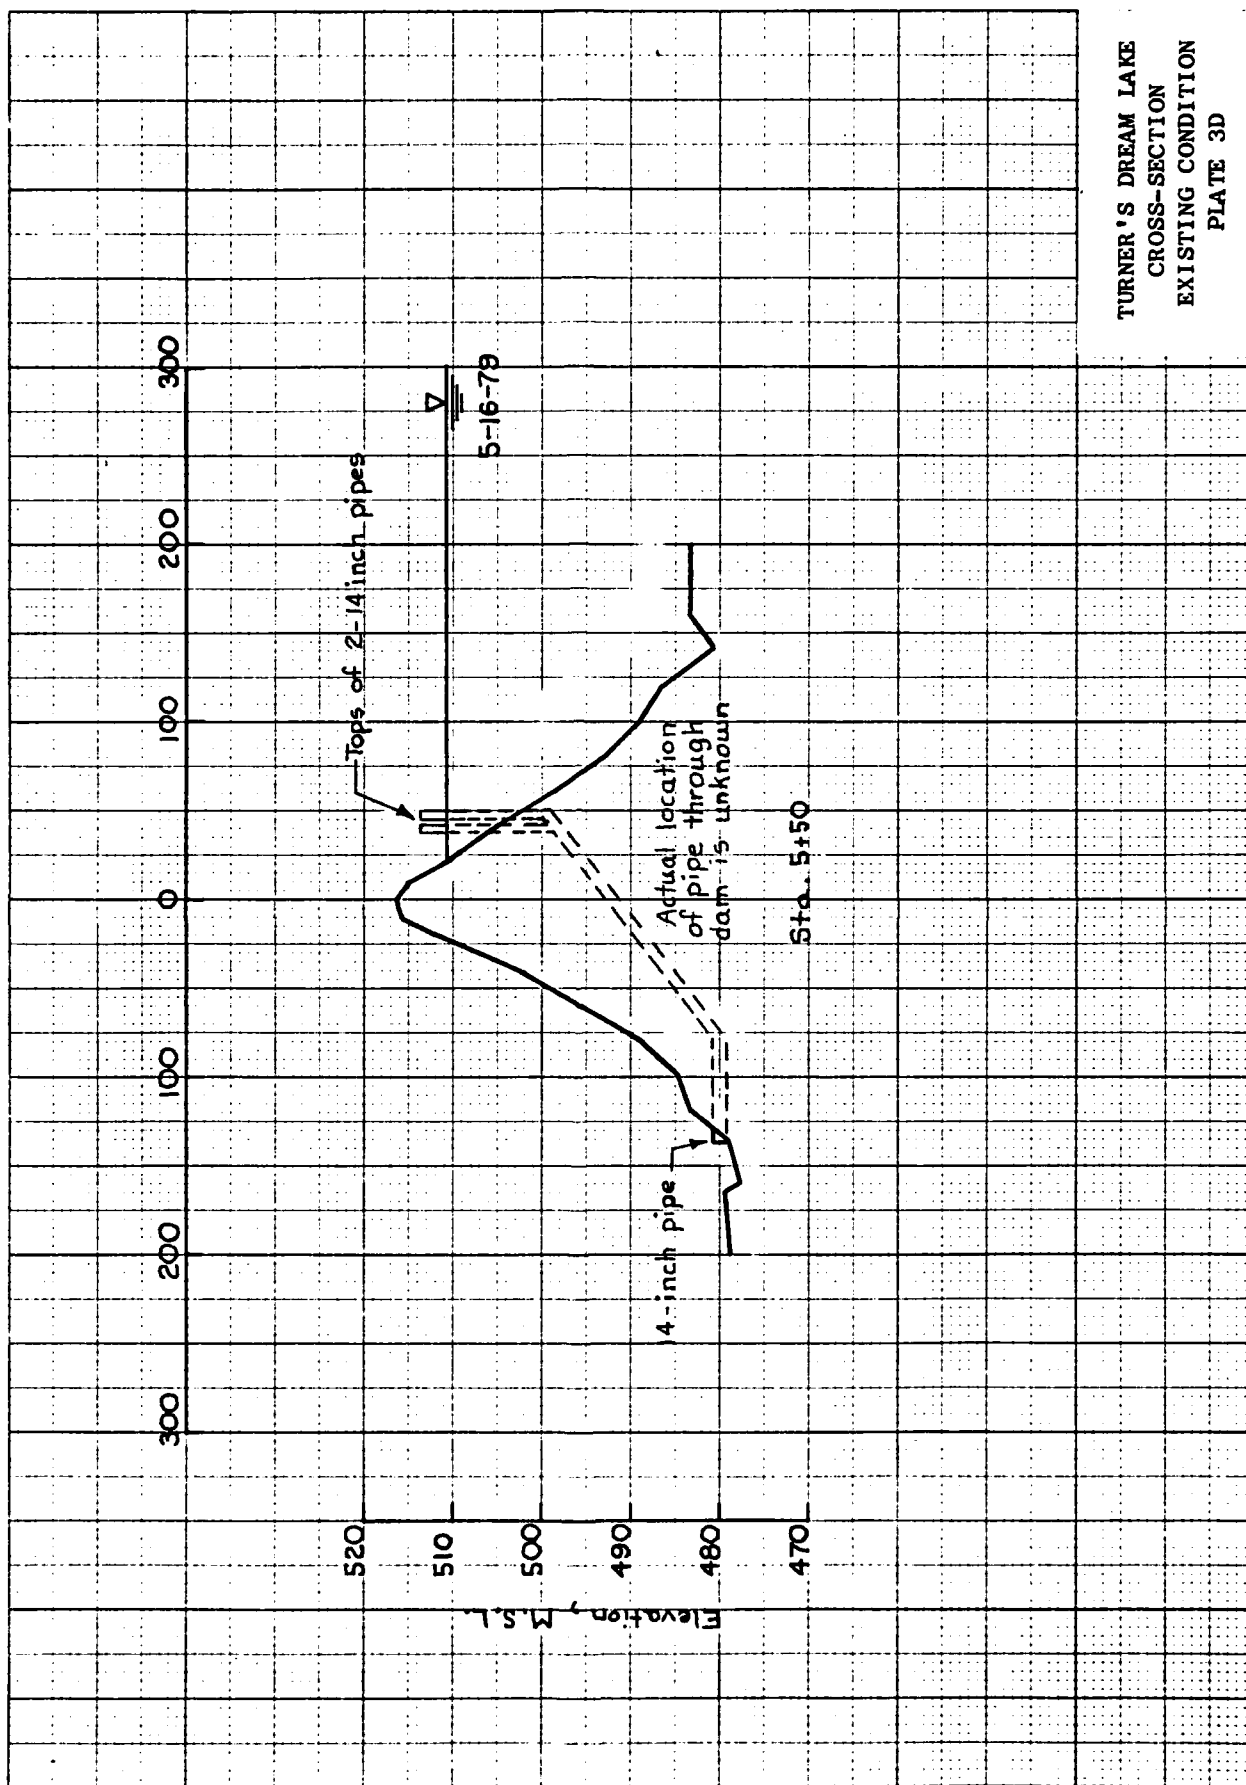
TURNER'S DREAM LAKE  
CROSS-SECTION  
EXISTING CONDITION  
PLATE 3D

(1) Dam. No detrimental settlement, cracking, slides or animal burrows were observed in or near the earth embankment. Typical existing cross-sections of the embankment are shown on Plate 3D. The crown width was 20 feet. Based on the existing cross-section, the upstream embankment has an average slope of 1V on 2.9 H (See Plate 3D), and the downstream embankment has an average slope of 1V on 3.5 H (see Plate 3D and Photo 3D).

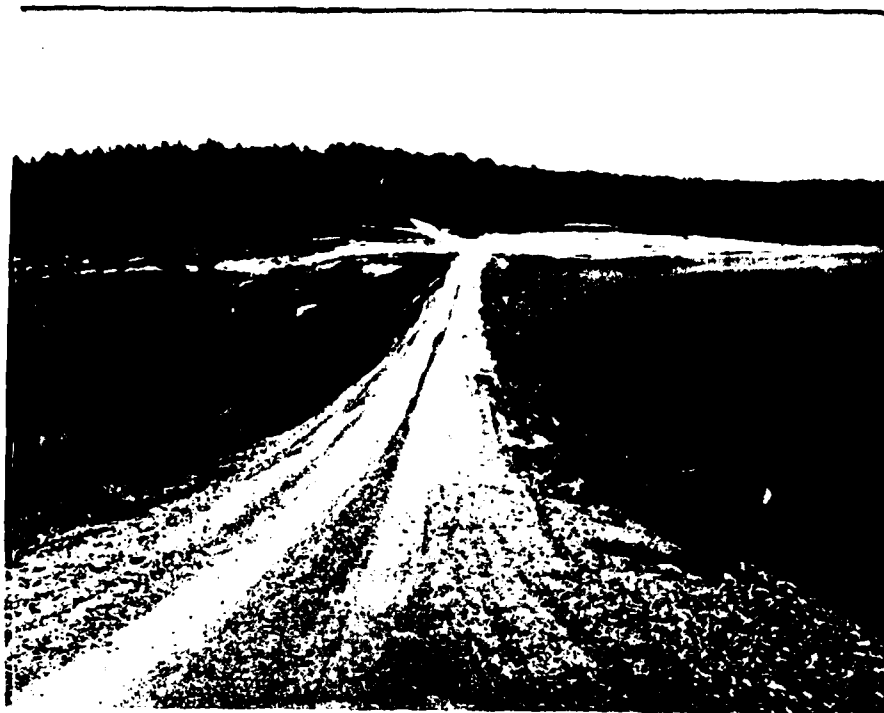
PHOTO 1B: Overview of Lake and Dam

The growth of trees and bushes is almost non-existent on the dam embankments (see Photos 1B, 2B, and 3B). On the downstream embankment grass has been sown to prevent erosion. However, erosion gulleys have formed near the dam crest. The most serious of these gulleys have been repaired with riprap (see Photo 9B). The upstream slope is protected with riprap except near the right abutment. In this area, slight wavewash is present on the dam face (see Photo 6B).

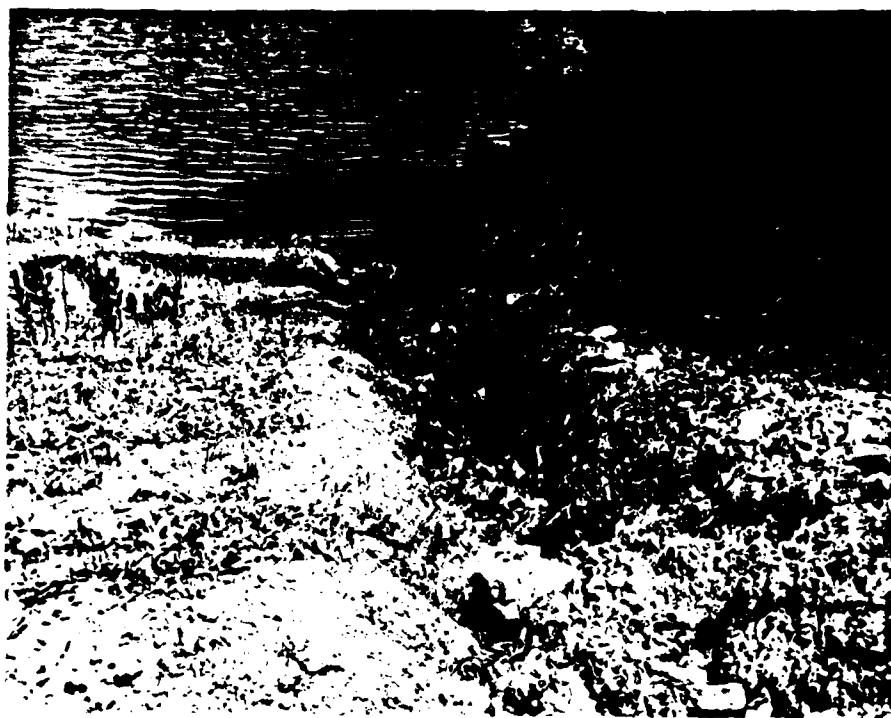
PHOTO 7B: Erosion Gully in Upstream Embankment  
near Left Abutment

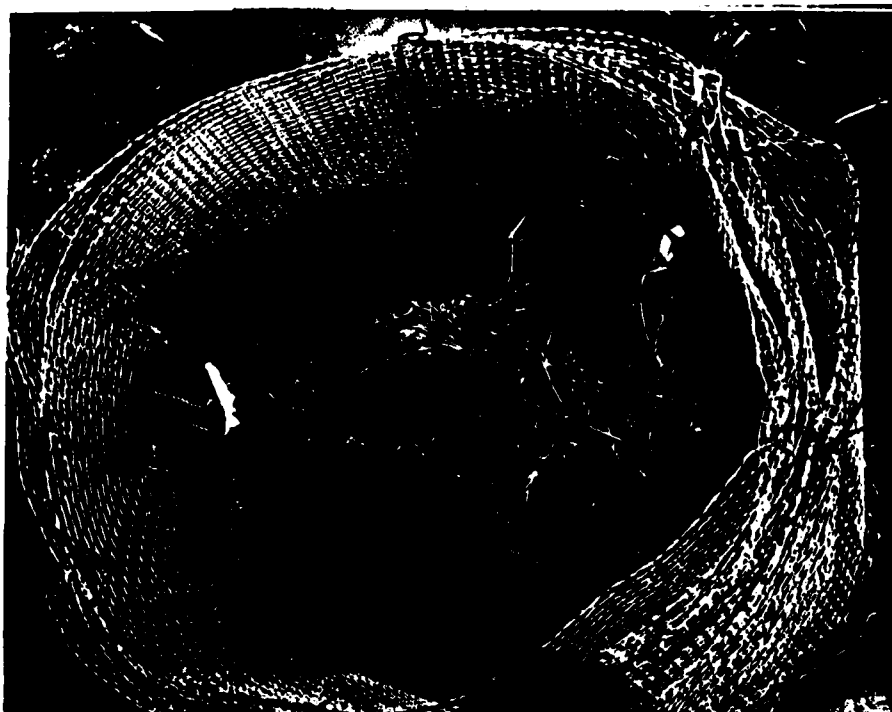
PHOTO 4E: Inlet of Vertical Discharge

(2) Appurtenant Structures. Two separate drop inlet structures are the primary means of discharge for this structure (see Photo 4E). Each respective drop inlet consists of approximately 2 feet of 14 inch steel pipe junctioned with 40 feet of 14 inch horizontal pipe through the embankment. The drop inlets and outlet pipes appear to be in good condition. There is no emergency spillway for this structure. The outlet channel for the primary discharge was in good condition (see Photo 6E).
