CHAIN OF LAKES DAMS
WAYNE COUNTY, MISSOURI

MISSOURI INVENTORY NOS. 30347
30348
31032

PHASE I INSPECTION REPORT
NATIONAL DAM SAFETY PROGRAM

MAY 1978

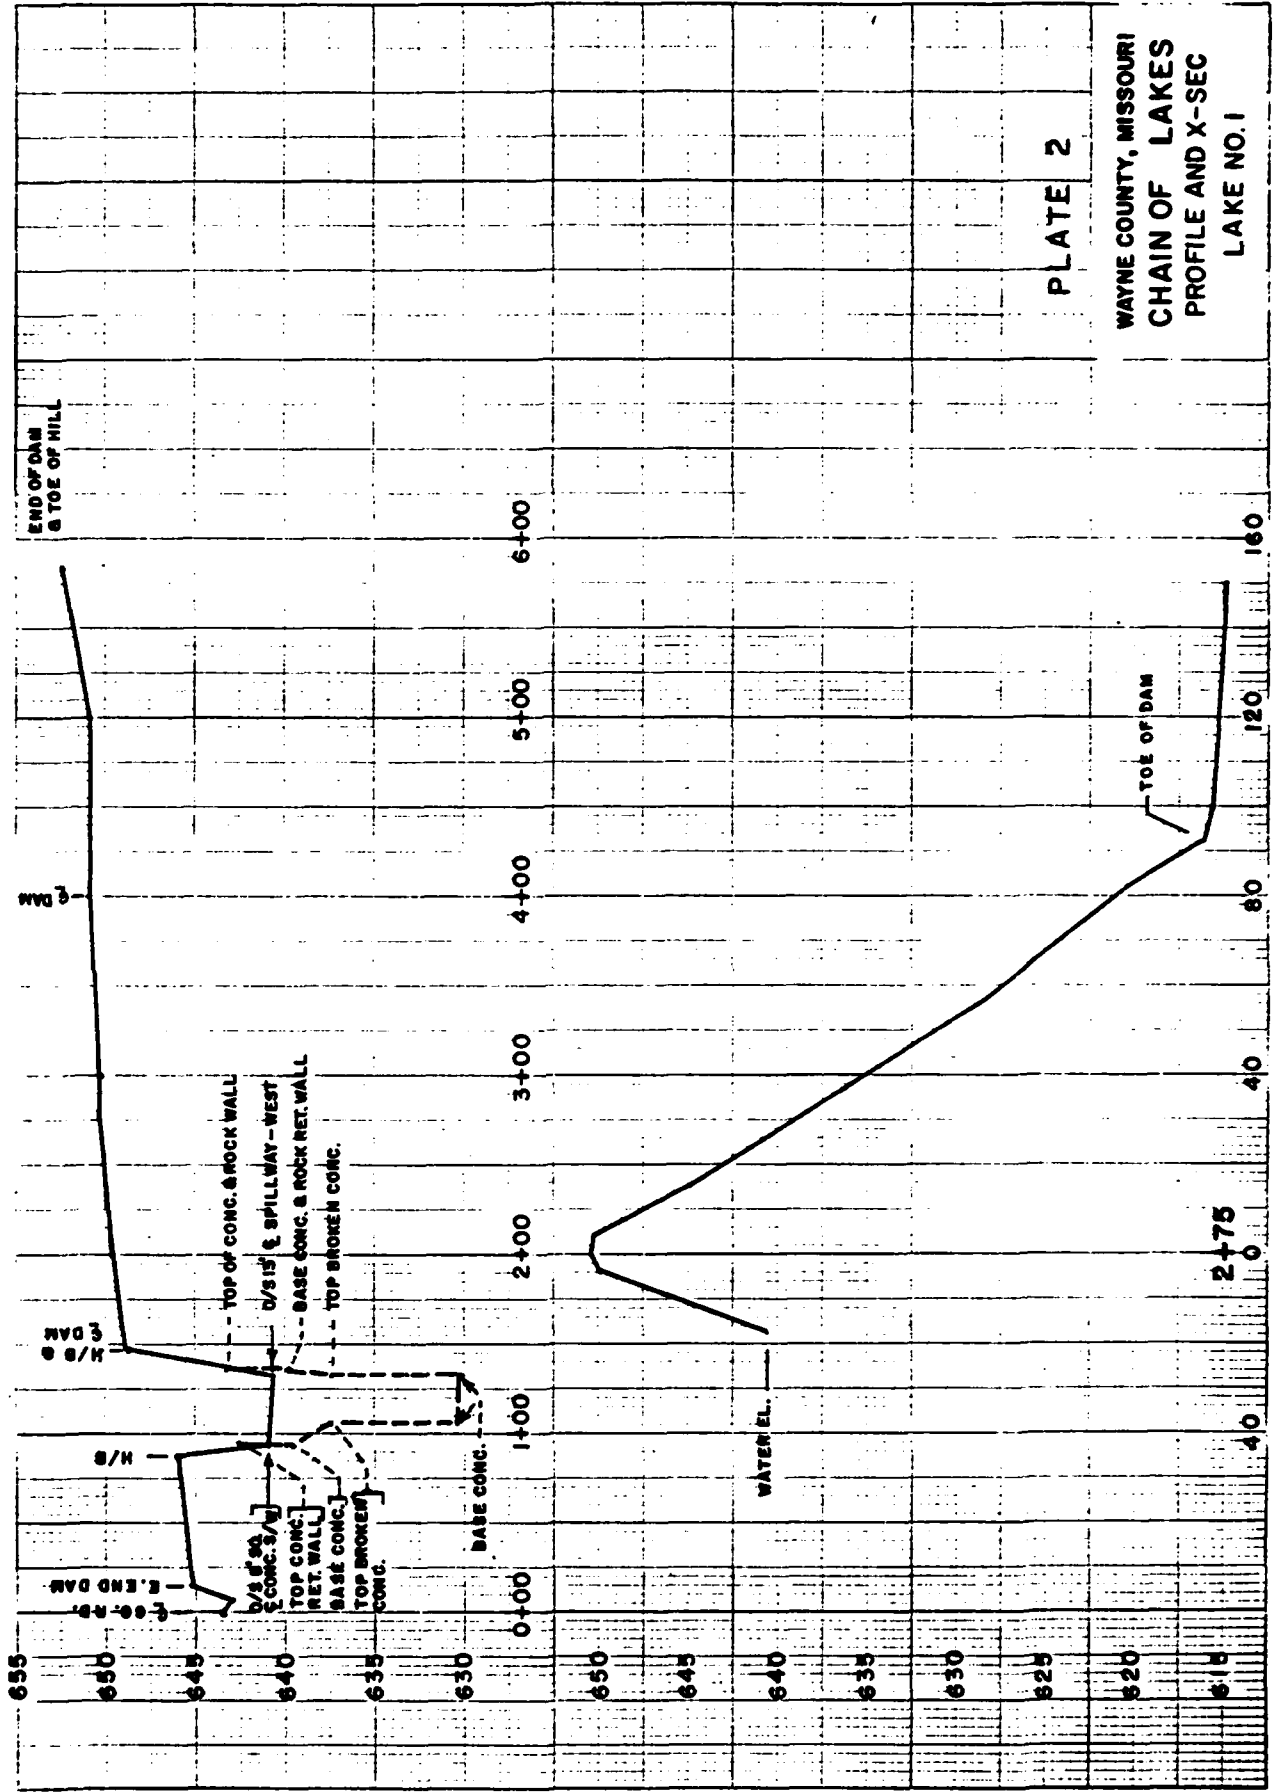
PLATE 2

Embankment cross-sections at the maximum height section for each dam are shown on Plates 2 through 4. In a few areas, the embankment slopes are considerably steeper than the section shown. One animal burrow was noted near the crown of dam No. 2. No burrows were noted below pool level at any of the dams but some could be present and masked by vegetation.
