LAKE LOTAWANA DAM
JACKSON COUNTY, MISSOURI
MO. 20040

PHASE 1 INSPECTION REPORT NATIONAL DAM SAFETY PROGRAM

PHASE I INSPECTION REPORT
NATIONAL DAM SAFETY PROGRAM

BLACK & VEATCH
CONSULTING ENGINEERS
KANSAS CITY, MISSOURI

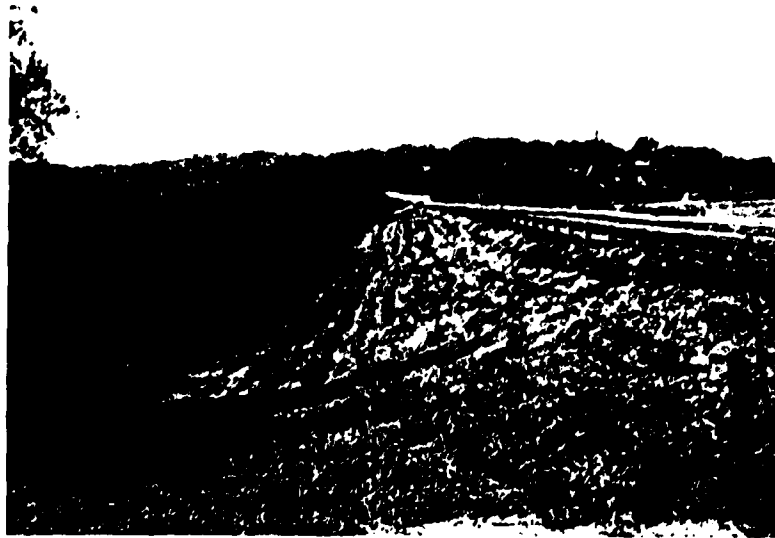
Existing seepage, deterioration of the uncontrolled outlet pipe, and excessive growth of small timber and brush observed on the downstream side of the dam increase the potential for failure and warrant regular monitoring and control.

PHOTO 1: DOWNSTREAM FACE OF DAM (LOOKING SOUTH)

(6) A regular maintenance program should be initiated to control the growth on the downstream slope of the dam.

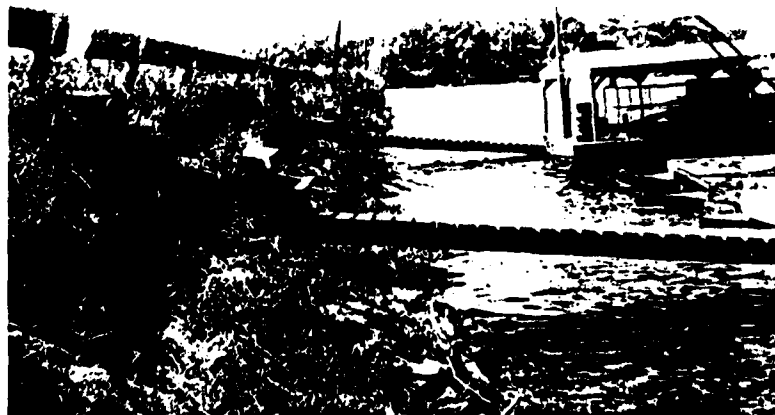
b. Dam. The inspection team observed the following items at the dam. The upper three feet of the upstream face of the embankment did not have riprap protection. Also an area of the upstream face extending from the south abutment to approximately 50 feet north of the south abutment was not protected by riprap. Some sloughing of the riprap on the upstream face was observed. This appeared to be due to the steep slope of the embankment. The existing riprap was limestone rock in sizes generally less than 50 pounds. At several locations on the upstream face the embankment material has eroded approximately 1 to 2 feet in depth leaving the riprap to bridge over the eroded area. An erosion ditch was observed along the upstream side of the south abutment. The surface material on the downstream side of the embankment and the south abutment was loose and uncompacted. This material is sloughing and eroding. Erosion and moist soil conditions in this same area indicate the presence of seepage through the south abutment. A heavy growth of brush and trees exist along the downstream toe of slope of the dam. The cast iron discharge pipe near the south abutment has been broken to about 2 feet from the embankment. Only one of the drains provided at the toe of the downstream slope was observed to flow freely. Others were either clogged or could not be observed.

PHOTO 2: UPSTREAM FACE OF DAM (LOOKING SOUTH)

(3) The riprap surface on the upstream face should be repaired to prevent further erosion of embankment material.

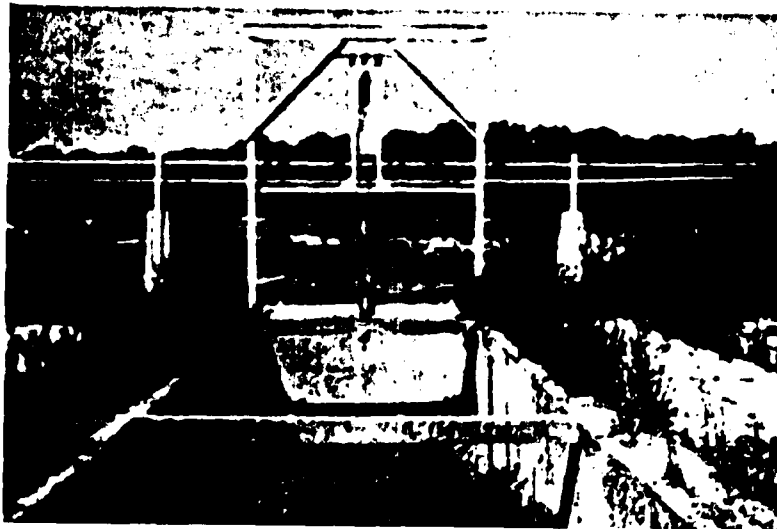
(2) A concrete lined spillway channel was constructed after excavation of the limestone strata in the north abutment. A 7 by 12 feet channel was excavated within the spillway apron to permit lake drawdown of 7 feet during the reconstruction of the dam crest and downstream face. A vertical lift gate was provided to prohibit flow into the 7 by 12 feet channel. The lift mechanism and gate have been welded in place and are not operable.

PHOTO 3: VERTICAL LIFT GATE AND BRIDGE OVER SPILLWAY

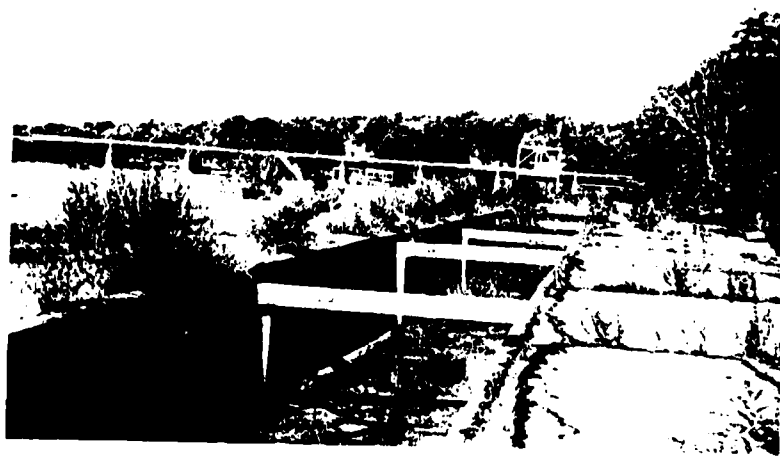
PHOTO 4: SPILLWAY AND CHANNEL (LOOKING UPSTREAM)

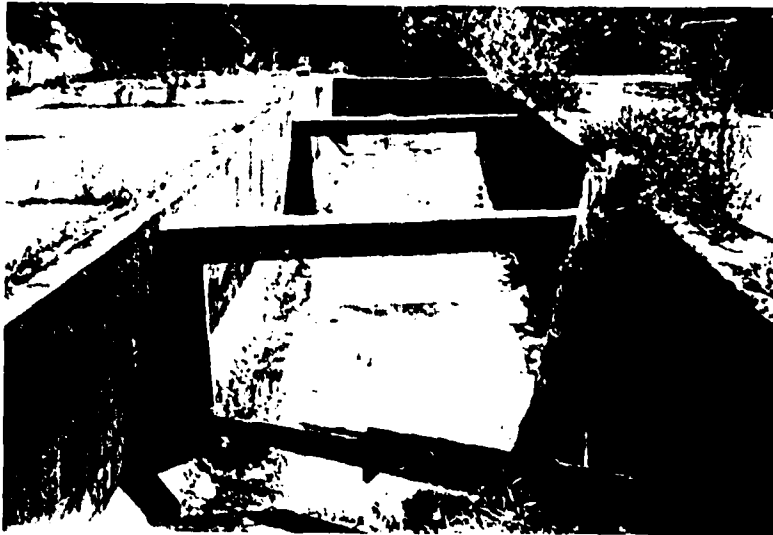
PHOTO 5: SPILLWAY AND CHANNEL (LOOKING DOWNSTREAM)

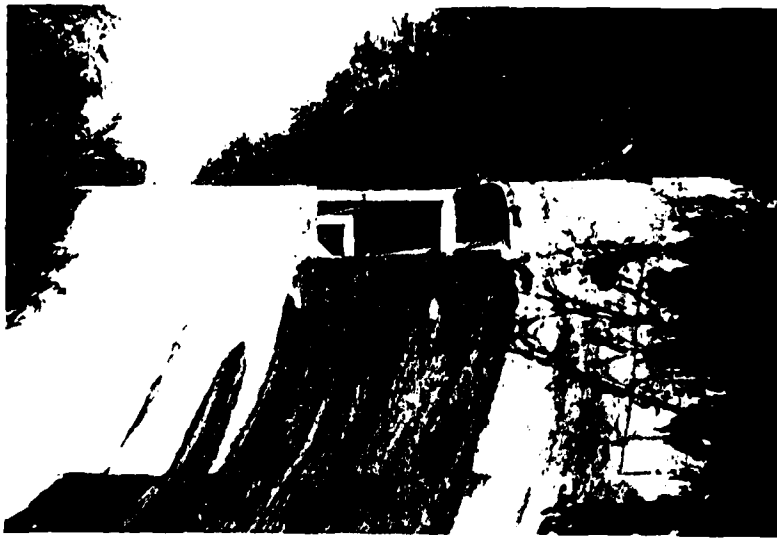
(1) Concrete spillway and the spillway discharge channel are in good condition. Seepage was observed from the weep hole on the inclined face of the spillway outlet at the end of the channel. Minor erosion was noted behind the north training wall of the spillway outlet.

PHOTO 6: SPILLWAY DROP AND END OF CHANNEL (LOOKING UPSTREAM)

(2) Measures to curtail seepage along the spillway and south abutment could be undertaken to minimize water loss and potential hazards.

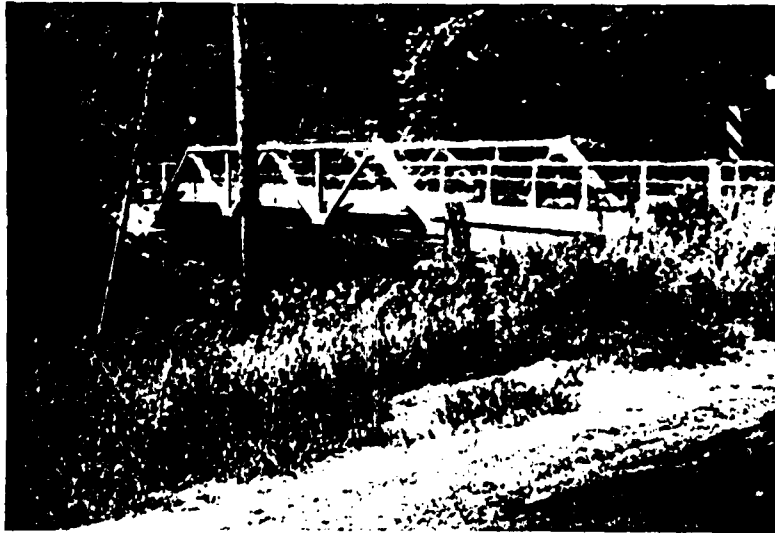
PHOTO 13: COLBURN ROAD BRIDGE (APPROX. 1 MILE
DOWNSTREAM OF DAM)
