SEVAN DAM

JEFFERSON COUNTY, MISSOURI

MO 30453

PHASE I INSPECTION REPORT  
NATIONAL DAM SAFETY PROGRAM

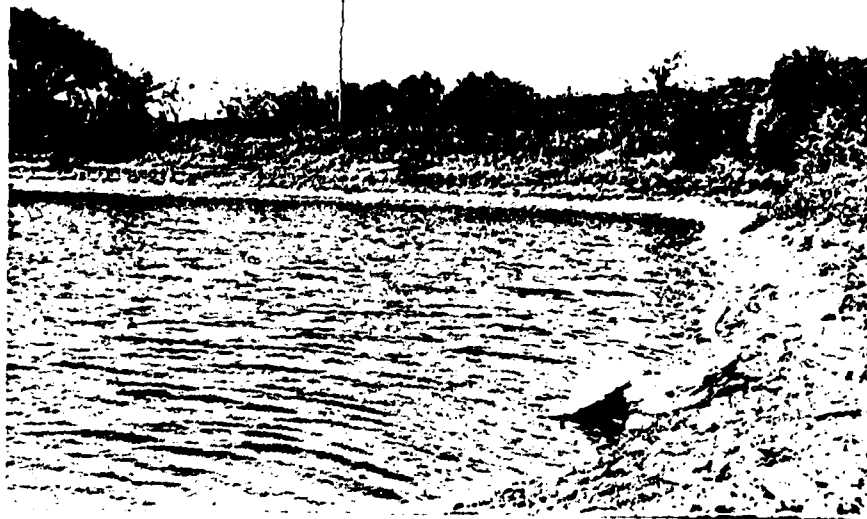
The upstream slope of the embankment is provided with a light vegetative cover. Minor sloughing was observed on the slope near the normal high water mark. Some trees and large brush were observed growing on the slope near the crest of the embankment.

Photo 3 - View of upstream slope of embankment taken from right side of dam.
