MO. NO NAME NO. 258 DAM
JEFFERSON COUNTY, MISSOURI
MO. 30455

PHASE I INSPECTION REPORT
NATIONAL DAM SAFETY PROGRAM

JULY 1981

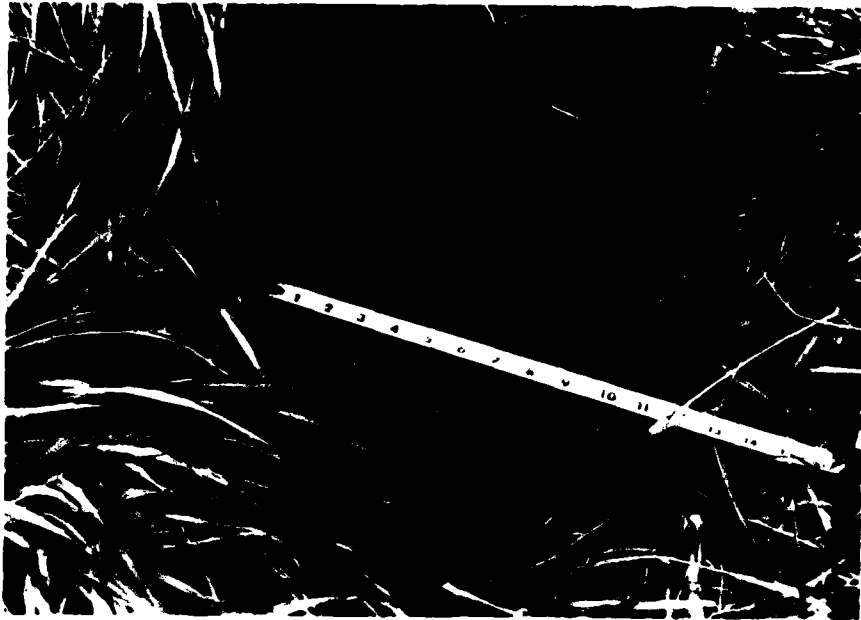
Rodent burrows up to four inches in diameter were observed in several places on the downstream slope (see Photo 5). No evidence of burrowing animals was apparent on either abutment or the remaining portion of the dam.

7. The animal burrows observed on the downstream slope could jeopardize the safety of the dam. The holes created by the animals make avenues for possible piping.

Photo 5 - Close-up view of a rodent burrow on the downstream embankment slope.
