MALE (C T) ASSOCIATES SCHENECTADY NY  
NATIONAL DAM INSPECTION PROGRAM. TILLSON LAKE DAM (NY00083), LO--ETC(U)  
AUG 81 K J MALE, W M SMITH

| REPORT DOCUMENTATION PAGE | | READ INSTRUCTIONS<br>BEFORE COMPLETING FORM |
|---|---|---|
| 4. TITLE (and Subtitle)<br>Phase I Inspection Report<br>Tillson Lake Dam<br>Lower Hudson River Basin, Ulster County, N.Y.<br>Inventory No. 83 | | 5. TYPE OF REPORT & PERIOD COVERED<br>Phase I Inspection Report<br>National Dam Safety Program |

31 Aug 81

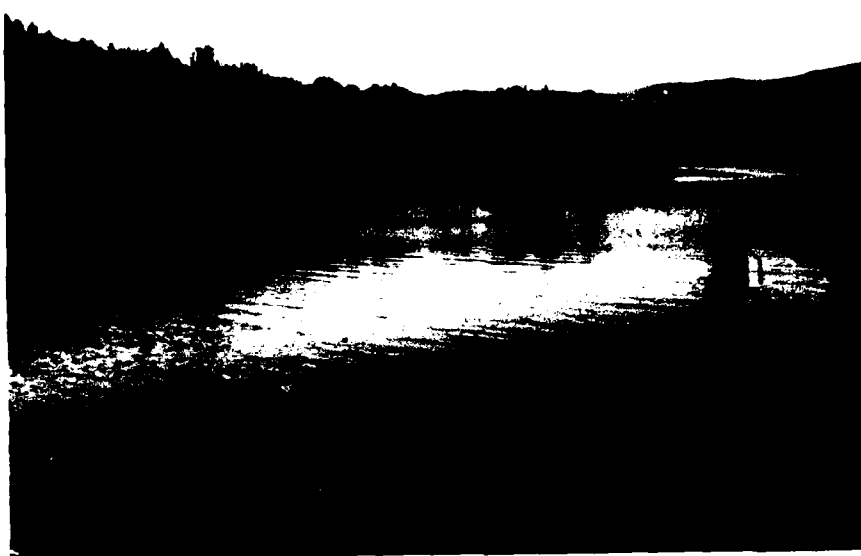
A-9A Reservoir shoreline looking upstream from dam. Note control tower at left - 4/8/81

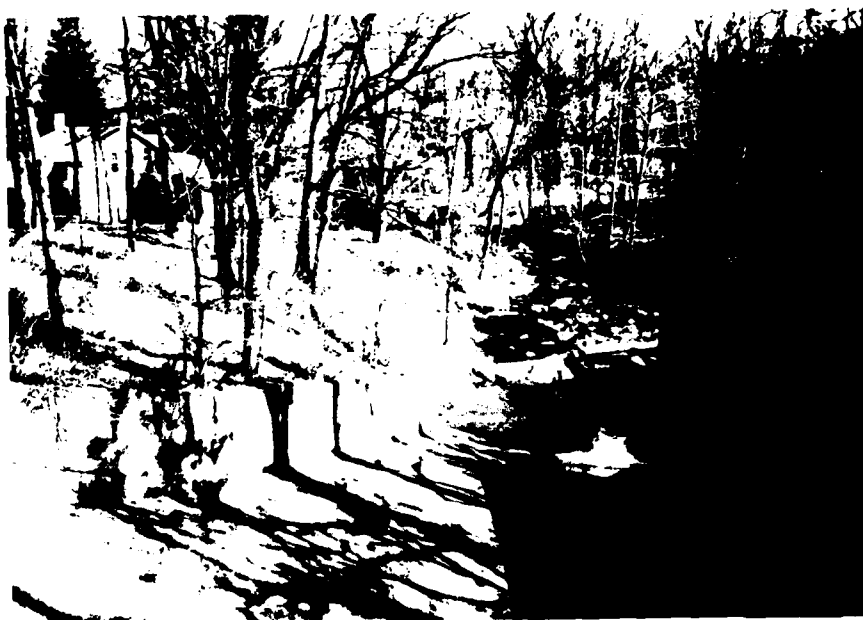
A-9B Downstream channel from spillway crest - 4/8/81
