**SKY HAVEN LAKE DAM  
JOHNSON COUNTY, MISSOURI  
MO 20177**

**PHASE 1 INSPECTION REPORT  
NATIONAL DAM SAFETY PROGRAM**

**SKY HAVEN LAKE DAM  
JOHNSON COUNTY, MISSOURI  
MISSOURI INVENTORY NO. 20177**

| Date of Inspection | 5 June 1980 |

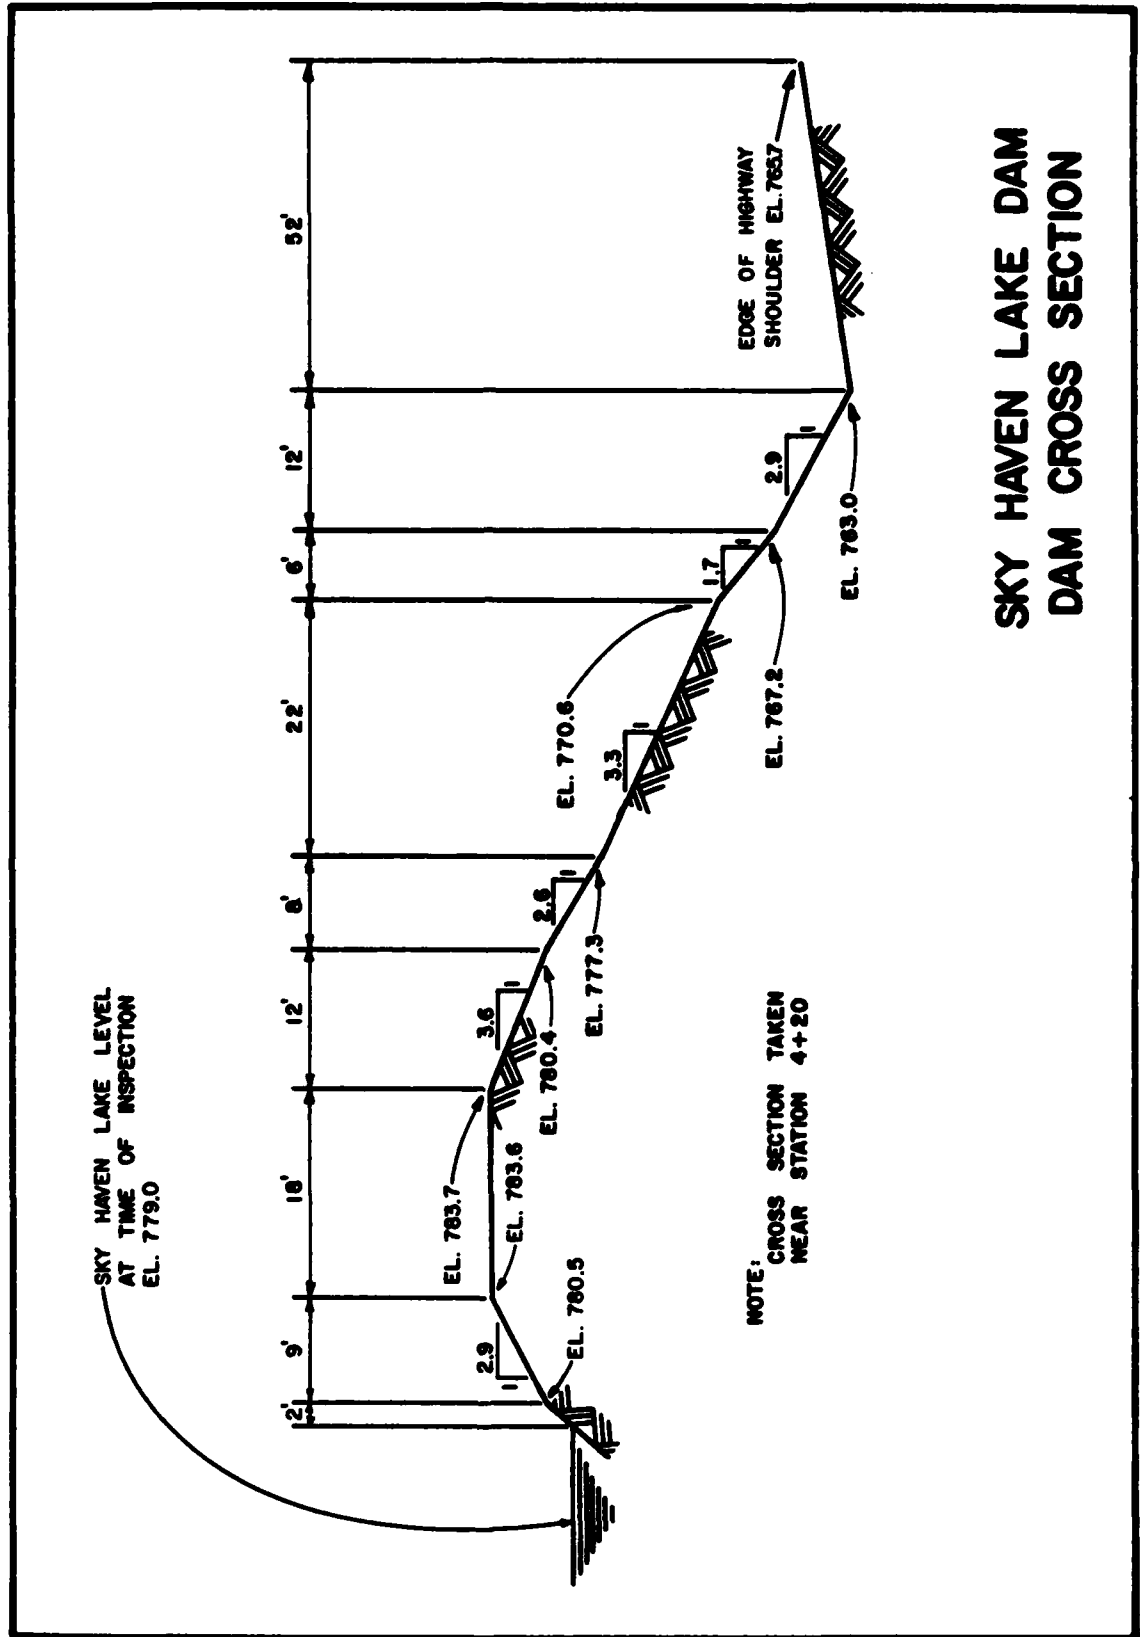
**SKY HAVEN LAKE DAM  
DAM CROSS SECTION**

SKY HAVEN LAKE LEVEL  
AT TIME OF INSPECTION  
EL. 779.0
