SUBJECT: Duck Creek State Wildlife Refuge - Pond 3  
Stoddard County, Missouri  
Missouri Inventory No. 40094

DUCK CREEK STATE WILDLIFE REFUGE - POND 3  
STODDARD COUNTY, MISSOURI  
MISSOURI INVENTORY NO. 40094

PHASE I INSPECTION REPORT  
NATIONAL DAM SAFETY PROGRAM

December, 1980

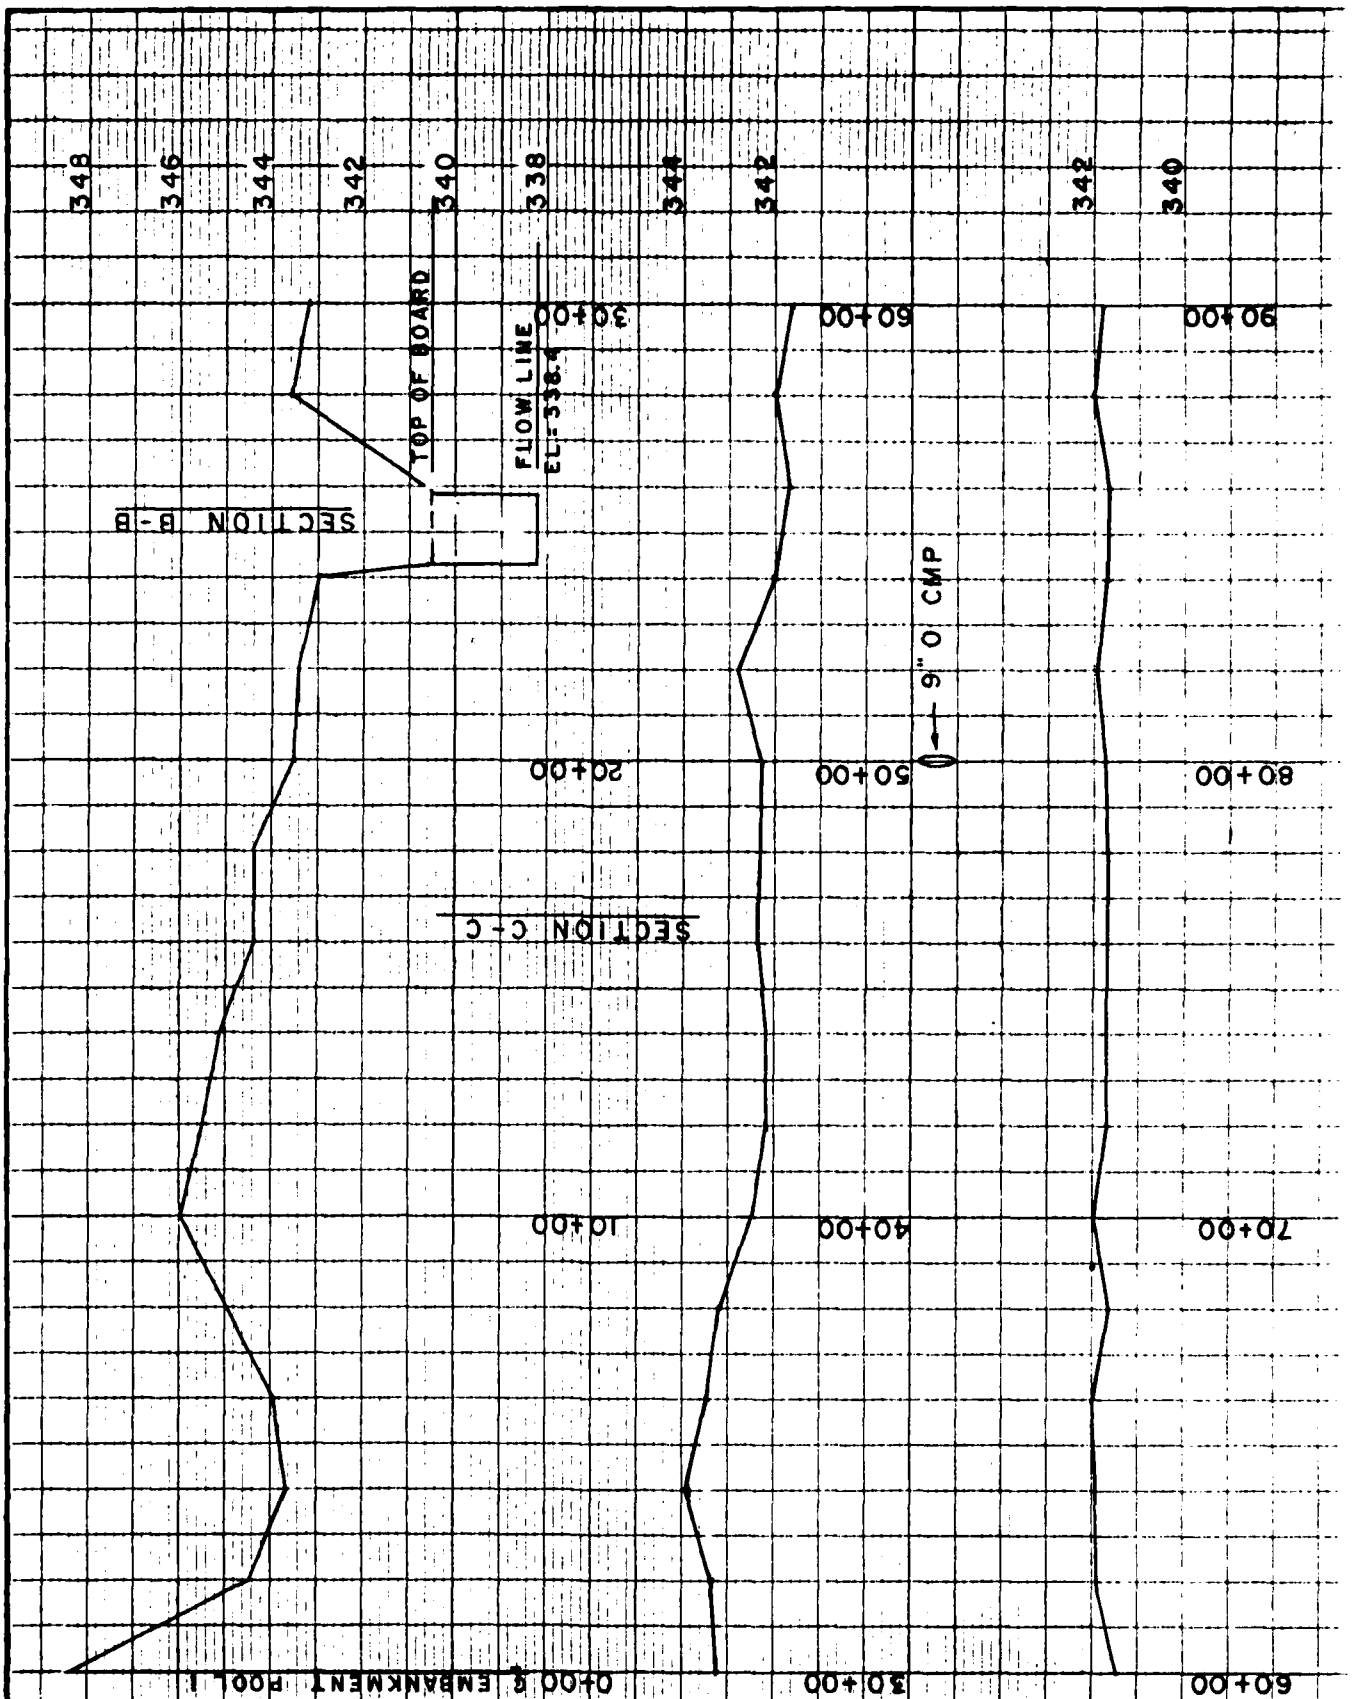
SHEET 4 , APPENDIX A

The vertical alignment of the crest was generally good, with some irregularities of the profile observed (See Sheets 4 and 5 of Appendix A).

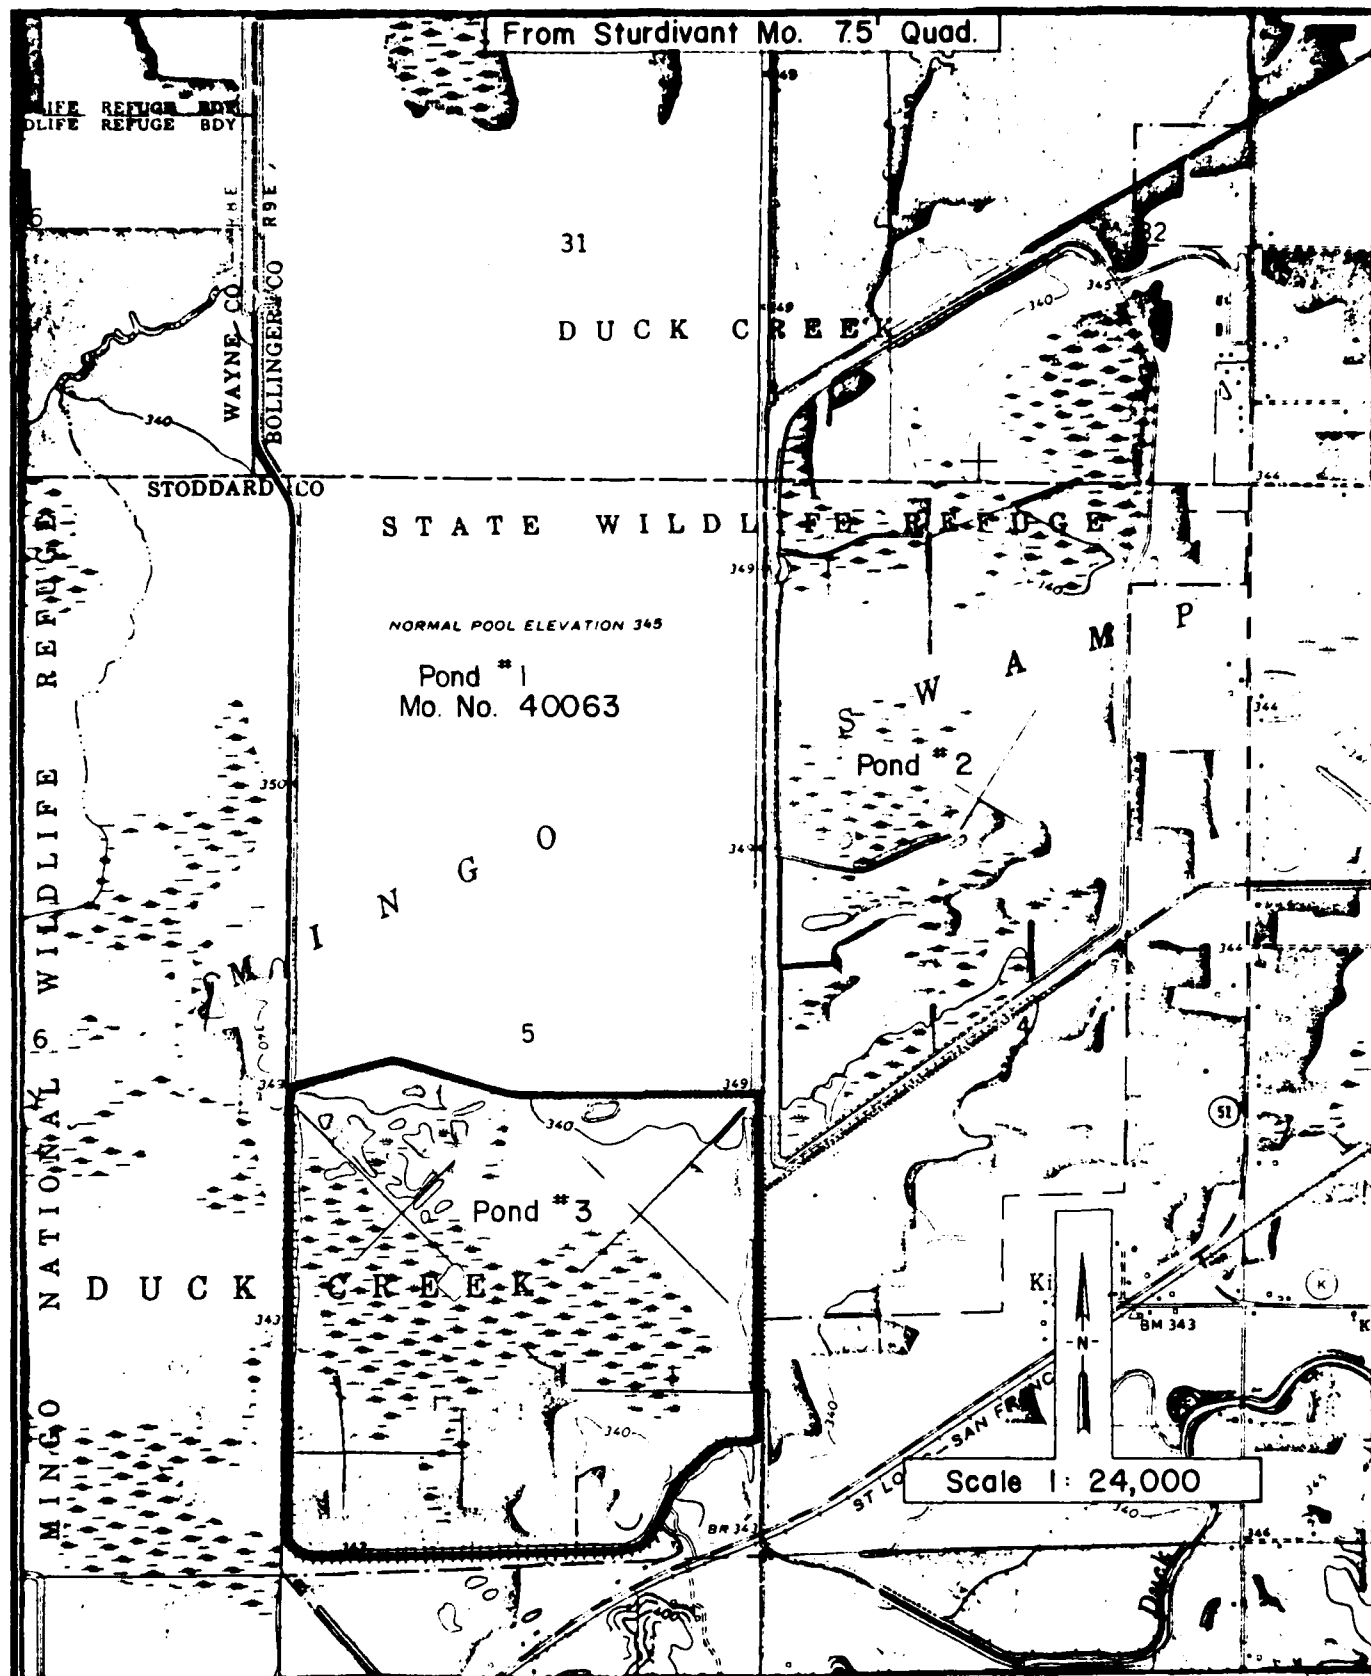
LAKE AND WATERSHED MAP

Based on the hydrologic and hydraulic analysis presented in Appendix C, overtopping of the dam will occur for discharge in excess of 35 percent of the Probable Maximum Flood (PMF). The Probable Maximum Flood is defined as the flood discharge that may be expected from the most severe combination of critical meteorologic and hydrologic conditions that are reasonably possible in the region. The recommended guidelines from the Department of the Army, Office of the Chief of Engineers, require that this structure (intermediate size with significant

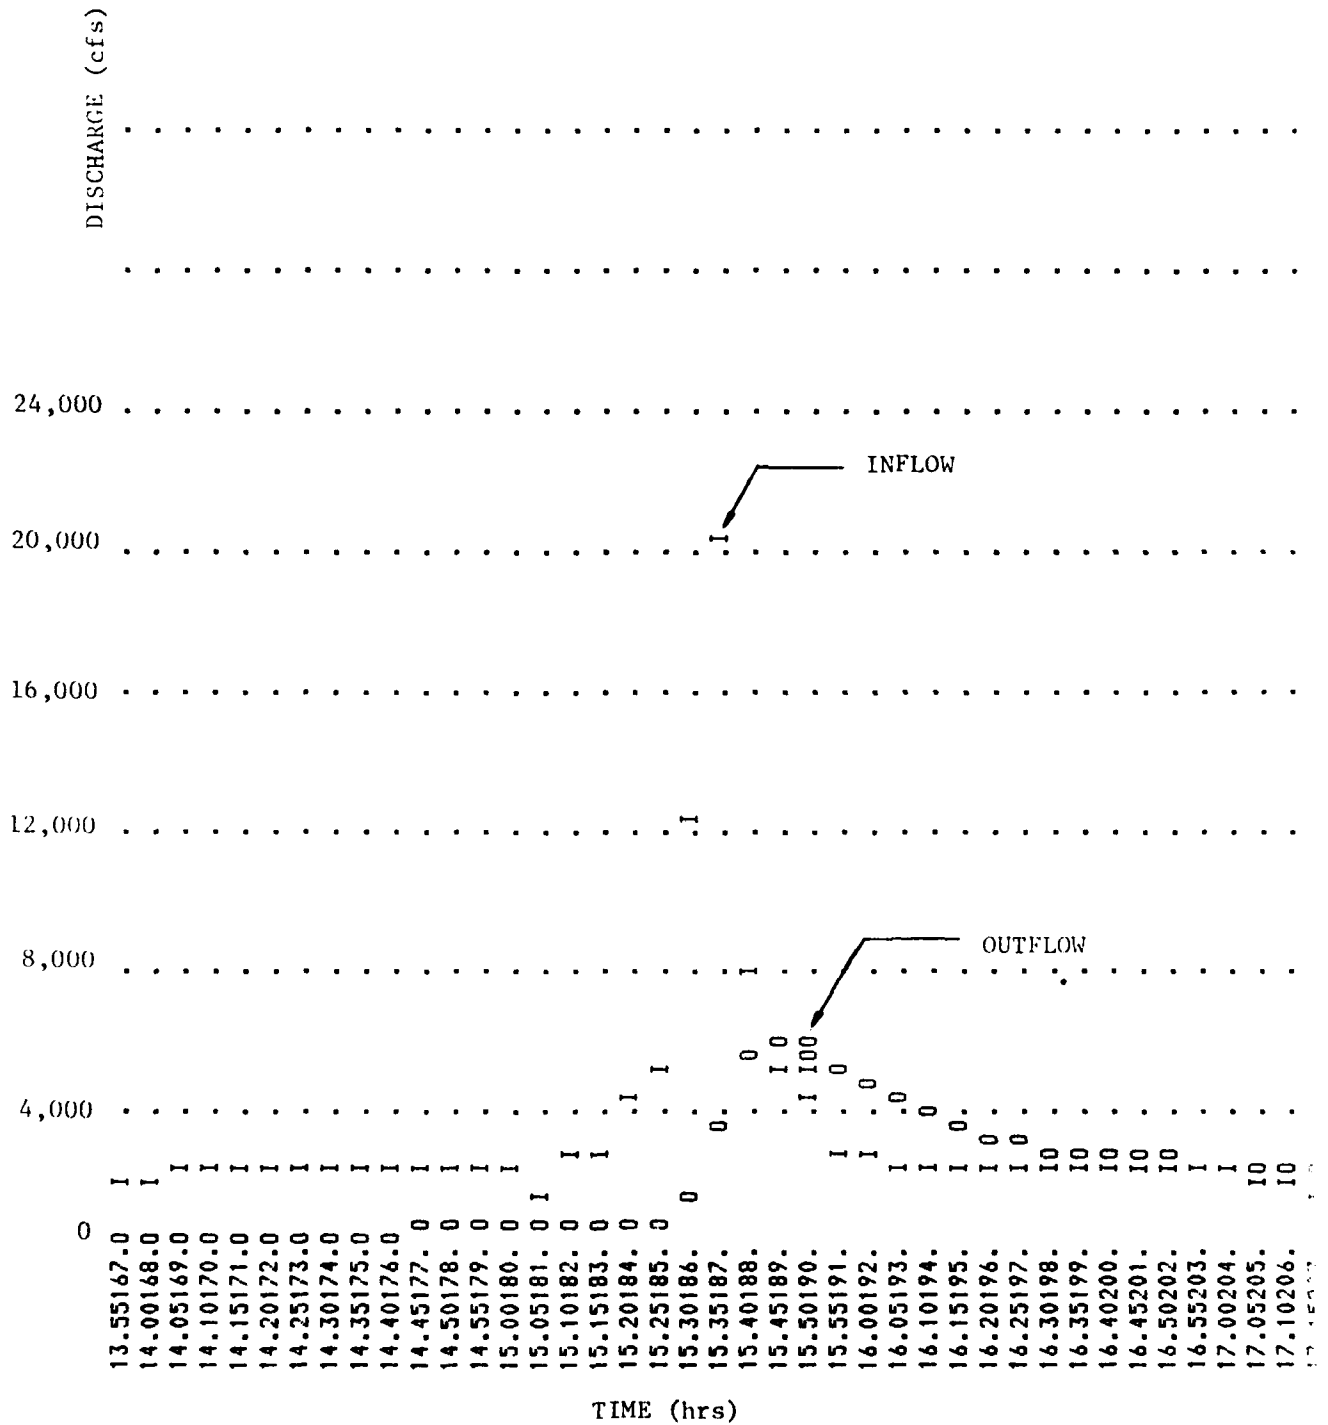
INFLOW-OUTFLOW HYDROGRAPH  
FOR THE PMF  
(Assuming gates fully open)

Max. Inflow = 20,500 cfs  
Max. Outflow = 5,650 cfs
