PHASE I INSPECTION REPORT  
NATIONAL DAM SAFETY PROGRAM

LAKEWOOD (EAST) LAKE DAM

MISSOURI INVENTORY NO. 20373

| Date of Inspection | 8 August 1978 |

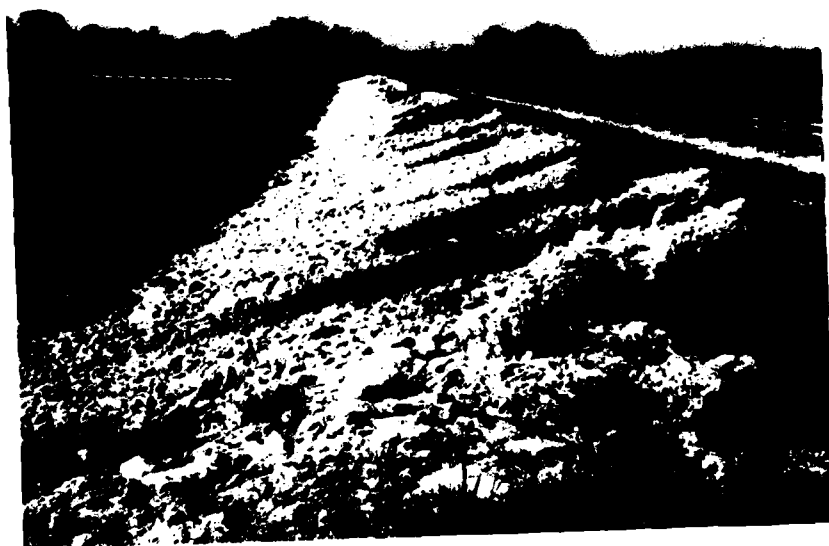
OVERVIEW OF DAM

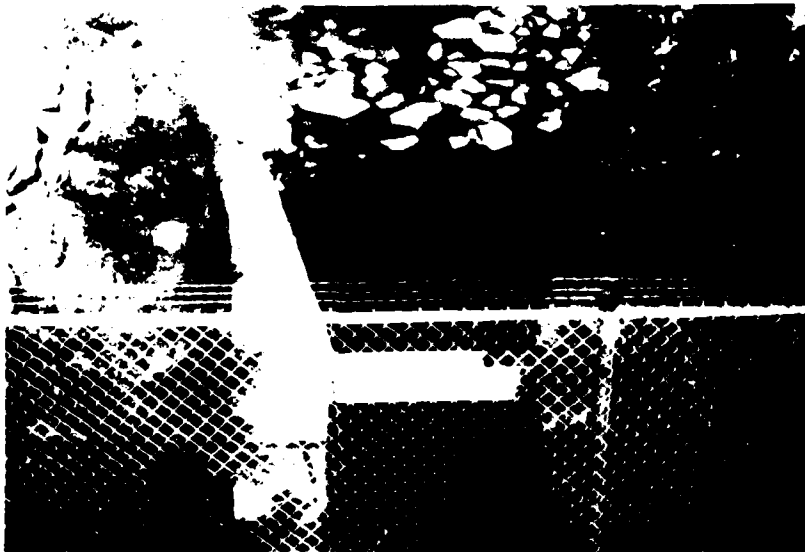
PHOTO NO. 9: STILLING BASIN IMMEDIATELY DOWNSTREAM OF  
DROP INLET DISCHARGE OUTLET (Looking Downstream)
