TENNESSEE STATE DEPT OF CONSERVATION NASHVILLE DIV 0--ETC F/G 13/13  
NATIONAL PROGRAM OF INSPECTION OF NON-FEDERAL DAMS, TENNESSEE. --ETC(U)  
SEP 81 P F BLUMM DACW62-81-C-0056

REPORT DOCUMENTATION PAGE		READ INSTRUCTIONS BEFORE COMPLETING FORM
1. REPORT NUMBER	2. GOVT ACCESSION NO. AD-A208252	3. RECIPIENT'S CATALOG NUMBER
4. TITLE (and Subtitle) National Program of Inspection of Non-Federal Dams, Tennessee. Lambert Dam (Inventory Number TN 00901) near Six Mile, Tennessee, Blount County, TN., Little Tennessee River Basin		5. TYPE OF REPORT & PERIOD COVERED Phase 1 Investigation Report

20. ABSTRACT (Continue on reverse side if necessary and identify by block number) Lambert Dam is a linear earthfill structure 605 feet long and 53 feet high with a crest width of 18 feet. The upstream and downstream slopes are 1V on 3.8H and 1V on 3.4H respectively. It has a capacity of 336 acre-feet at normal pool and 454 acre-feet at the top of the dam. The principal spillway consists of a 2.5 feet by 7.5 feet (ID) reinforced concrete riser which feeds a 30 inch diameter outlet pipe. Drawdown of the reservoir is controlled by a 24 inch square sliding headgate. The emergency spillway is an uncontr

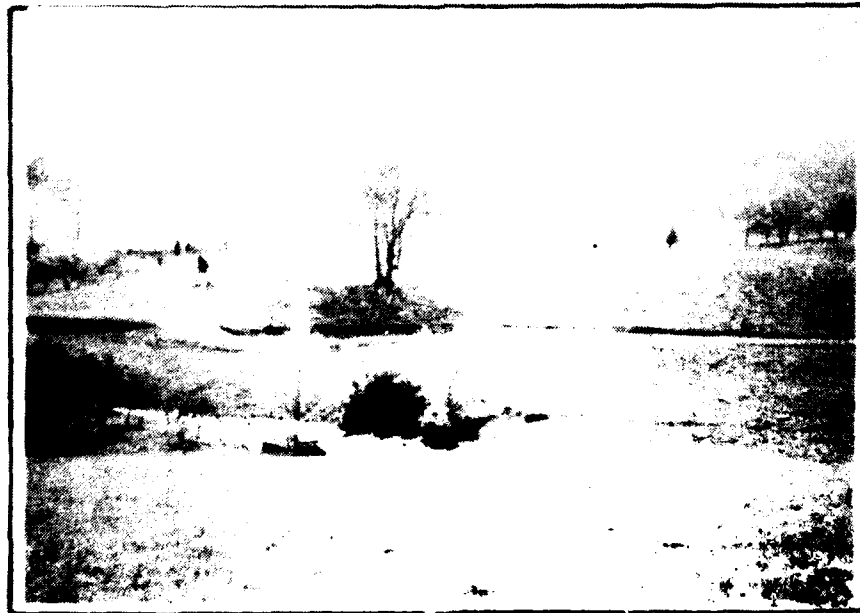
PHOTO NO. 16

| 16 | View from crest of downstream area |

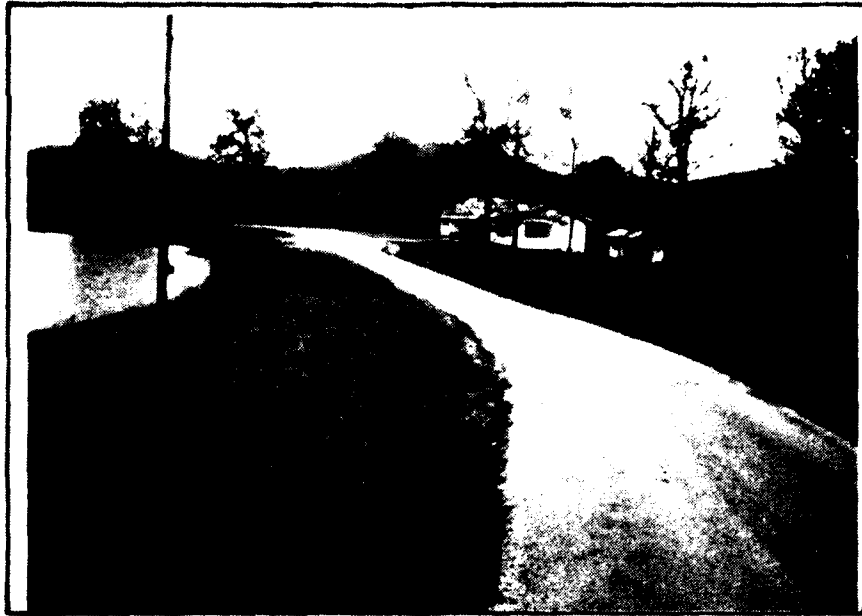
PHOTO NO. 17

| 17 | View of "lowpoint" in access road. |

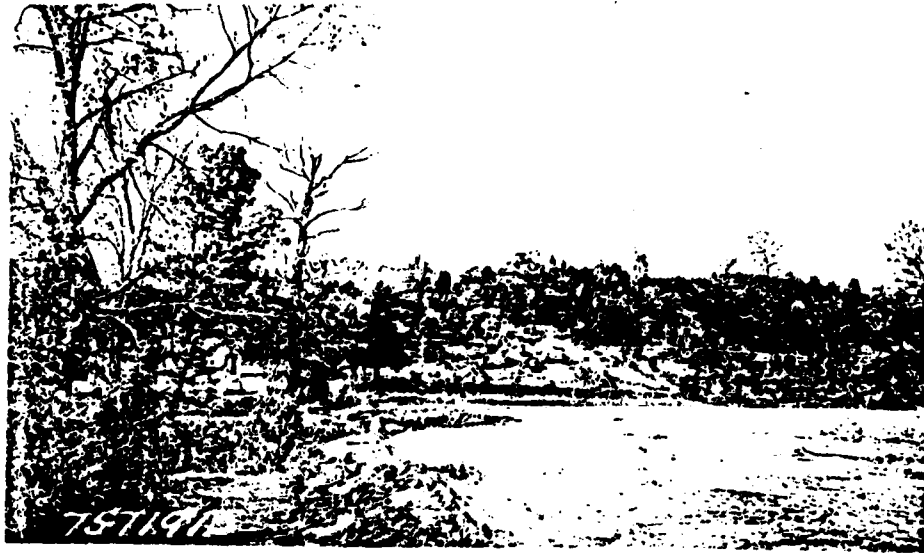
(a) Looking upstream on Six Mile Creek from Montvale Road. Note wash and highwater marks 2300 feet downstream from Lambert Brother's Dam.

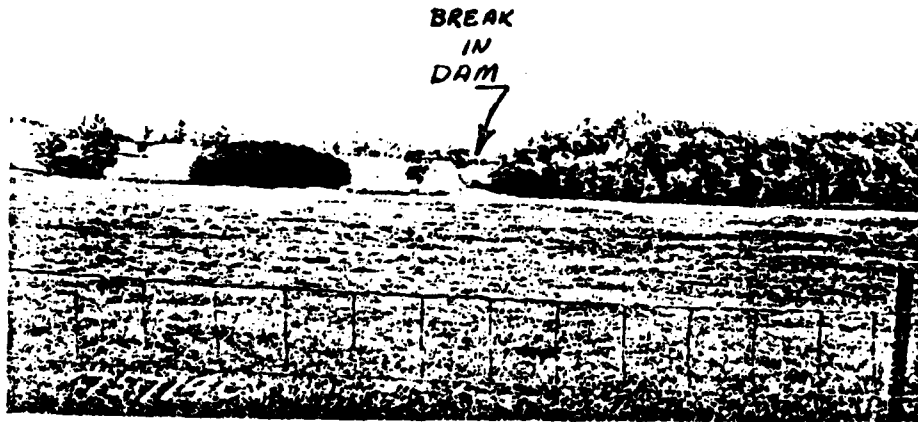
(c) Looking east and upstream at break in dam, center background, from Montvale Road.

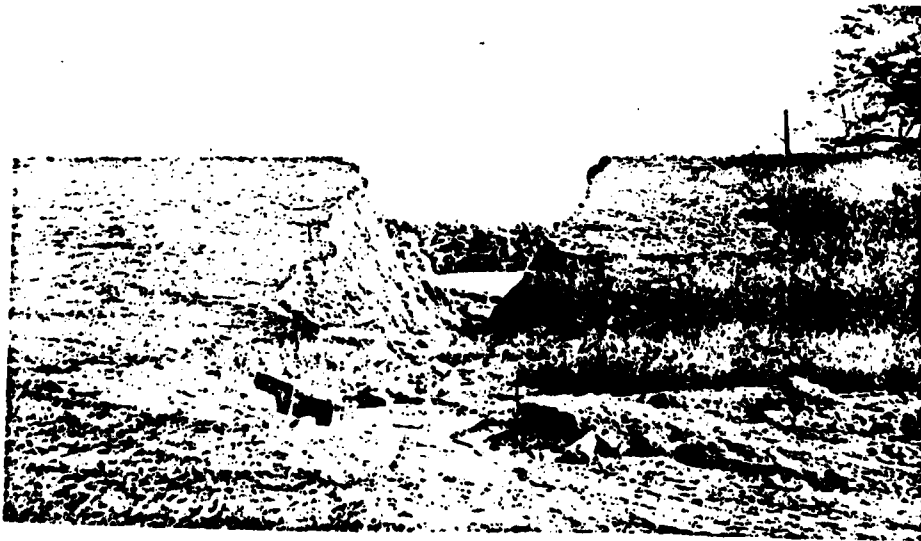
(d) Looking upstream at break in dam. Note a portion of vertical morning glory type overflow section at left center.

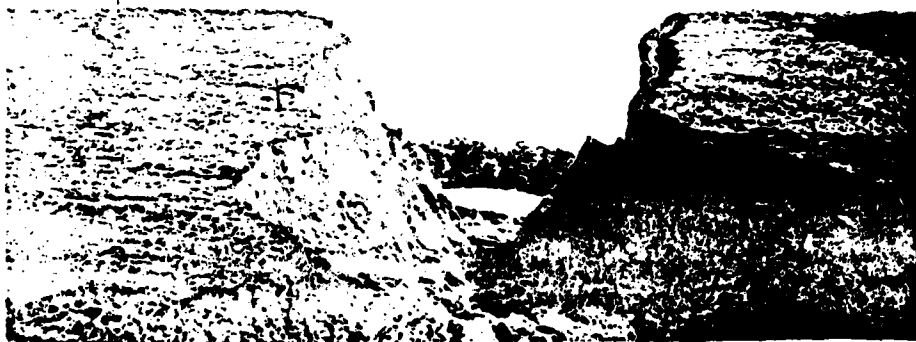
(e) Close-up view of break in Lambert Brother's Dam as seen from downstream.

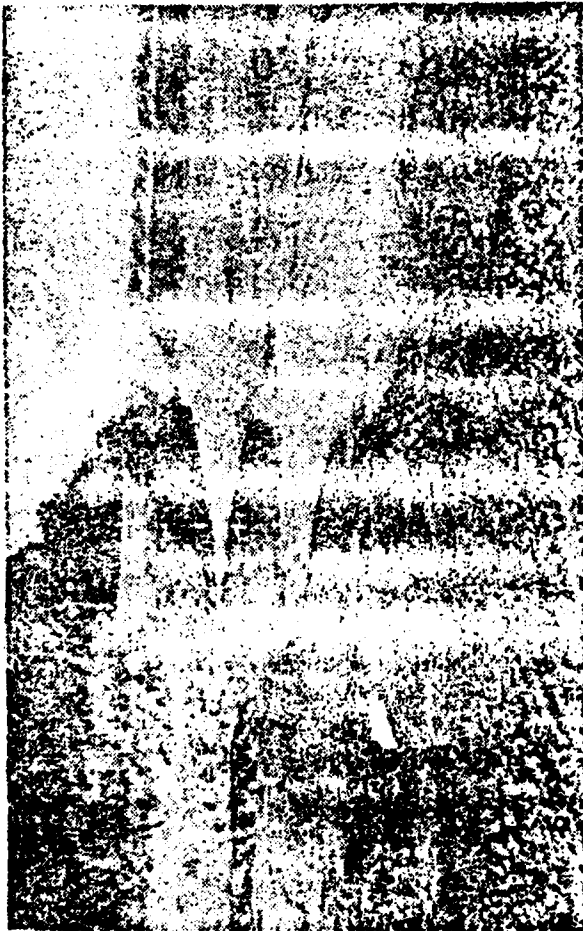
**WHERE DAM BROKE** — Arrow in aerial view (left) by Soil Conservation Service shows point where break occurred Saturday night in dam on Lambert Brothers farm. Large sycamore tree near point of arrow was

swept away by the water. At right is view from behind dam after the break in background. Two men, tiny specs near dam (background) were picking up fish. When water receded, tracks made seven years ago by

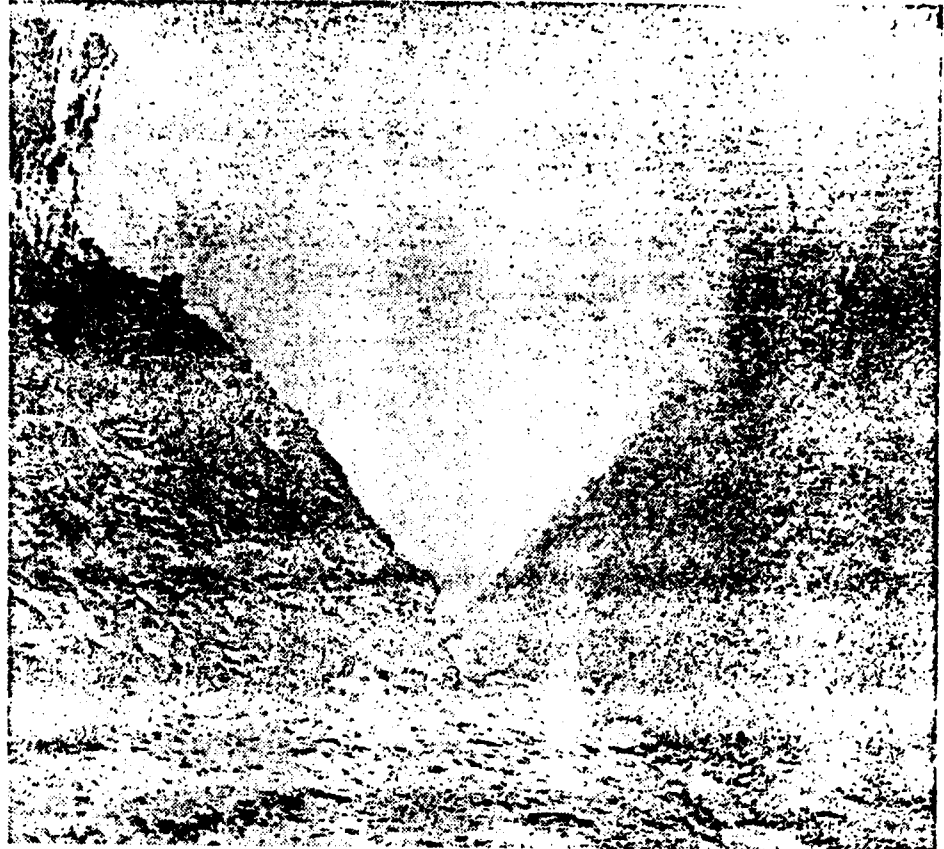
**BREAK IN DAM** — About 35 feet wide at the top is this break in the 47-foot high dirt fill dam at the 17-acre lake on Lambert Brothers farm at Six Mile on Montvale Road.
