STRUCTURES NOTE 469

**DISENGAGEMENT OF SAFETY HARNESS BUCKLES**  
**-CT4**

# DISENGAGEMENT OF SAFETY HARNESS BUCKLES —CT4

During the crash of a CT4 Airtrainer in August, 1979 both safety harness buckles disengaged.

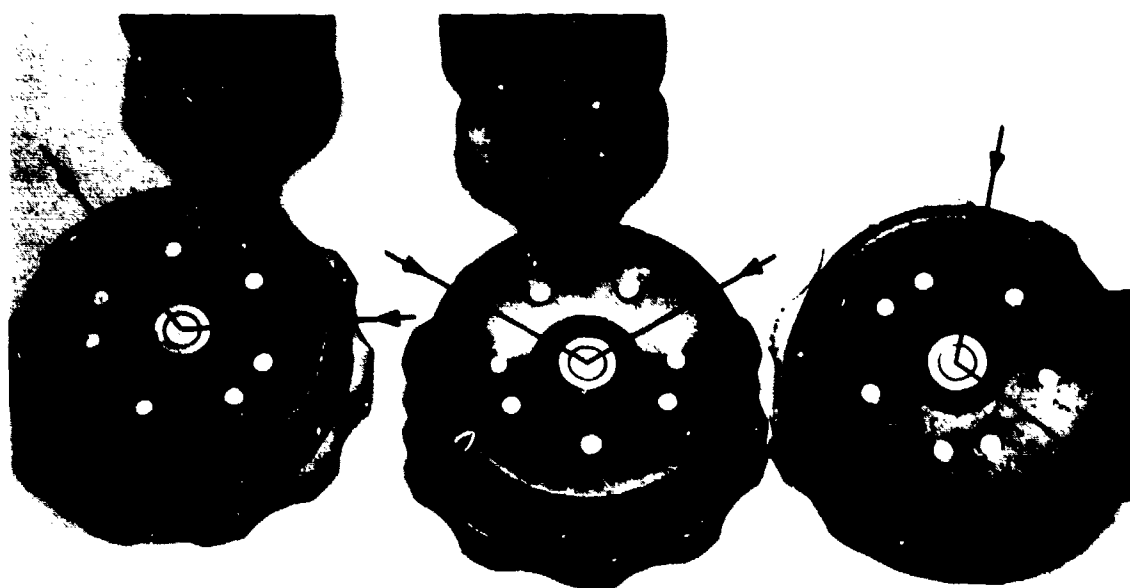
The backs of both buckles were dished as shown on Figure 1a. The deflection was greatest at the sides adjacent to the lap strap tongues as shown in Figure 1b. This figure also shows the flat back of a new buckle. The slots for the tongues were enlarged and some of the rivets which connect the front and back together were elongated. The distortion of the back suggested that the outer ends of the lap strap tongues had been pulled backwards and had prized the front and back of the buckle apart.

FIG. 1(b) THE BACKS OF A NEW BUCKLE AND THE BUCKLES FROM THE CRASHED AIRCRAFT SHOWING 'DISHING'. POSITIONS FOR THE LAP STRAP TONGUES ARE ARROWED.

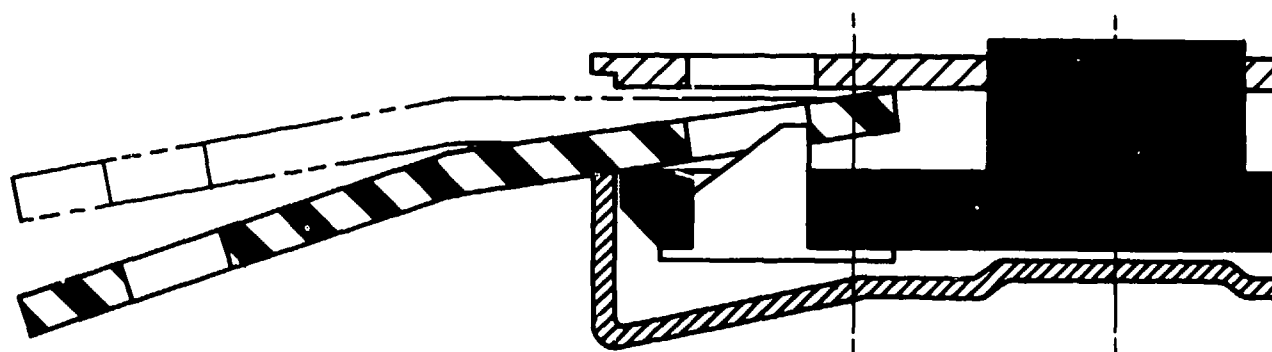
If the ends of the tongues are pulled backwards they will tend to prize the buckle apart as shown on Figure 6. As the sides of the case are forced back the load plate will also be pushed back against spring pressure and this will withdraw the latch pins from the tongues. The buckle is drawn to scale in Figure 6, with the width of the slot 6.4 mm as measured on the buckle from the crashed aircraft. The maximum deflection would have been greater than the permanent distortion of the buckle case and even if the pin withdrawal was insufficient to allow free disengagement, partial disengagement would greatly increase the tendency for the parts to deflect and slip apart as suggested in Figure 5.

FIG. 6 PARTIAL DISENGAGEMENT OF THE LATCH WHEN THE TONGUES PRIZE THE BUCKLE APART. SCALE DRAWING WITH SLOTS ENLARGED TO 6.4 mm.

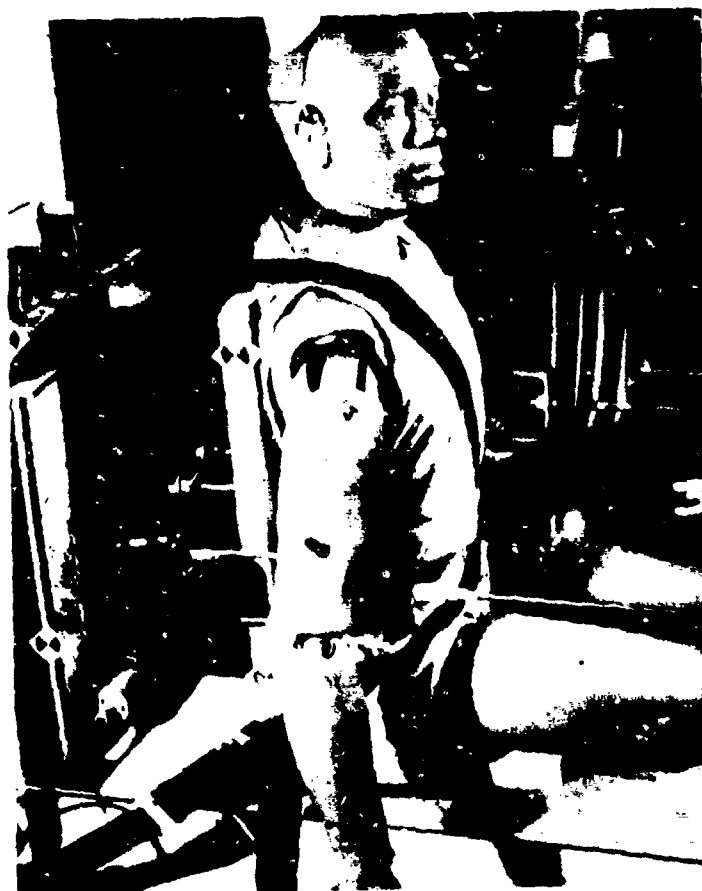
8(b) Static test  
with an anthropometric  
dummy

A third harness was fitted on an anthropometric dummy and loaded statically as shown in Figure 8b. The crotch strap could not be fitted with this loading system.

In two tests (one with the body block) the lap strap webbing failed at loads of about 20 kN, but in the remaining test the buckle disengaged. This occurred at a load of 23 kN and it is probable that the tongues slipped off the latch pins in the manner suggested in Figure 5. There was slight "dishing" of the buckle as shown in Figure 9a, but it was much less than occurred in the aircraft Figure 9b. Similarly enlargement of the slots in the sides of the buckle was less as shown in Figures 10a and 10b.

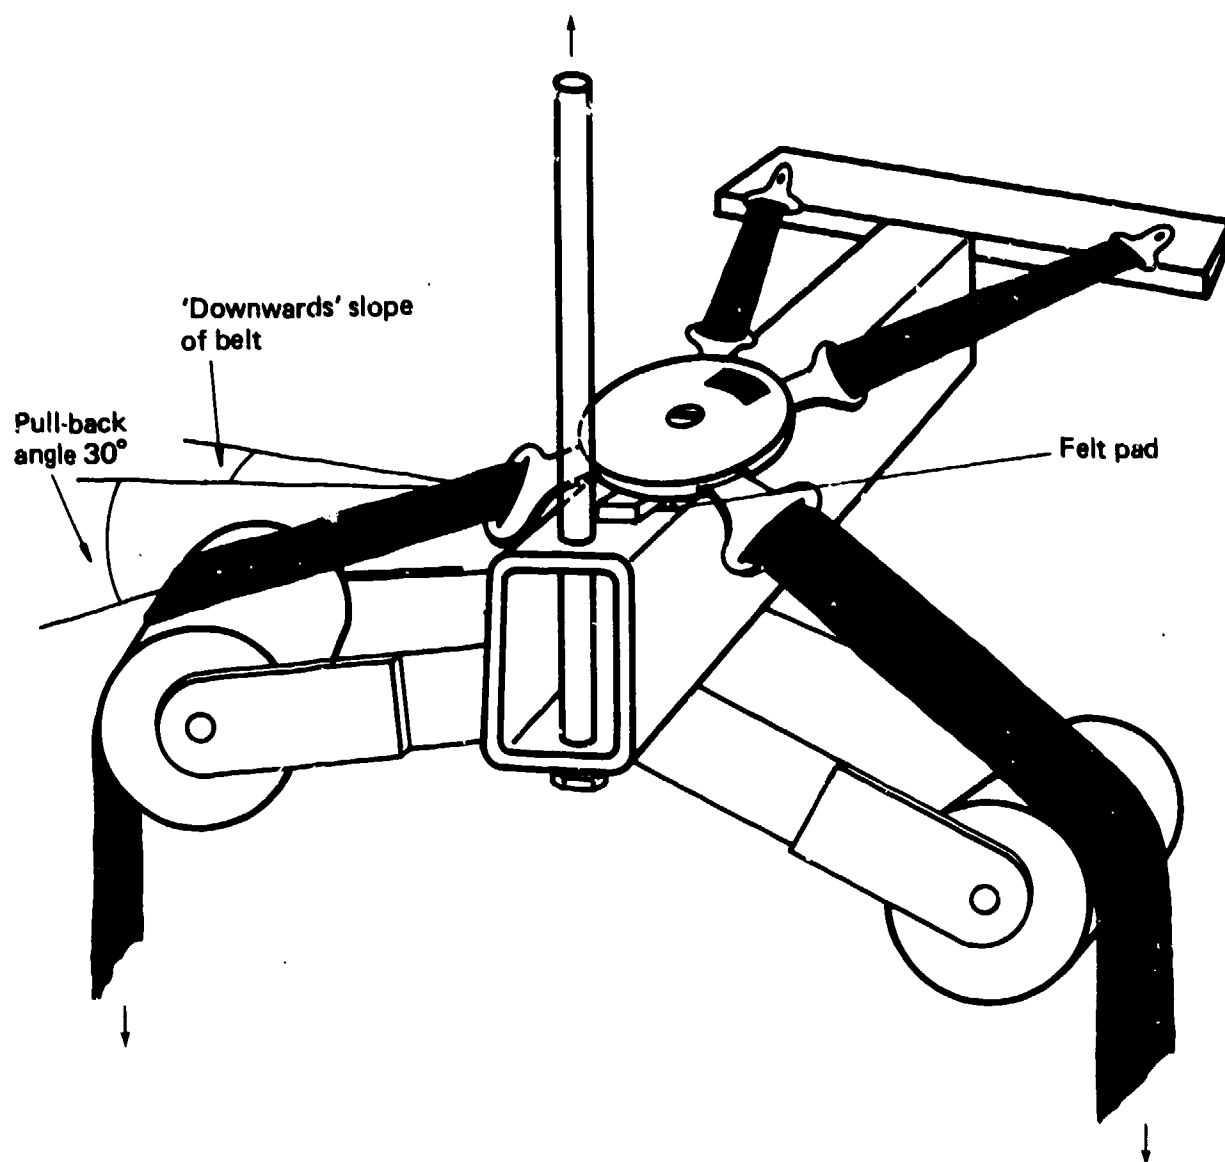
FIG. 12 'PULL-BACK' TEST 'A'.

The buckle, lap strap and shortened shoulder straps were set up on a loading rig as shown in Figure 12. The lap straps were pulled in a direction  $30^\circ$  to the plane of the buckle and the back of the buckle was supported on a hard felt pad 25 mm wide and 12 mm thick. Compression of the pad and deflection of the buckle during the test reduced the pull back angle but the assembly was photographed at intervals so that the angle could be measured.

Deflection of the back of the case was evident when the load had reached 4 kN. This was accompanied by enlargement of the slots and partial disengagement of the latch pins. The buckle

disengaged when the load reached 5.4 kN. The strap angle was then 26°, resolution of the forces indicates that the force on the back of the buckle was 2.4 kN.

amount of misalignment but until research indicates a better value the test procedure of "Pull-back" test A is recommended.

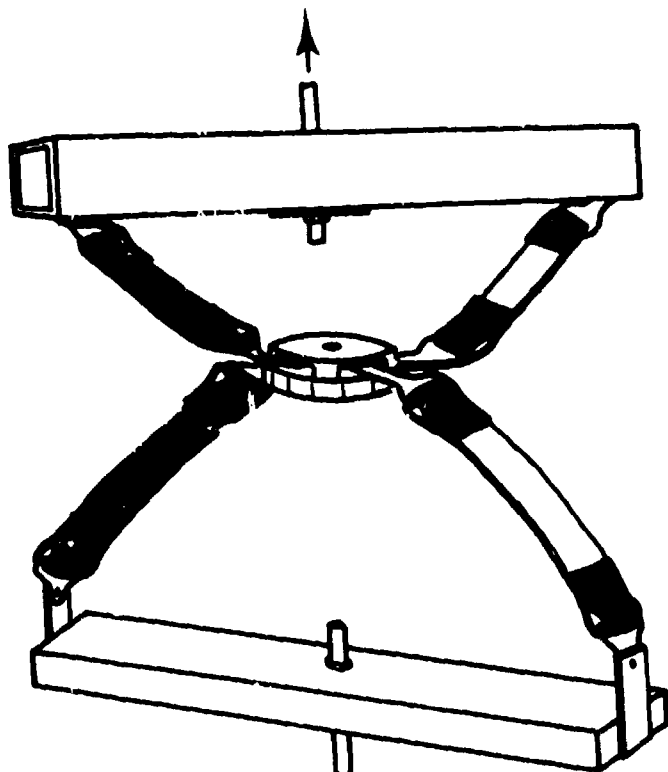
FIG. 13 'PULL-BACK'  
TEST B

The arrangement is shown in Figure 13. The lap strap caused dishing of the back of the buckle while the tongues of the shoulder and crotch strap pressed against the front plate. This deflected until the load was carried by the release handle and transmitted into the case by tension in the spindle (construction shown on Fig. 2). When the load reached 3 kN the retaining ring sheared off the spindle. The buckle was prised open and the straps disengaged.

The 3 kN load would represent the difference between the forwards and rearward load vectors at the buckle rather than a net body block force and corresponds to the force of 2.4 kN on the buckle in the "Pull-back" test A.

Separation of the retaining ring shows that the tension on the spindle was greater in test B than in the crash although the backs of the buckles from the crashed aircraft show deformation which could be associated with tension in the spindle.

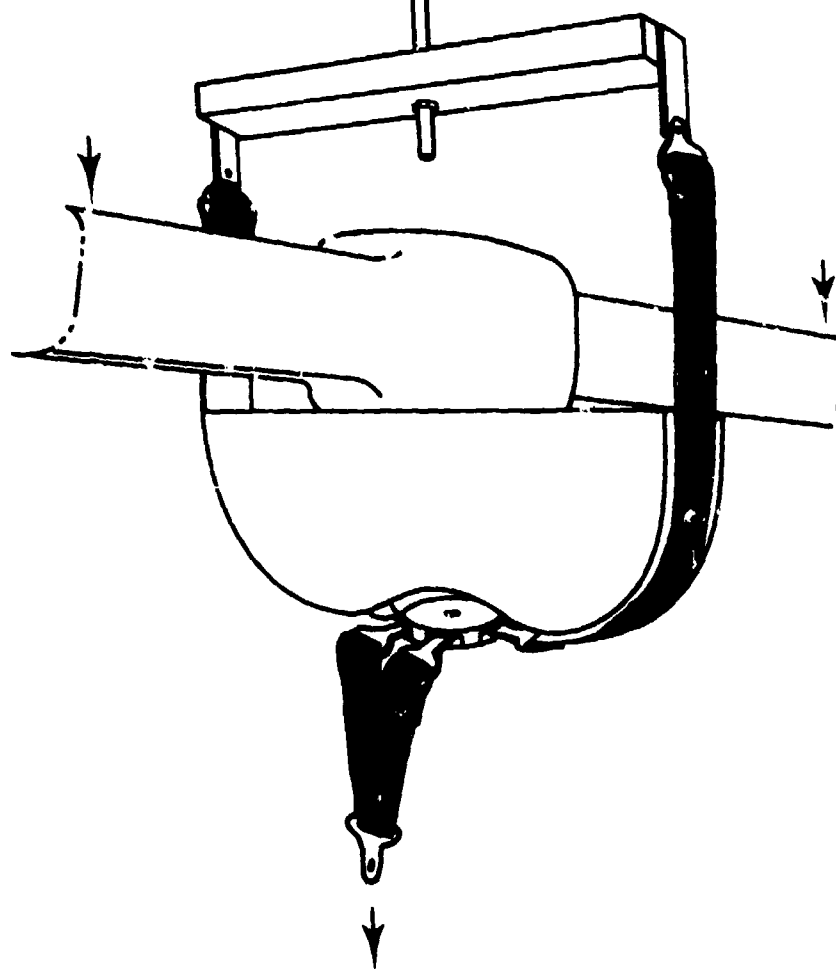
FIG. 14 'PULL-BACK'  
TEST C

The loading arrangement is shown in Figure 14. The lap strap was fitted to a body block, which was recessed behind the buckle, and a load of 6 kN was applied to hold the strap tight. Load was then applied progressively to the shoulder strap so that the buckle was twisted by the lap strap tongues. As the load approached 360 N partial withdrawal of the latch pins was evident but then the buckle appeared to "stick". Sticking in this way can be variable and unpredictable so to break the "friction" the crotch strap was jerked by hand, this resulted in separation of the assembly.

The test was qualitative rather than quantitative because the buckle had been used in earlier tests, although it had not previously disengaged, and the jerk force is unknown but the forces were very low in relation to the rated strength of the harness (about 2%).
