LOOMIS LAKE DAM

NDI No. PA 00048
PennDER NO. 58-127
Dam Owner: Irving N. Loomis, Sr.

PHASE I INSPECTION REPORT NATIONAL DAM INSPECTION PROGRAM

Loomis Lake Dam, Susquehanna County, Pennsylvania
NDI No. PA 00048, PennDER No. 58-127
Unnamed Tributary to Hop Bottom Creek
Inspected 29 October 1980

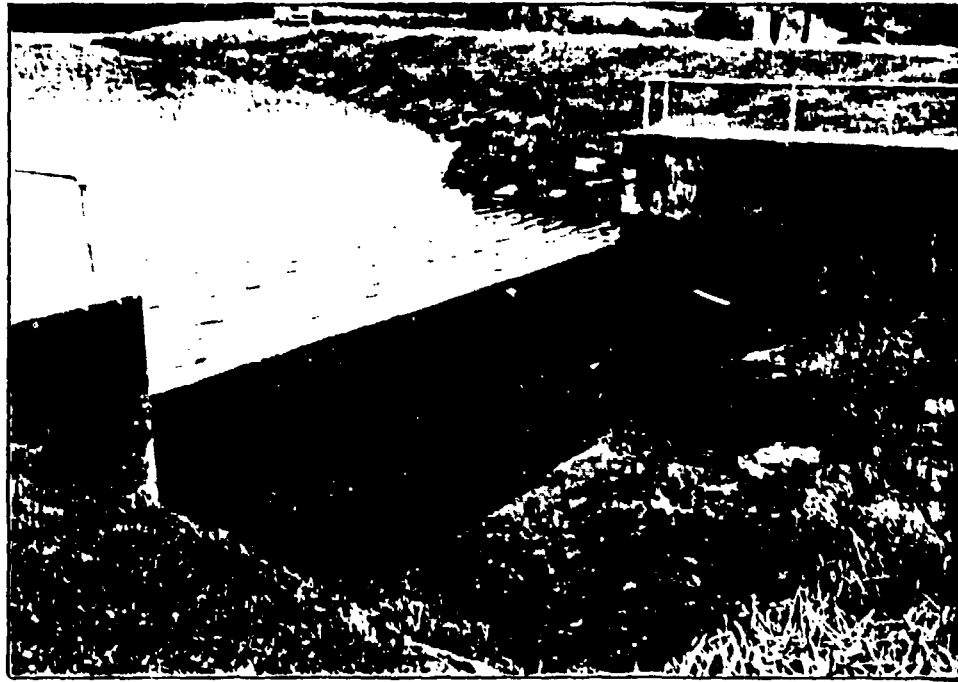
PHOTO 1. View of Spillway Crest from Right Abutment

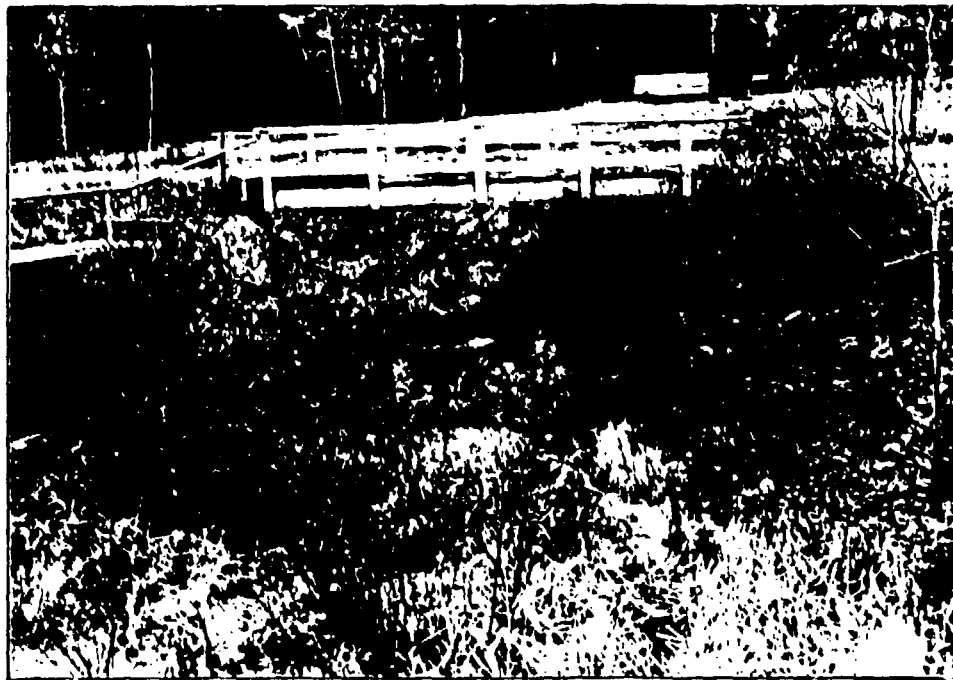
- 3) Cattails and debris were observed in the spillway discharge channel.
 - 4) The bridge over the spillway discharge channel has badly fractured concrete and rock foundation supports.

Bridge over spillway channel with no piers in channel; however, bridge abutments and underlying rock are badly fractured.

PHOTO 2. View of Township Road Bridge over Spillway Outlet Channel

- 10) Replace the wood cover on the valve pit for the abandoned outlet works or fill in with earth.
- 11) Coordinate with the township to expedite repairs to the abutment supports of the bridge over the channel.

The township has responsibility for the bridge and piers. Repairs are reportedly planned for the bridge.
