DELAWARE RIVER BASIN  
MILLTOWN DAM  
WEST CHESTER AREA MUNICIPAL AUTHORITY

NDI NO. PA-00218  
DER NO. 15-146

PHASE I INSPECTION REPORT  
NATIONAL DAM INSPECTION PROGRAM

Name of Dam: MILLTOWN DAM  
State & State No.: PENNSYLVANIA, 15-146  
County: CHESTER  
Stream: EAST BRANCH CHESTER CREEK  
Date of Inspection: APRIL 9, 1981

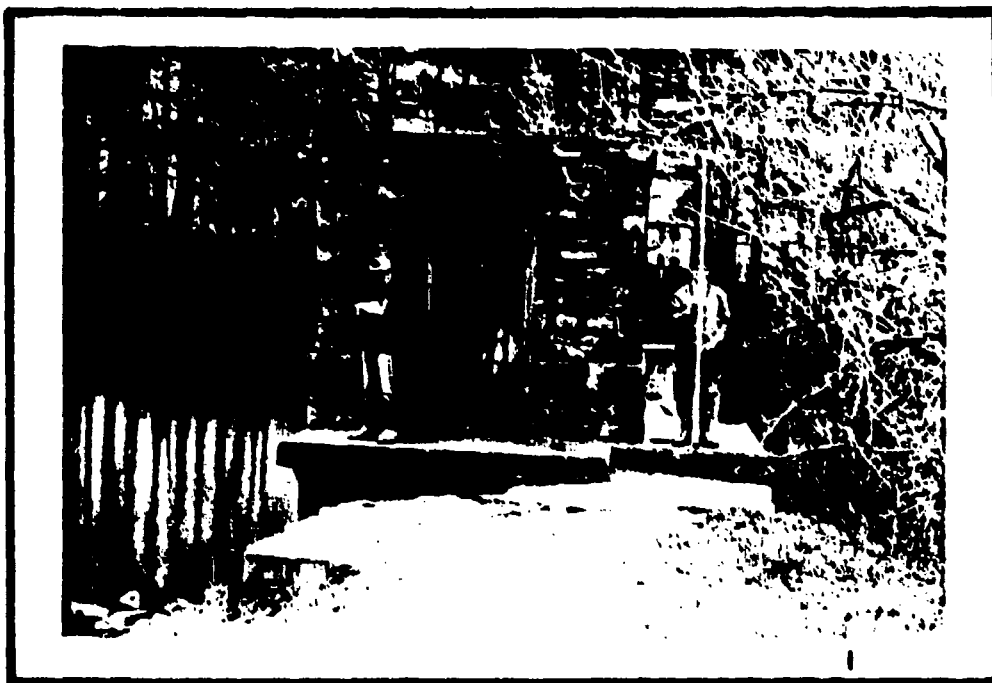
The intake control structure is located in the right spillway wall and is in fair condition. The downstream valve on the drawdown line has not been operated in many years.

CONTROL TOWER - NO. 5  
NOTE: CONCRETE SLABS

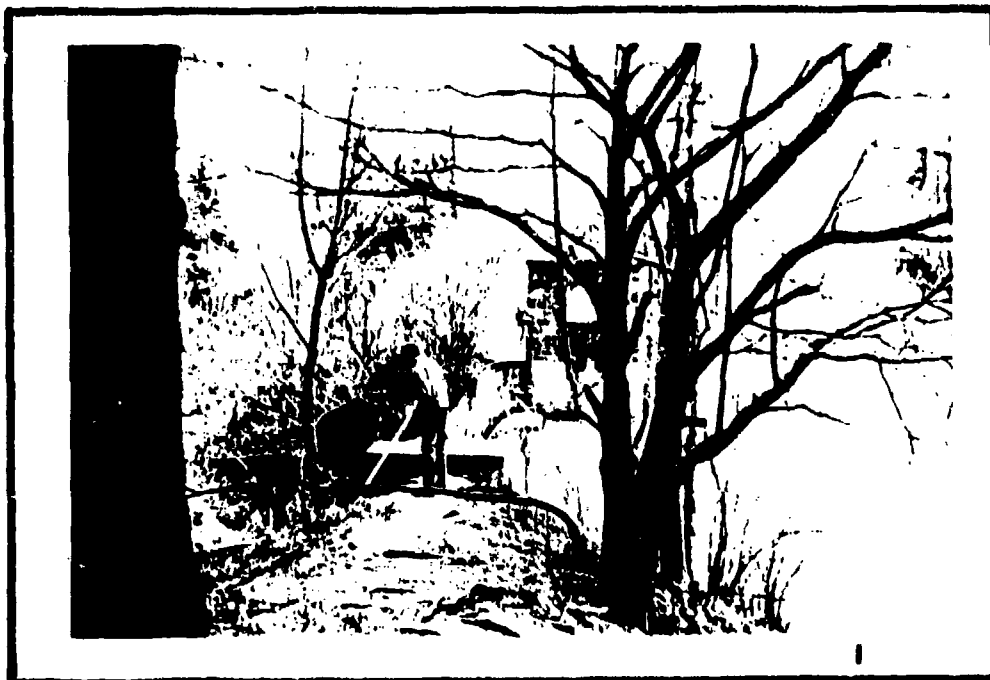
The embankment on the left side of the spillway has a low and narrow crest (Photographs No. 1 and No. 6). Several large trees are growing on both the upstream and downstream slopes. The embankment to the right of the spillway has a poor appearance. The crest is below the design elevation and has very little protective cover. The upstream slope is covered with dumped rock with a considerable growth of brush near the normal flow line (Photograph No. 3). The downstream slope has very dense brush over most of its surface, which prevented close observation of the condition of this slope. Rubbish and fill have been dumped on this slope. A steep, bare footpath is located adjacent to the spillway on the downstream slope. A concrete slab has been placed on the crest adjacent to the control structure (Photograph No. 5). A sewer line and several man holes are located immediately downstream of the dam (Plate A-I). Piles of rock, brush, tires, and other debris were dumped in this area.

LEFT EMBANKMENT - NO. 6  
NOTE: TREES AND NARROW CREST

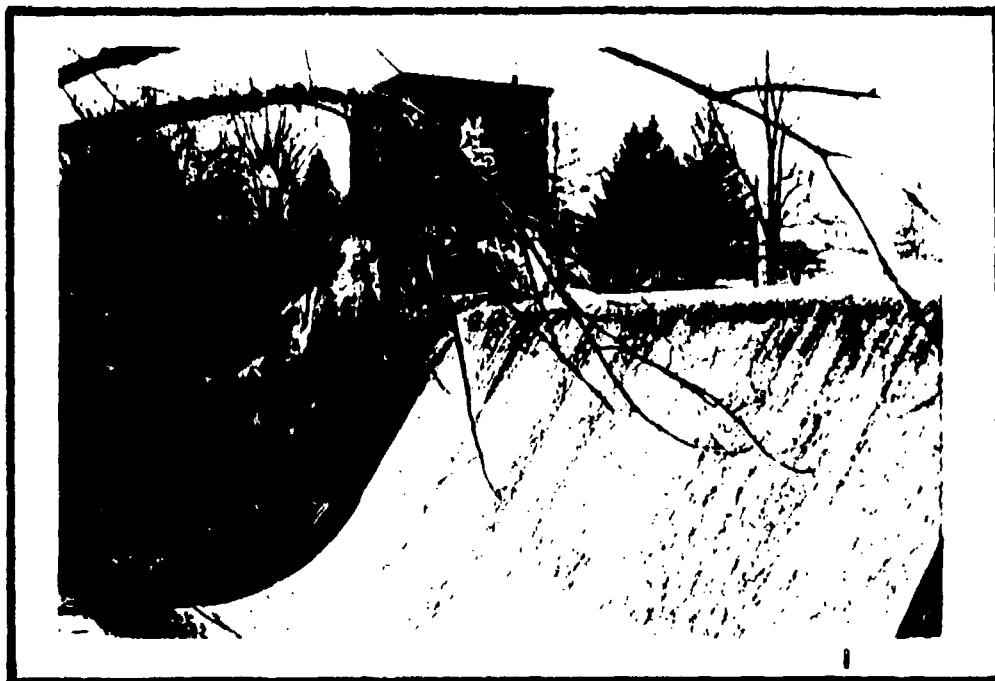
The ogee concrete spillway has a 41 foot wide low flow notch in its center. (See Photographs No. 7, 8 and 10.) The concrete in this area has deteriorated. A large piece of concrete has spalled off adjacent to the low flow notch (Photograph No. 10) at the top of the weir. The spillway abutment walls have many small cracks, but appeared to be stable. At the downstream end of the concrete ogee section there is a two foot deep basin with an endsill (Photograph No. 9). It appears that the original riprap in this area has eroded. Further investigation is required to determine the depth of erosion and the condition of the bottom of the basin. Placing additional heavy stone in this basin is recommended.

OVERVIEW OF SPILLWAY - NO. 8
