PENNSYLVANIA
NDI NO. PA.00993
DER NO. 45-148

RAKES DAM

OWNER: W. ADOLPH RAKE, SR.

PHASE I INSPECTION REPORT
NATIONAL DAM INSPECTION PROGRAM

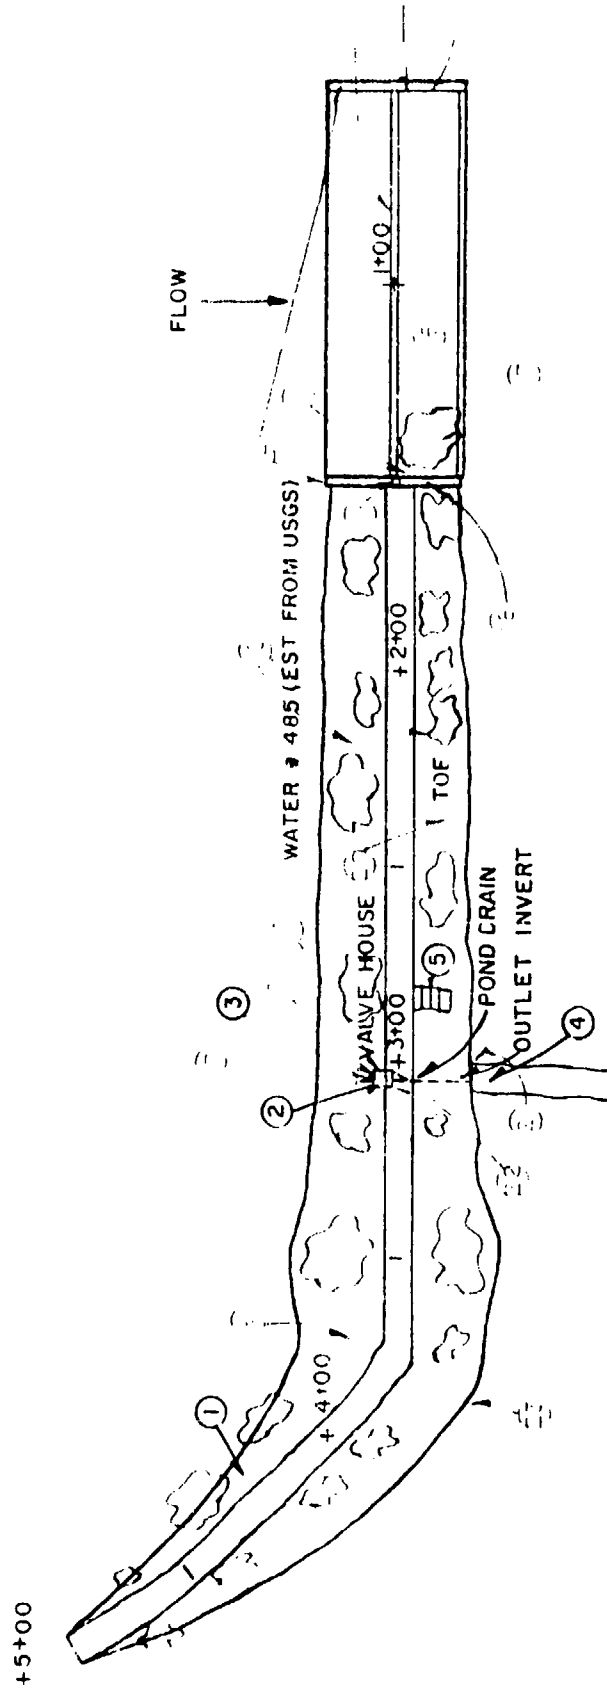
FIELD OBSERVATION PLAN
 RAKES DAM

6. Stone on upstream face irregular, possible benching at waterline.
7. Slots inside of upstream face for stop-logs have deteriorated.
8. Gate well has deteriorated concrete and missing stone.

9. Supports for gate hoist not attached.
10. Brush and trees up to 18 inches in diameter on up- and downstream embankment slopes.
11. Deteriorated concrete.

12. Upstream end of spillway walls are broken.
13. Flow over spillway crest not uniform.
14. Spalling concrete.
15. Concrete erosion along waterline.
16. Sloping rock and concrete apron deteriorated and displaced.

21. Pond drain outlet structure side walls have disintegrated at waterline.
22. Slight erosion/foot traffic damage adjacent to upstream side of gate well.

23. Utility pole guy anchored in embankment.
