SUN VALLEY DAM

PHASE I INSPECTION REPORT, NATIONAL DAM INSPECTION PROGRAM

POHOPOCO CREEK
SUN VALLEY DAM
MONROE COUNTY, PENNSYLVANIA

NDI NO. PA 00998
DER NO. 45-217

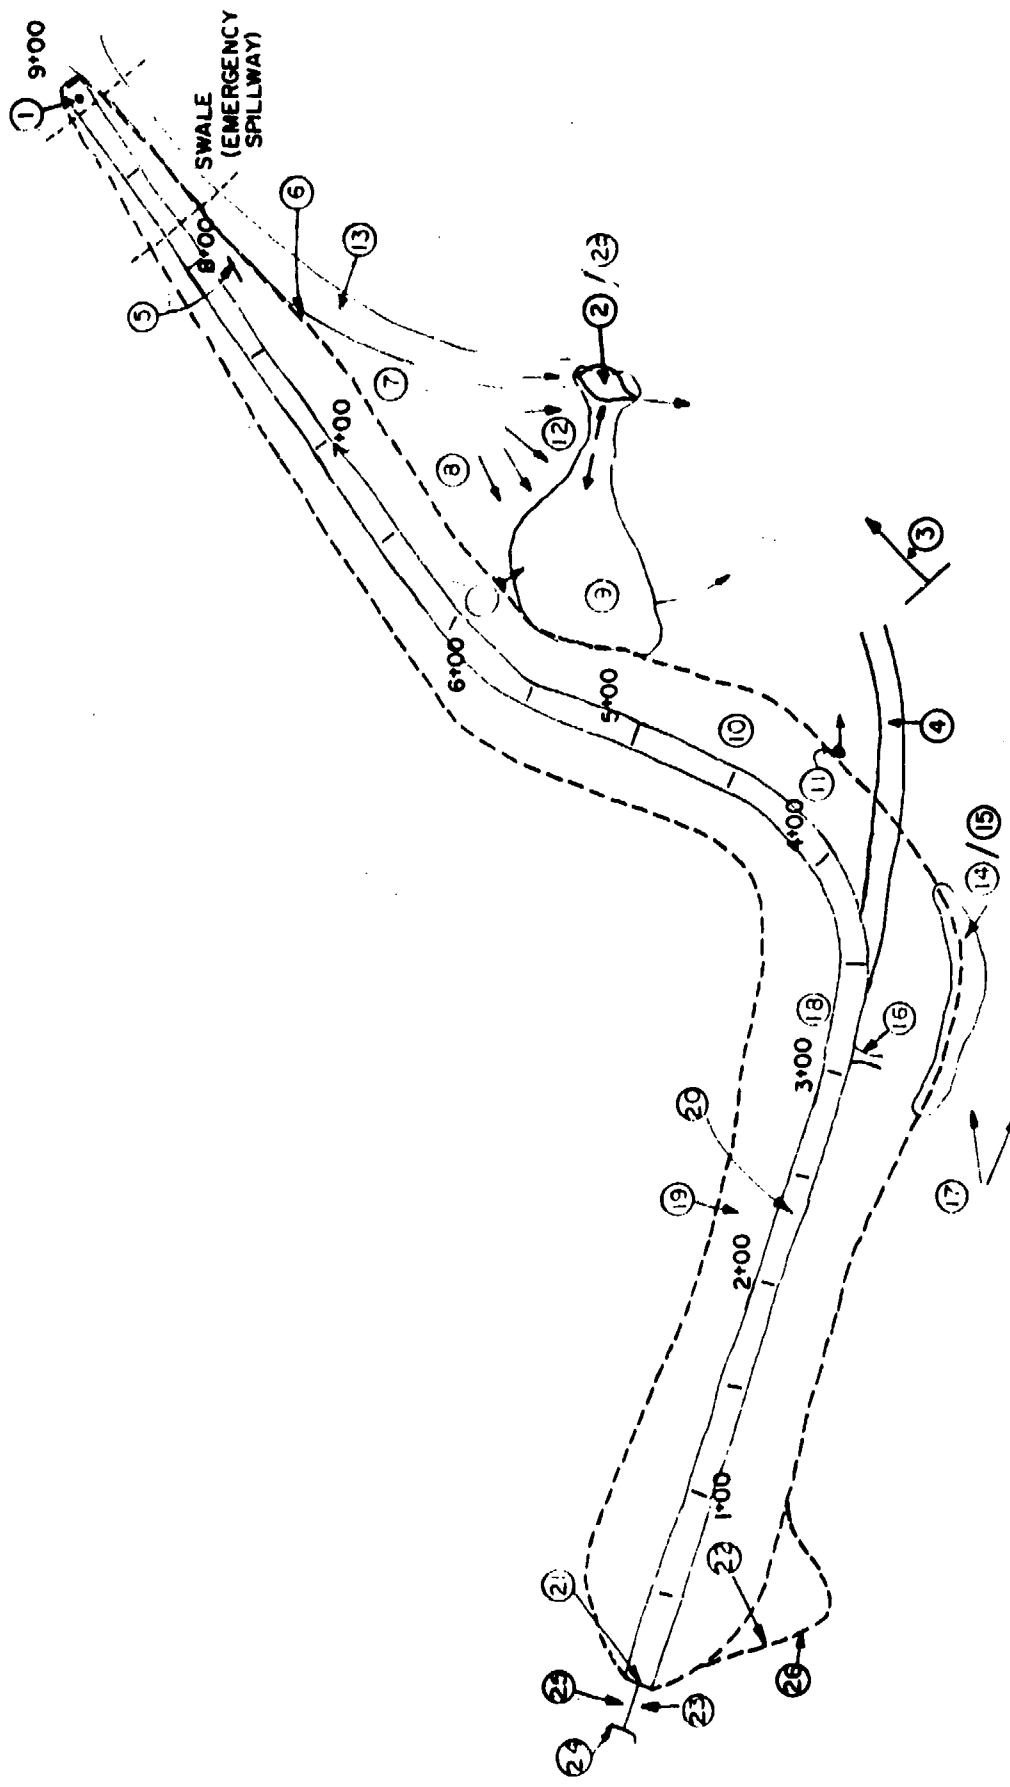
FIELD OBSERVATION PLAN
SUN VALLEY DAM
SHEET 5A

1. Artesian well.
2. Location of spring shown on original site plan and
 - 2a. currently existing pond with large sand boils.
3. Downstream embankment slope and area beyond toe extremely uneven with some ridges approximately perpendicular to dam.

19. Embankment becoming benched at lower pool level.
20. Very sparse grass on embankment crest, little or no damage to crest.
21. Minor cracking of spillway concrete.

22. No riprap as shown on design drawing.
23. Erosion in spillway channel and at downstream end of spillway.
24. Erosion.
25. Stones thrown upstream of weir by vandals.

26. Material, apparently excavated from spillway channel, forms spur dike deflecting spillway discharge away from toe.
