TRAX FARM DAM

PHASE I INSPECTION REPORT
NATIONAL DAM INSPECTION PROGRAM

JULY 1981

TRAX FARM DAM
WASHINGTON COUNTY, COMMONWEALTH OF PENNSYLVANIA
NDI NO. PA 00131
PennDER NO. 63-96

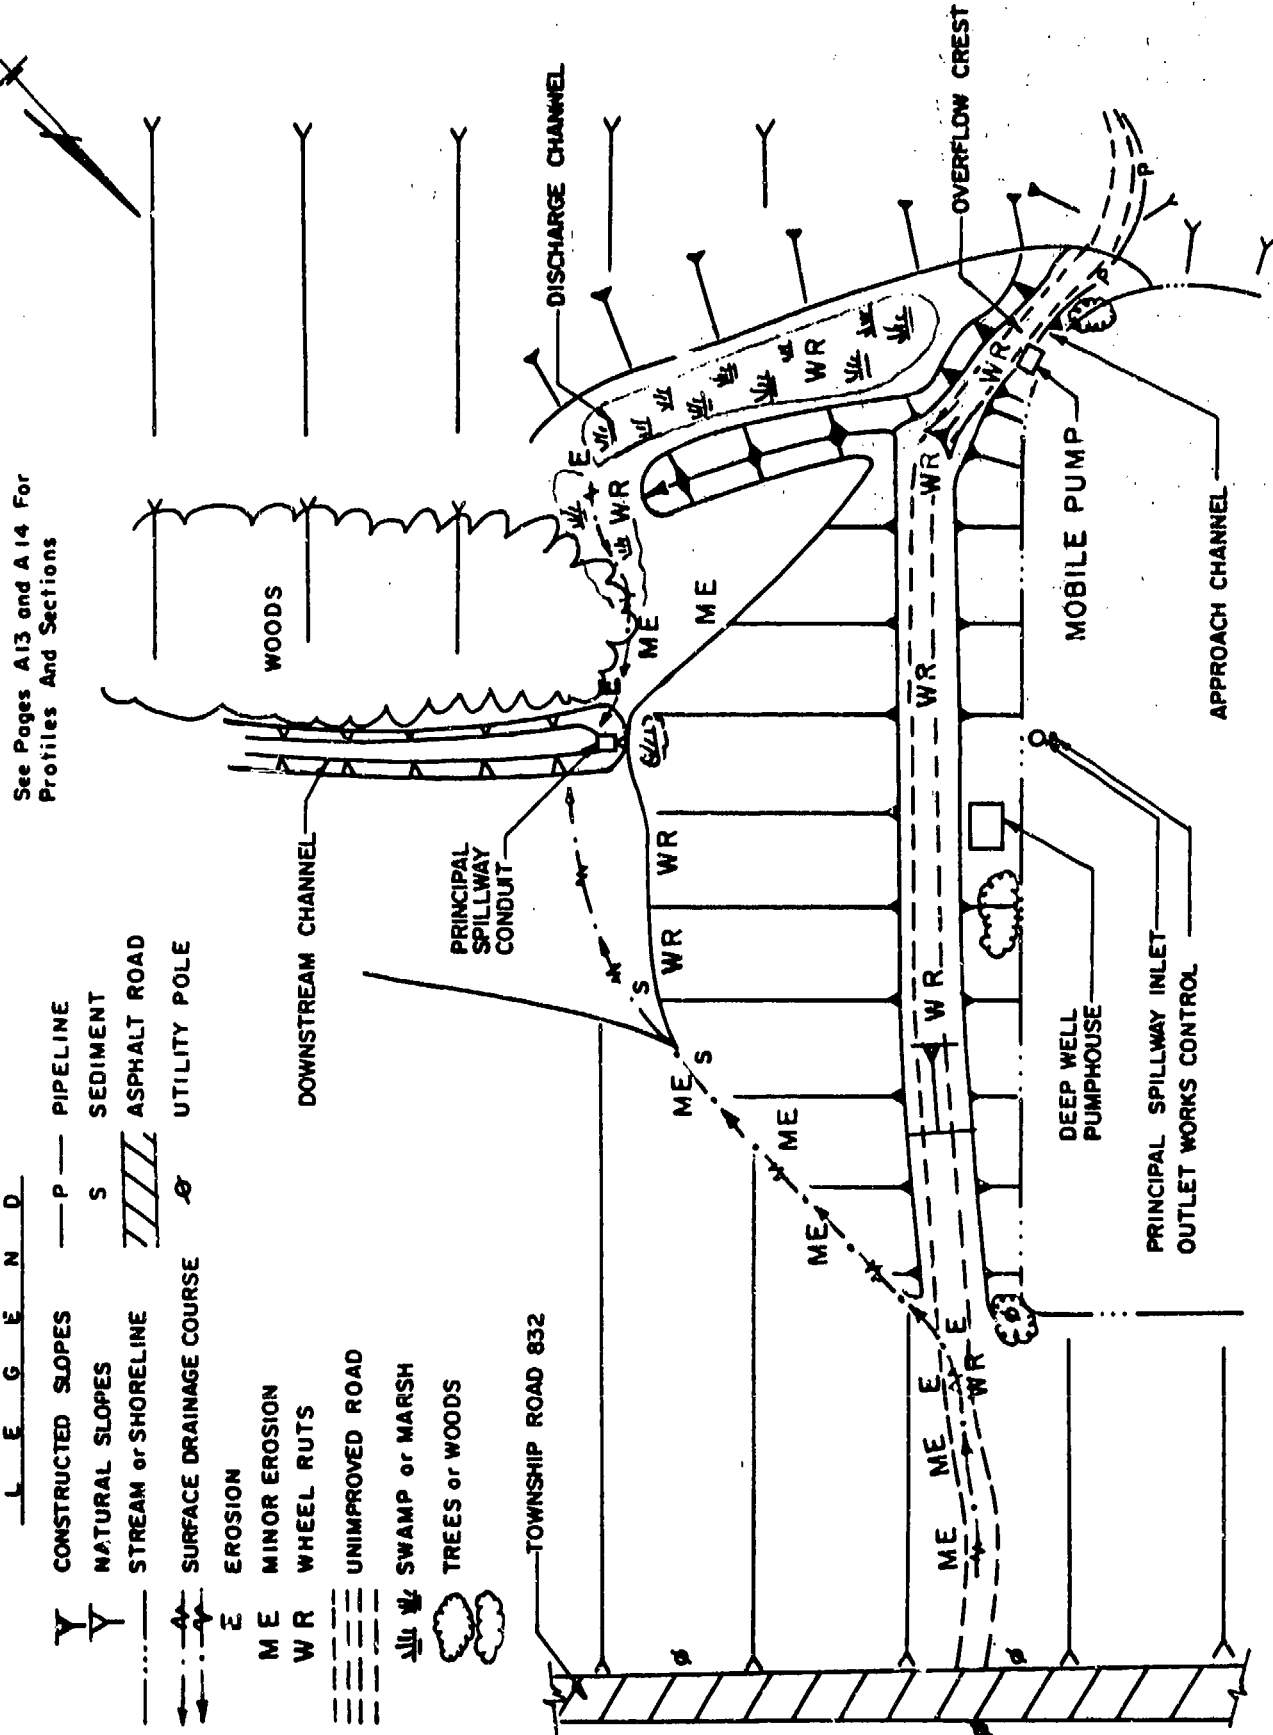
FIELD SKETCH

The embankment groins (junction of embankment and abutment) were in fair to good condition. They were vegetated and showed no signs of instability. However, the left groin contained noticeable erosion and some sediment deposits, apparently the result of surface runoff, flows from the upper left abutment. Some wheel rutting was also noted in and about the left groin.

Wet, swampy conditions were observed in the emergency spillway discharge channel bottom and on the abutment slope below the discharge channel outlet. It could not be determined whether the water was the result of seepage or poor surface drainage. However, the condition appeared to be longstanding and may be the result of seepage from the right abutment above. In the upper portion of the discharge channel, the wet areas appeared to exist at elevations above the observed reservoir pool level.

Below the discharge outlet, the hillside contained wet, swampy conditions with flowing water. Some erosion has occurred at the end of the discharge channel and down the hillside below to a point where the flow would enter the channel at the downstream toe of the embankment.
