NDI ID PA 00604  
PA DER 45-238

# SINCAVAGE LUMBER COMPANY DAM (LAKE SINCA DAM)

PHASE I INSPECTION REPORT  
NATIONAL DAM INSPECTION PROGRAM

Name of Dam: Sincavage Lumber Company Dam  
State: Pennsylvania  
County: Monroe  
Stream: Unnamed Tributary of Two Mile Run  
Coordinates: N41°01.2', W75°35.5'  
Date of Inspection: April 8, 1981

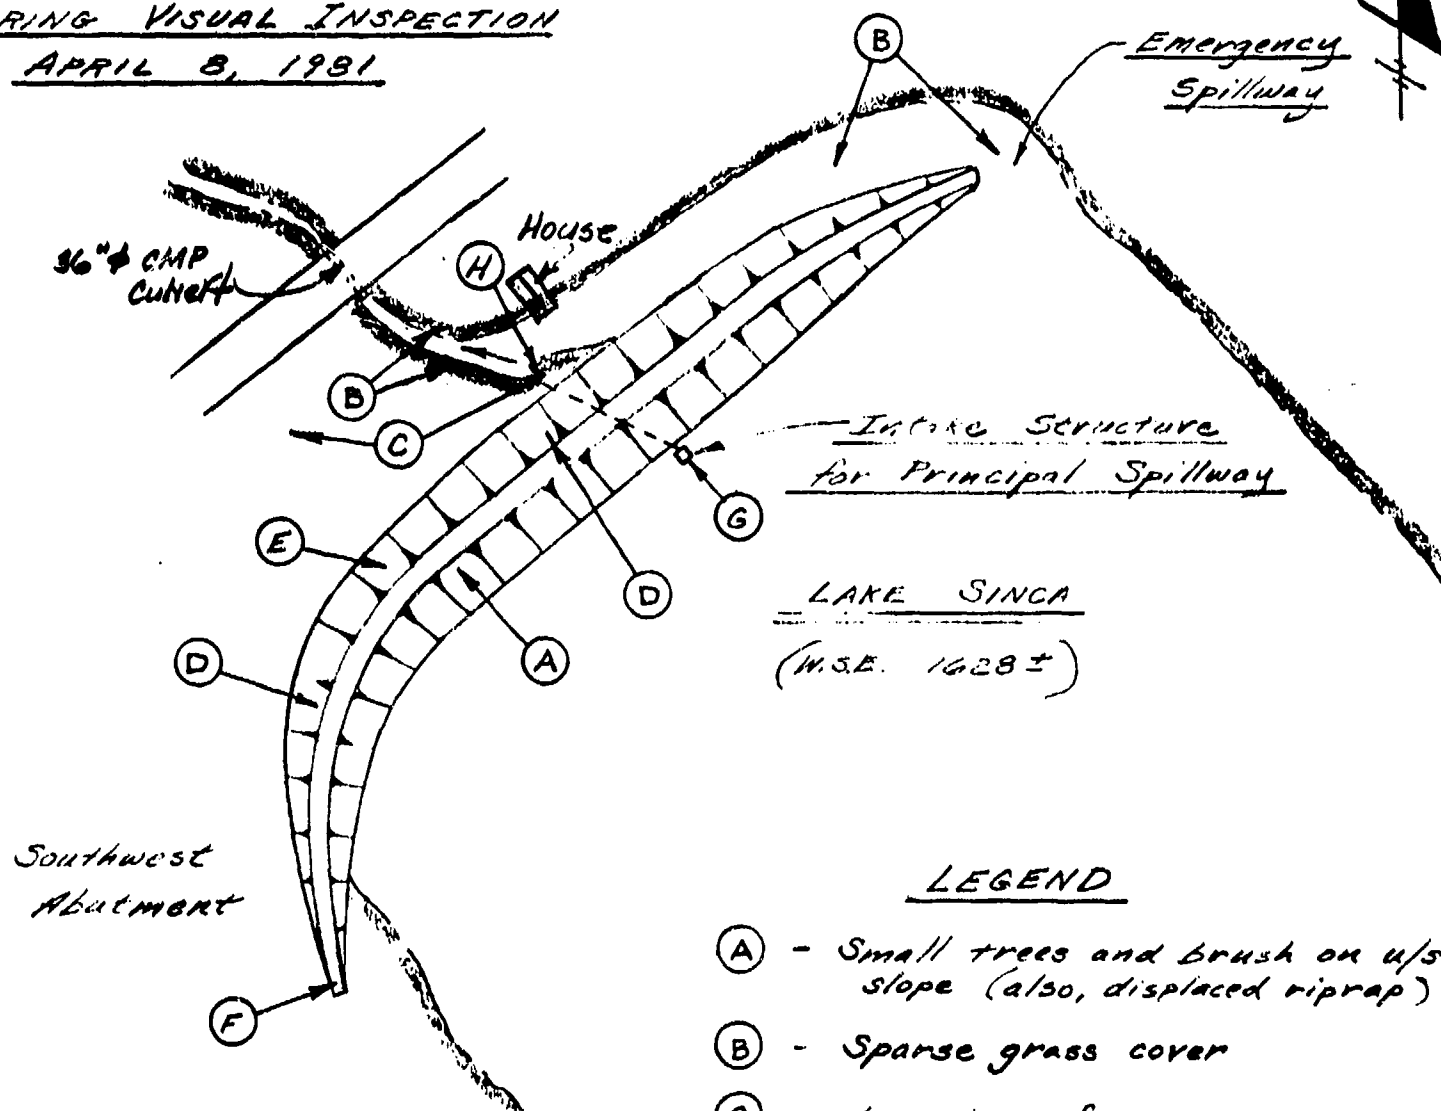
LOCATION PLAN OF  
DEFICIENCIES OBSERVED  
DURING VISUAL INSPECTION  
APRIL 8, 1981

- (A) - Small trees and brush on u/s slope (also, displaced riprap)
- (B) - Sparse grass cover
- (C) - Location of seepage
- (D) - Sloughing of embankment
- (E) - Large stones on d/s face
- (F) - Top of dam el. below design elev. for most of dam
- (G) - No access to intake structure
- (H) - Cracking of outlet headwall

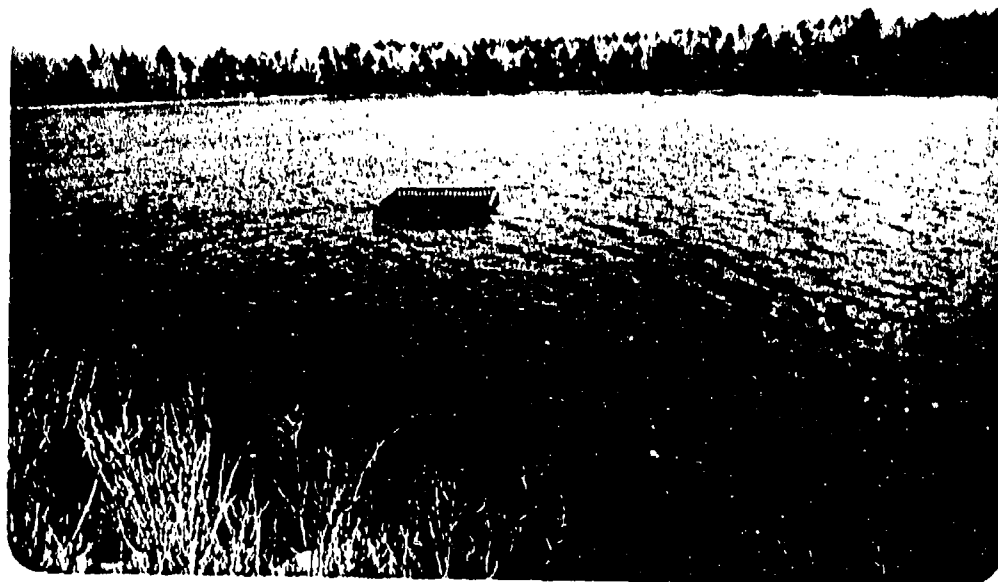
No access to the intake structure is available. From the dam, a concrete drop intake structure with a trash rack was observed. (Photo 1, Appendix C)

1. OVERVIEW OF THE IMPOUNDMENT SHOWING THE PRINCIPAL SPILLWAY INLET. (4/8/81)

2. Access to the intake structure should be provided to facilitate routine and emergency operation of the low level gate.

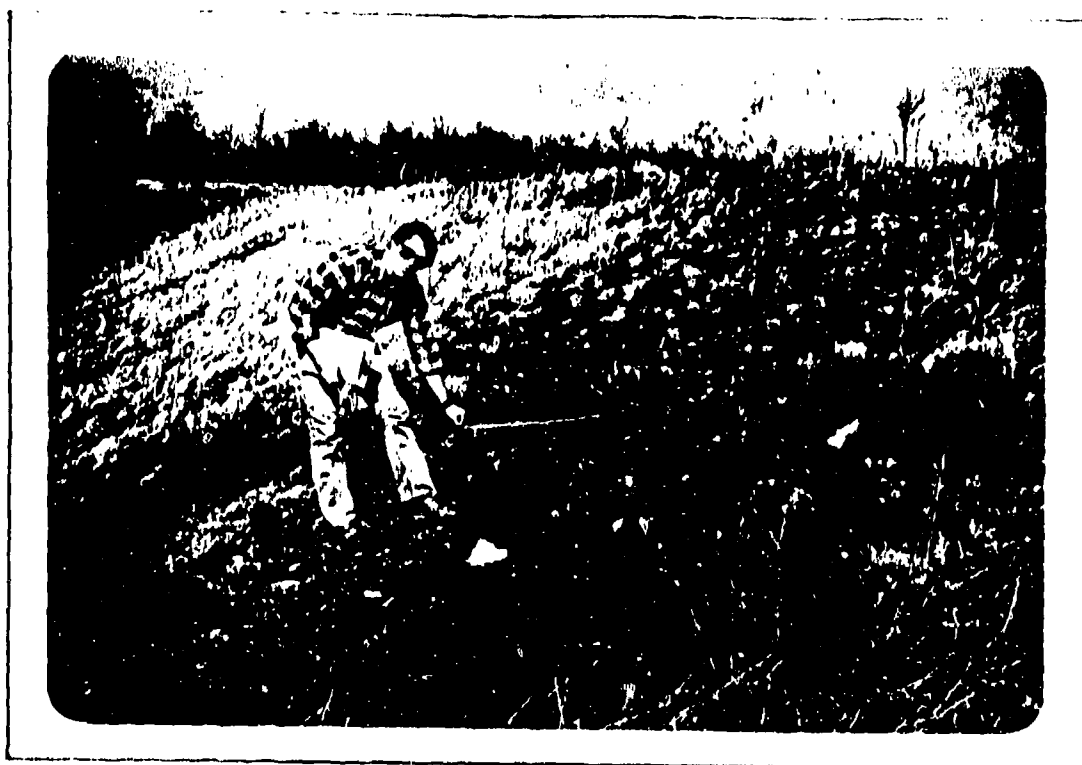
A number of local slope failures were observed on the downstream face of the dam. The most notable area is located approximately 20 feet southwest of the outlet structure, near the mid-height of the dam, where a two-foot depression has developed. Another location of instability is located near the southwest dam abutment, where a 25-foot long "bulge" is present on the downstream face. This condition is illustrated on the downstream overview photo.

9. SLOPE FAILURE IN THE DOWNSTREAM FACE OF THE DAM. (4/8/81)

3. Boulders present on the downstream face of the dam should be removed. Also, sloughed or settled areas should be backfilled with suitable material, compacted and provided with a good cover of grass.

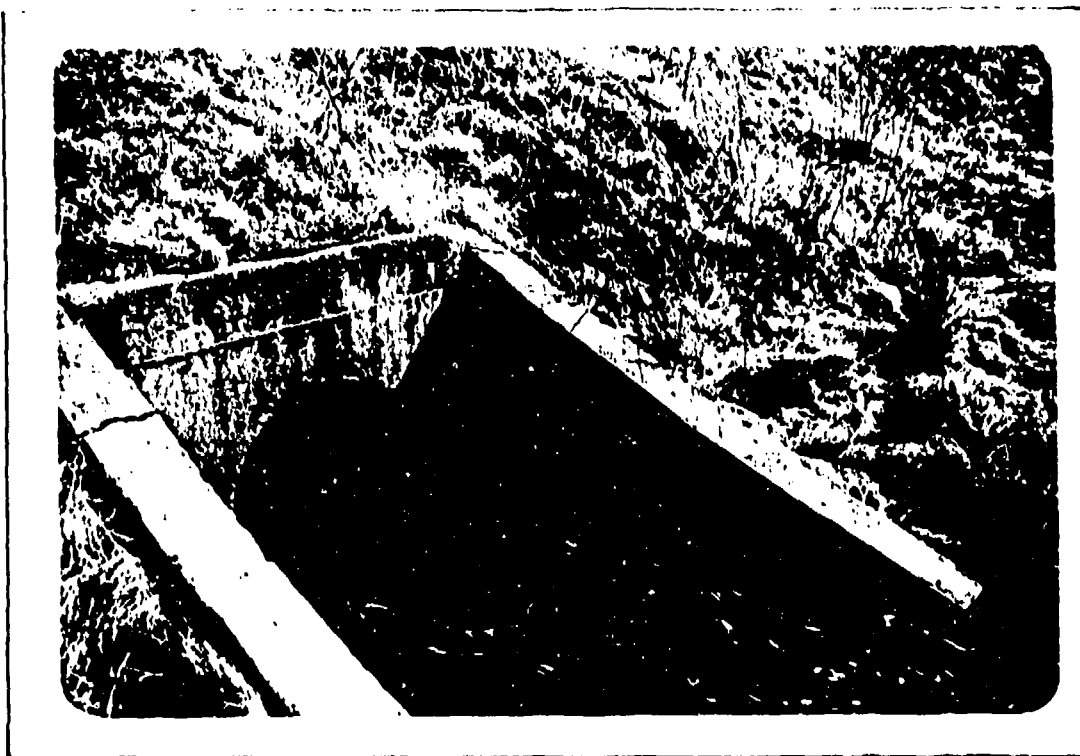
The concrete outlet headwall is cracked badly at the wing walls where the toe drain pipes emerge (Photos 11 and 12, Appendix C)

11. PRINCIPAL SPILLWAY OUTLET STRUCTURE. (4/8/81)

Repair concrete headwall

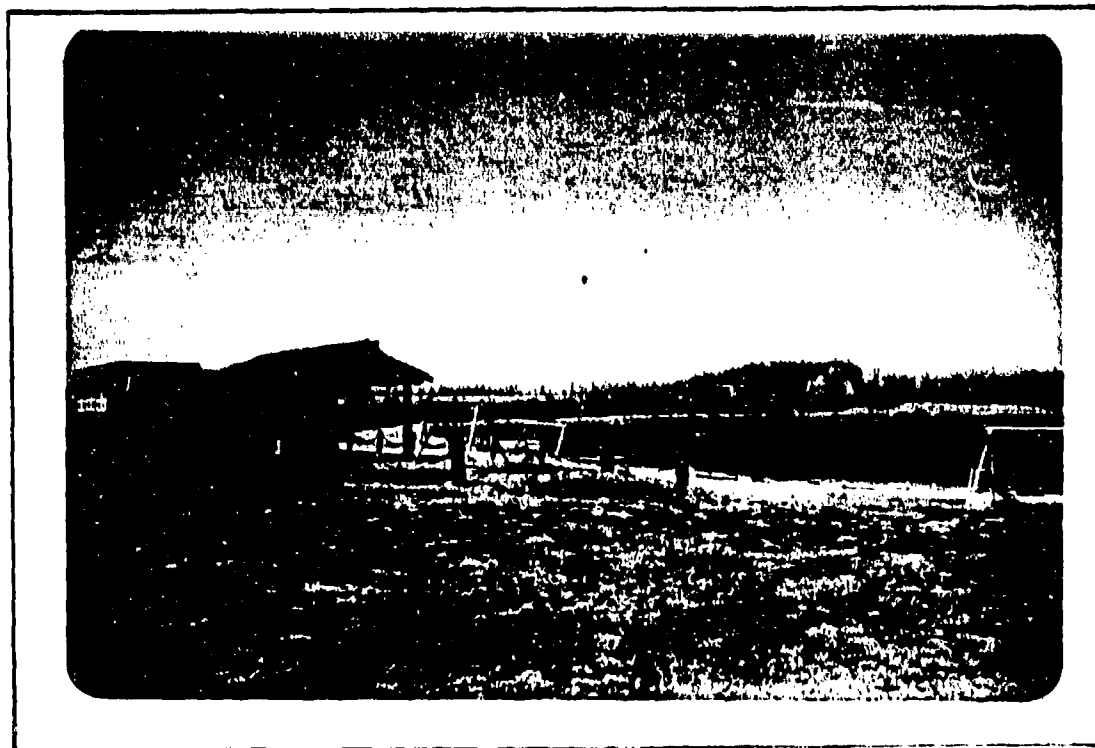
13. RECREATION DEVELOPMENT ON THE SHORES OF THE IMPOUNDMENT. (4/8/81)

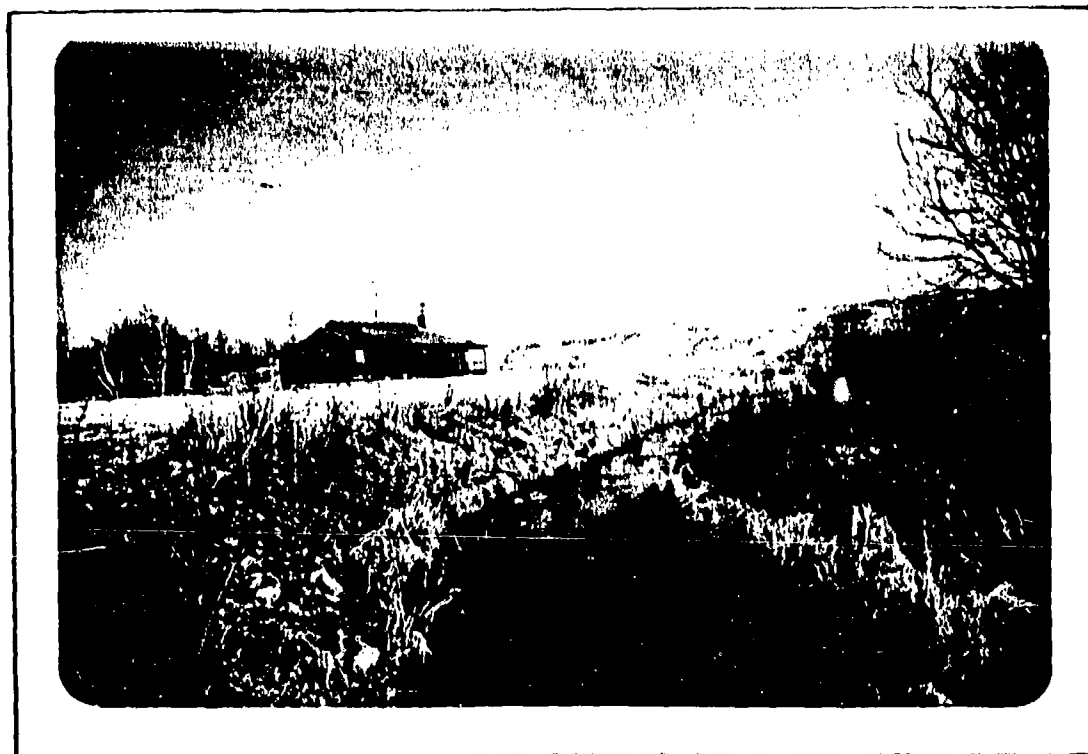
The hazard area lies just d/s of  
the dam where one home is located  
adjacent to the spillway channel.  
(Photo 14, Appendix C)

14. HAZARD AREA AND DOWNSTREAM CHANNEL WITH THE DAM IN THE BACKGROUND. (4/8/81)
