LARSEN DAM

NDI ID NO. PA-00367

PHASE I INSPECTION REPORT
NATIONAL DAM INSPECTION PROGRAM

JULY 1981

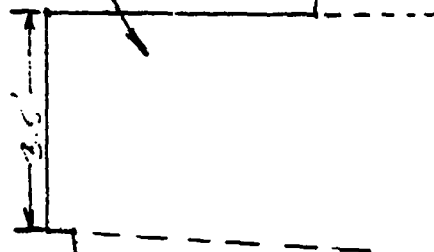
SECTION THROUGH EMBANKMENT
TO RIGHT OF SPILLWAY

The portion of the embankment to the right of the spillway has the corewall exposed over a 75-foot long reach (Photograph A). The maximum exposed height of corewall is 4.5 feet (Photograph B). About 15 feet to the right of the spillway, the corewall has a 1/8-inch wide crack that extends through the corewall (Photograph C). There is no misalignment at the crack, but concrete at that location has spalled. Near the right abutment there is an area where minor surface erosion of the embankment has occurred (Photographs A and B).
