CRAFT POND DAM

NDI ID NO. PA-01103

PHASE I INSPECTION REPORT  
NATIONAL DAM INSPECTION PROGRAM

JULY 1981

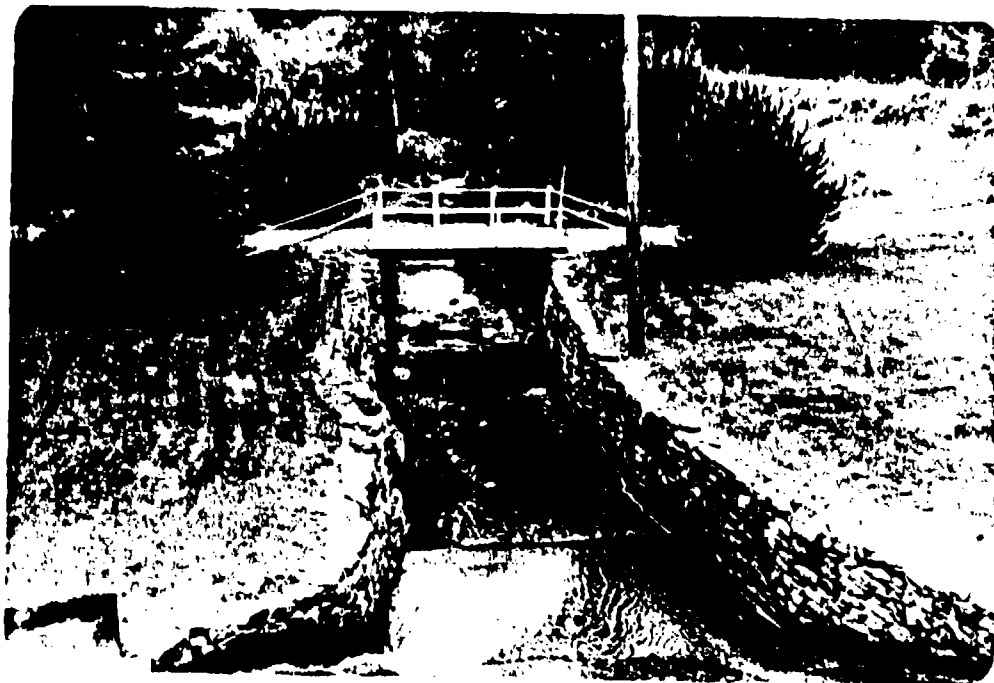
C. Spillway Channel
