ROSS DAM

NDI ID NO. PA-00978
DER ID NO. 58-134

PHASE I INSPECTION REPORT
NATIONAL DAM INSPECTION PROGRAM

JUNE 1981

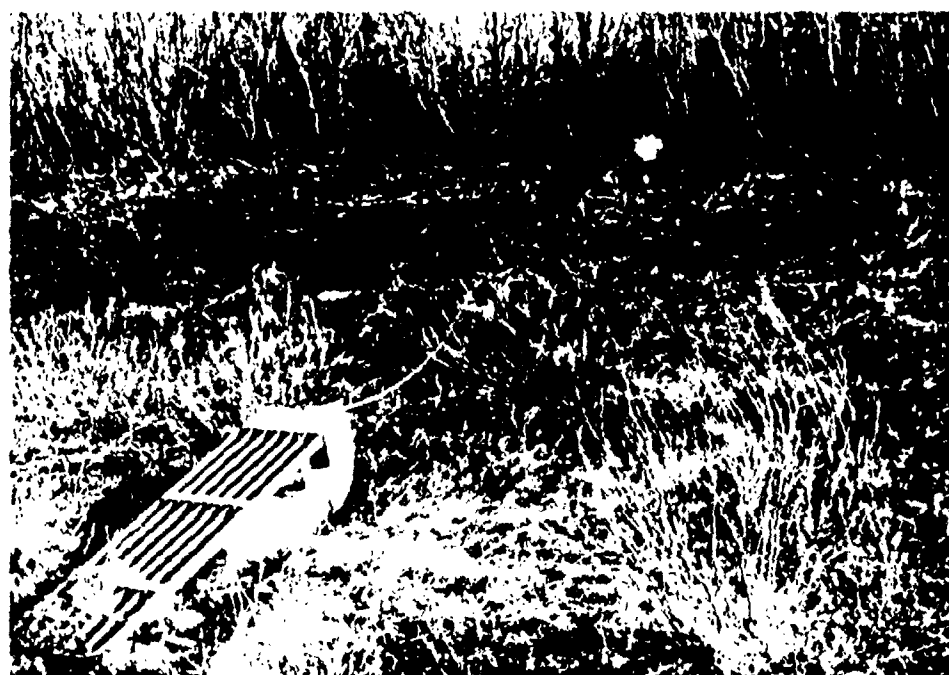
Although supported in several locations along its length, the control rod is severely bent in two locations below the spillway crest. The cause of the deformation is reported to be ice forces. In this present condition the gate is essentially inoperable. The 12 inch corrugated metal conduit and the outlet structure are in good condition. The discharge channel is the original streambed with trees and brush along the banks.

VISUAL EXAMINATION OF	OBSERVATIONS
Conduit	12" Corrug. metal; fair condition
Intake Structure	Conc. slab with trashrack; good condition.
Emergency Gate	Slide gate on surface of intake structure. Control rod bent; gate inoperable.
Outlet Structure	Concrete headwall; fair condition.
Outlet Channel	Original streambed; earth & rock with trees and brush on sides.

8. Outlet works intake structure. Note bent control rod.

b. The control rod for the outlet works slide gate control should be repaired prior to maintaining a permanent pool.
