INTERLAKEN DAM

NDI ID NO. PA-01037
DER ID NO. 35-087

PHASE I INSPECTION REPORT NATIONAL DAM INSPECTION PROGRAM

JUNE 1981

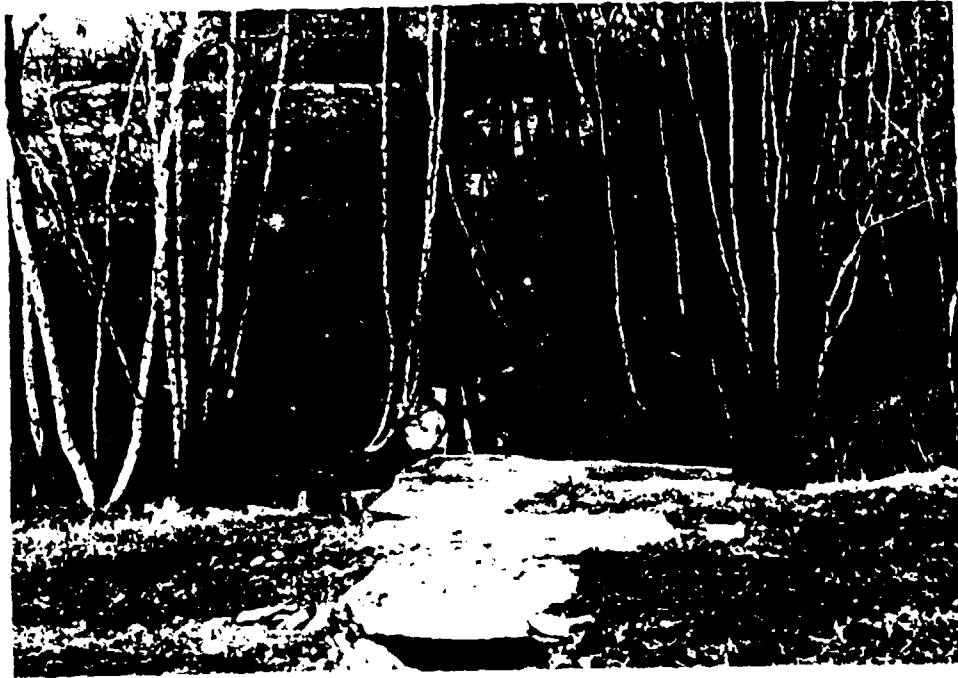
9. Discharge channel with rock culvert in foreground.

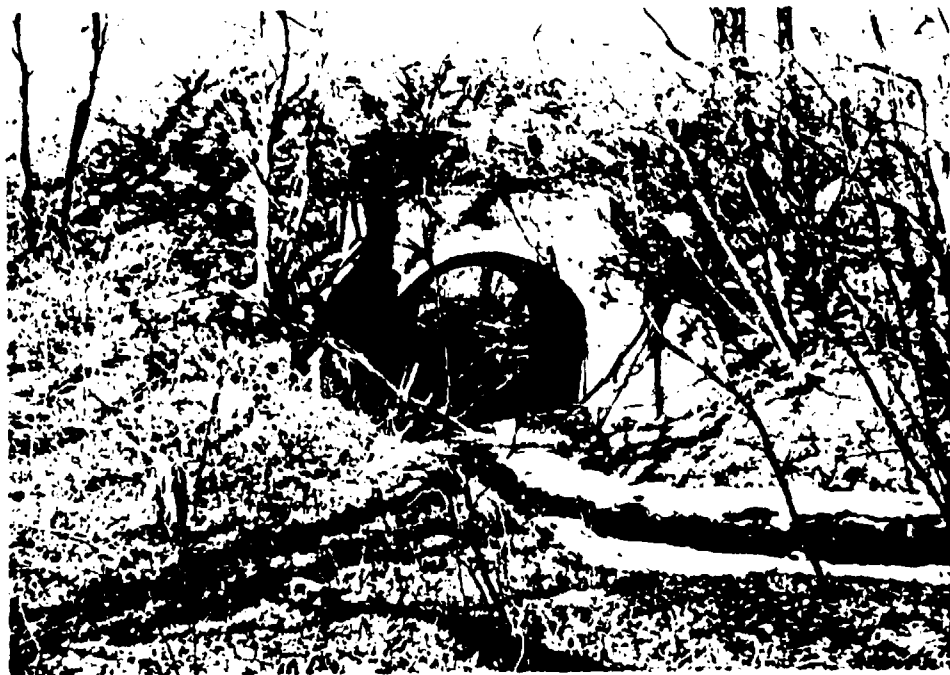
10. PA. Route 307 highway culver. (800 feet up)

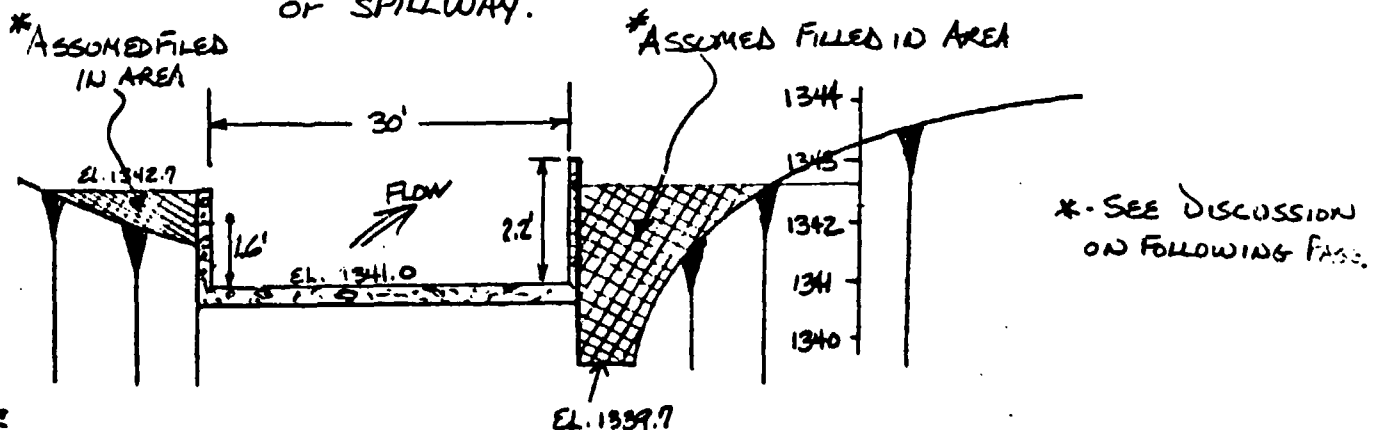
SPILLWAY SKETCH:

NOTE: UNDER EXISTING CONDITIONS THE BREAK AREA IS
DOWN TO ELEVATION 1339.7. THIS ELEVATION IS 1.3
FEET BELOW SPILLWAY CREST.
