LAKE IRENA DAM

NDI ID NO. PA-00179
DER ID NO. 40-215

PHASE I INSPECTION REPORT NATIONAL DAM INSPECTION PROGRAM

SEPTEMBER 1981

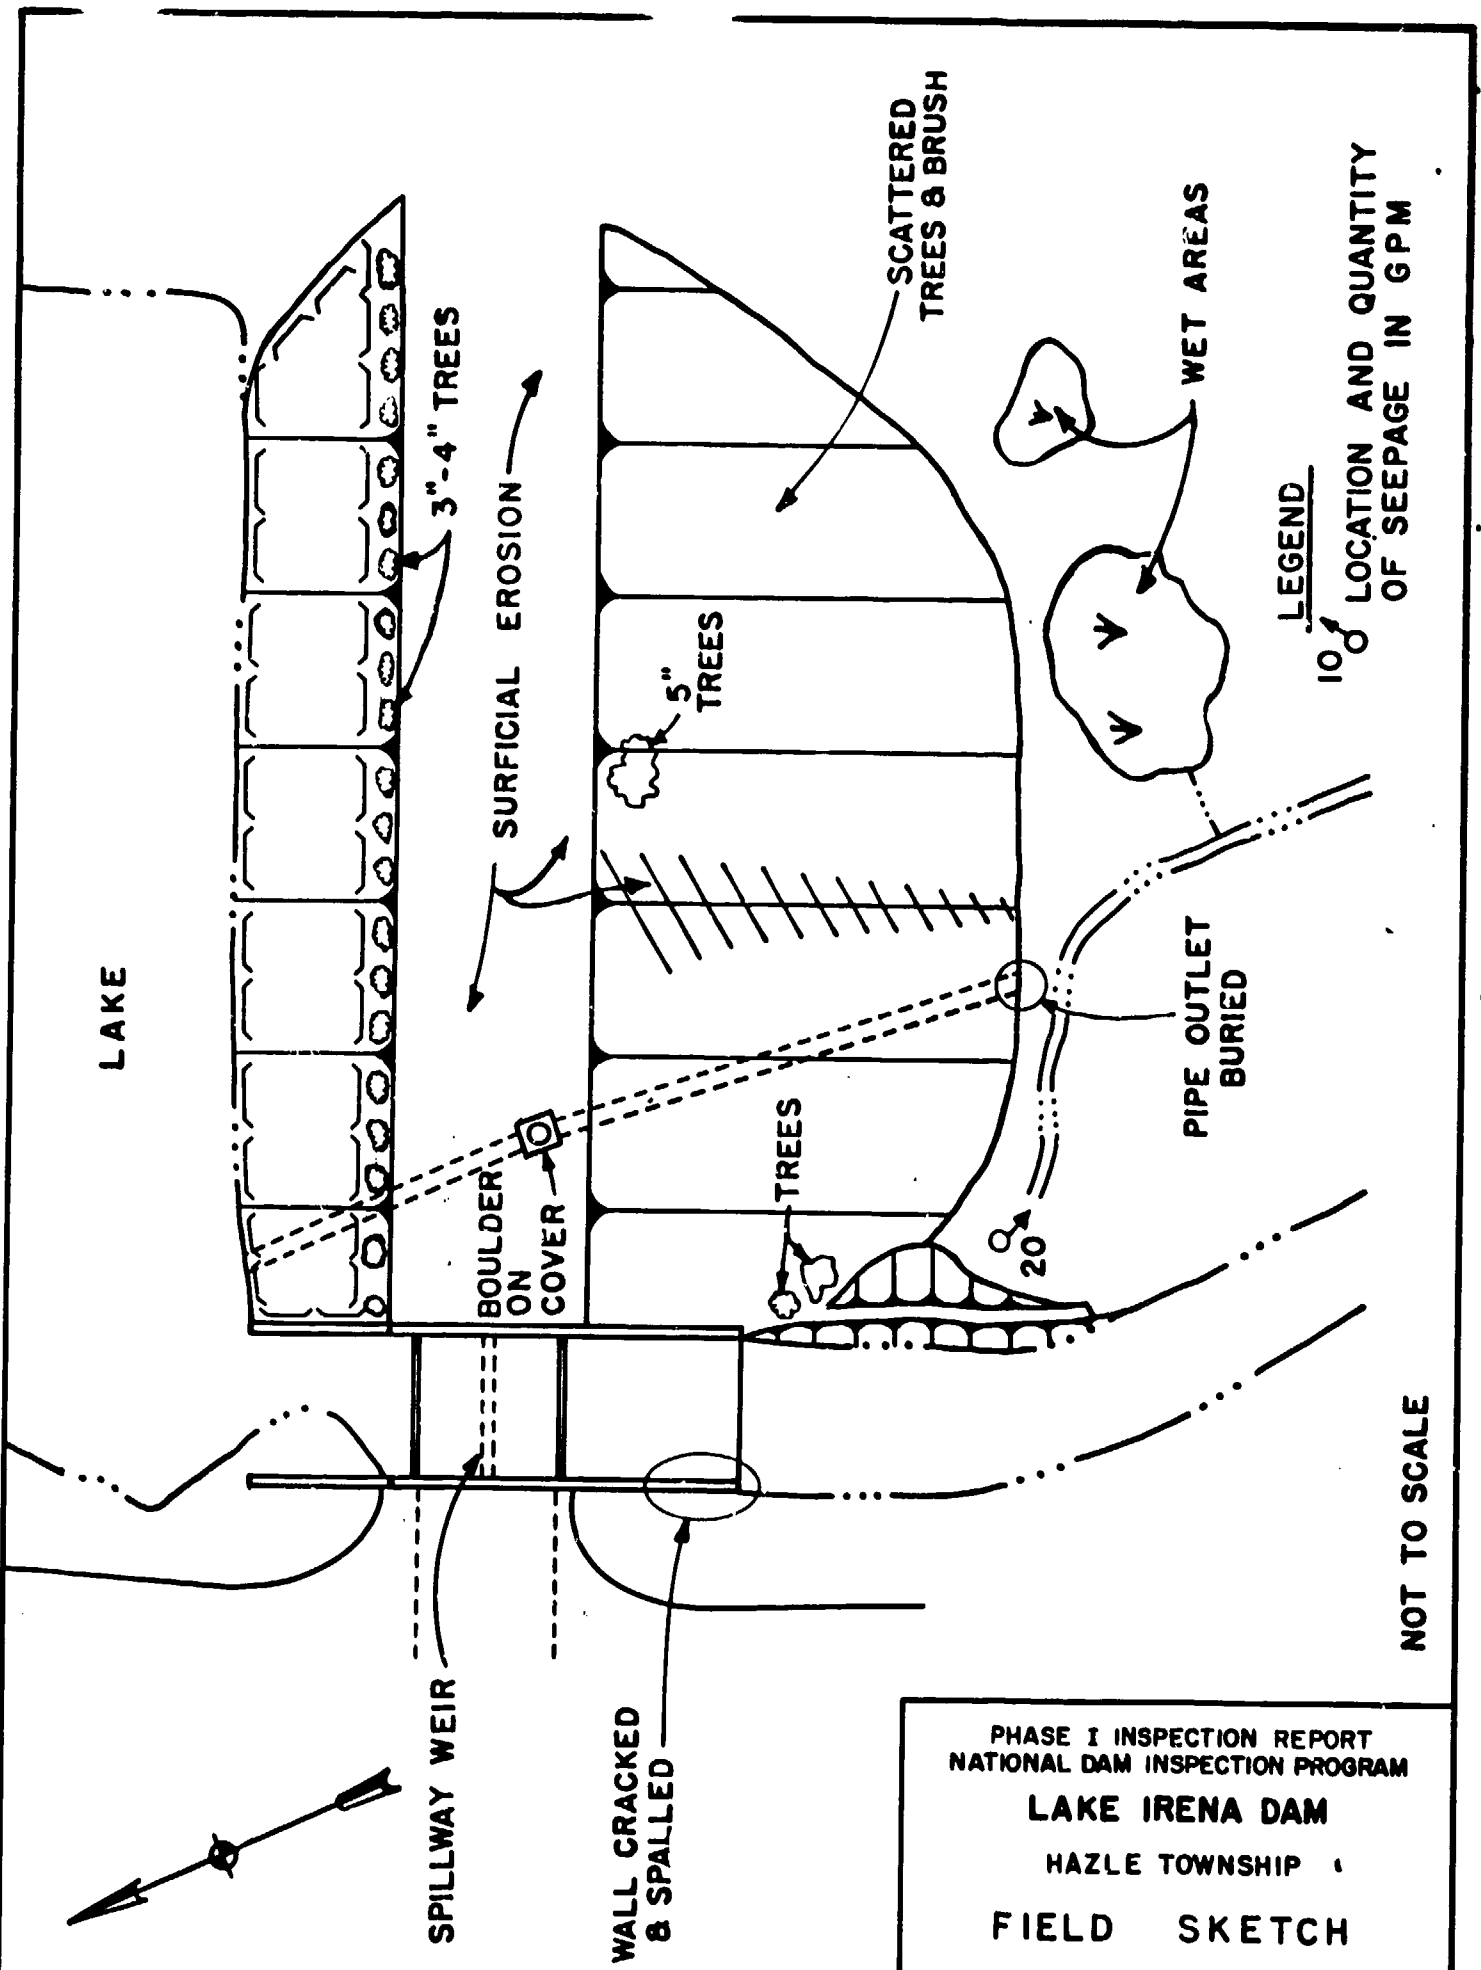
PHASE I INSPECTION REPORT
 NATIONAL DAM INSPECTION PROGRAM
LAKE IRENA DAM
 HAZLE TOWNSHIP
 FIELD SKETCH

WALL CRACKED & SPALLED

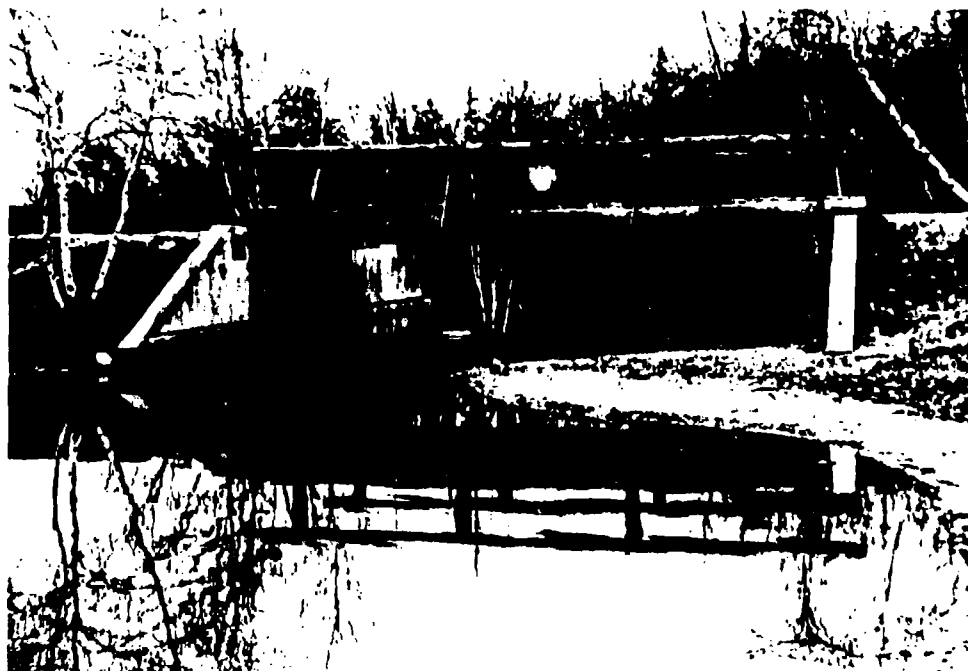
8. Spillway approach, walls and bridge.

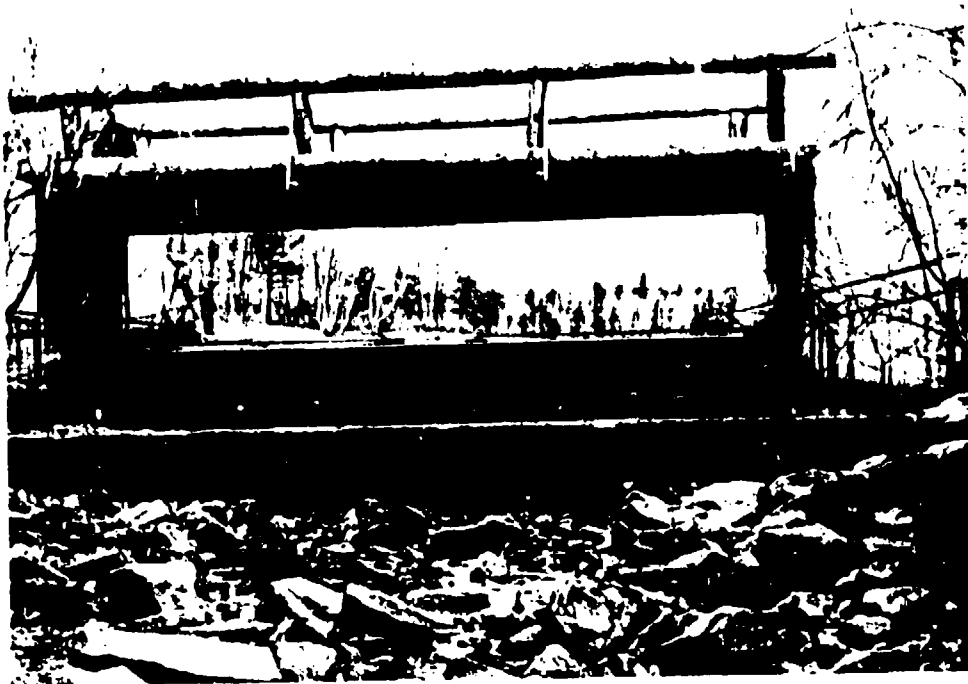
9. Spillway bridge, weir and discharge channel.

7. Make appropriate repairs to the spillway bridge to assure that no damage is done to the spillway by the passage of traffic.
