# RESERVOIR NO. 7 DAM

NDI ID NO. PA 00090  
DER ID NO. 641

FARVIEW STATE HOSPITAL

## PHASE I INSPECTION REPORT NATIONAL DAM INSPECTION PROGRAM

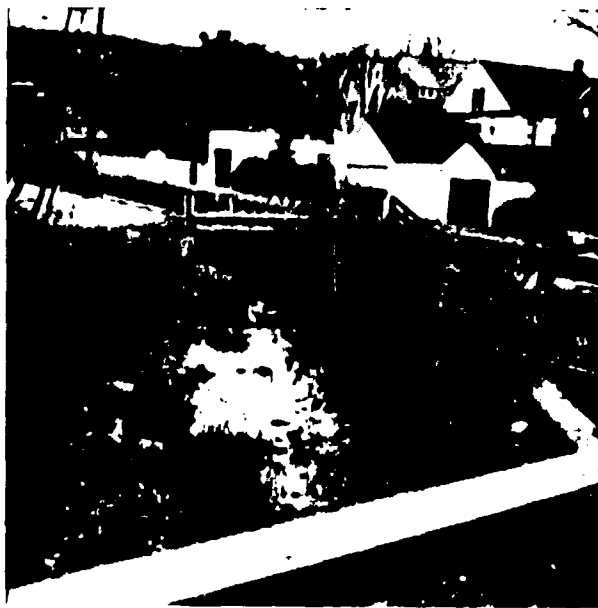
11. Downstream hazard area looking upstream from  
U.S. Route 6 bridge (3.0 miles d/s).
