**ARTIFICIAL ICING TEST**

**UTILITY TACTICAL TRANSPORT**  
**AIRCRAFT SYSTEM (UTTAS)**

**BOEING VERTOL YUH-61A HELICOPTER**

FINAL REPORT

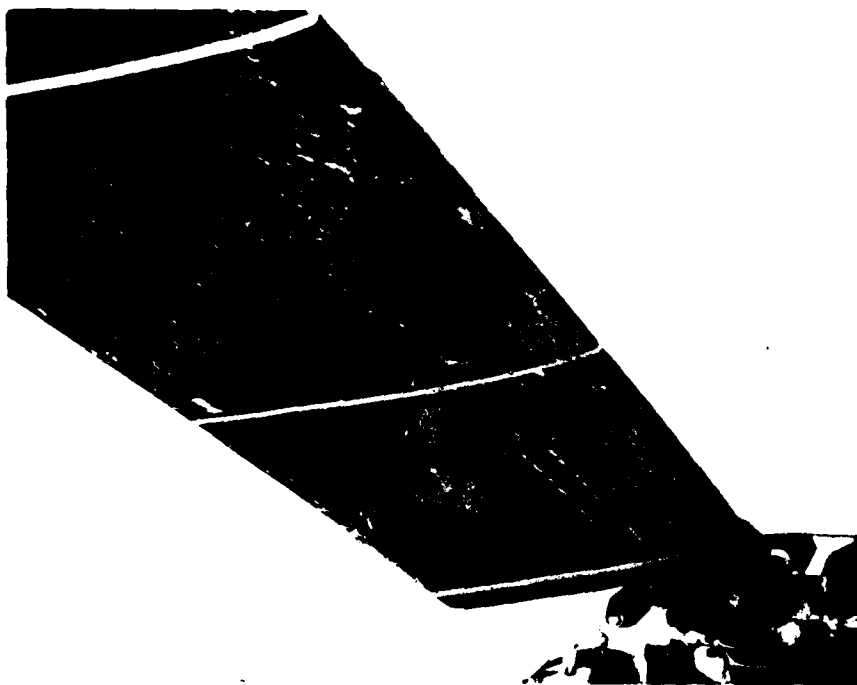
33. Random main rotor blade ice shedding was observed throughout the unheated blade phase. No ice shedding from the horizontal stabilizer was observed. Three incidents of asymmetrical shedding from the main rotor blades occurred during the second flight of the unheated blade phase. Each occurrence was characterized by a moderate lateral airframe vibration (para 53) which lasted approximately

**Photo A. Main Rotor Blade Lower Chord - Unheated Phase.**

1 minute. Flight control inputs by the pilot were not required to maintain adequate aircraft control during the asymmetrical sheds (HQRS 2). During landing and engine shutdown following this flight, numerous ice particles were observed shedding from the main rotor blades. The ice was shed in all directions and presented a potential hazard to ground personnel in the vicinity of the helicopter. The WARNING shown below should be placed in the operator's manual. Damage to the tail rotor gearbox fairing on the vertical fin was observed following this flight. Ice particles also impacted on the tail rotor blades, causing three blade skin deformations. The tail rotor blade strikes did not require blade replacement.

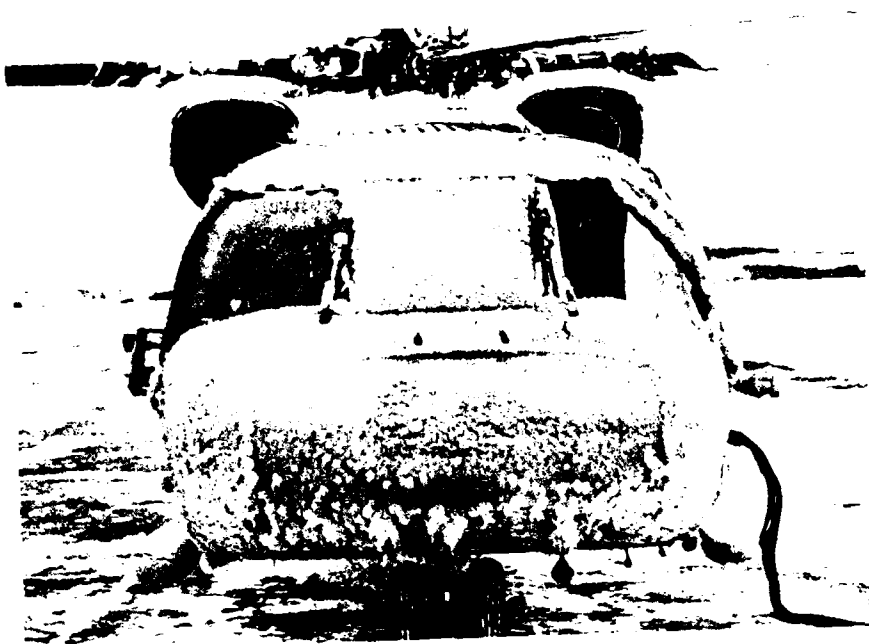
38. The majority of the ice accreted on the airframe occurred in the forward fuselage area. Negligible ice was accreted on the fuselage sides, fuselage bottom, upper fuselage (except the forward crown), engine nacelles, and tail boom. There were two types of glime ice accretion patterns (characteristics) observed. The ice accretion pattern at temperatures warmer than  $-16.5^{\circ}\text{C}$  was characterized by a rough surface with numerous irregularities (photo C). As the time in the cloud was increased, these irregularities grew in size, forming vertical columns of ice which grouped together to create ice ridges. The ice ridges were most pronounced on the chin bubbles, lower nose area, and pilot foot-steps. The second distinctive pattern was the ice formation at a temperature of  $-16.5^{\circ}\text{C}$ , which was characterized by a generally smooth uniform surface with no ice ridge formations (photo D). The ice particles on the fuselage were smaller and more numerous, which created the smoother, more regular-textured surface.

Photo C. Typical Accretion Pattern at Temperatures Warmer than  $-16.5^{\circ}\text{C}$ .

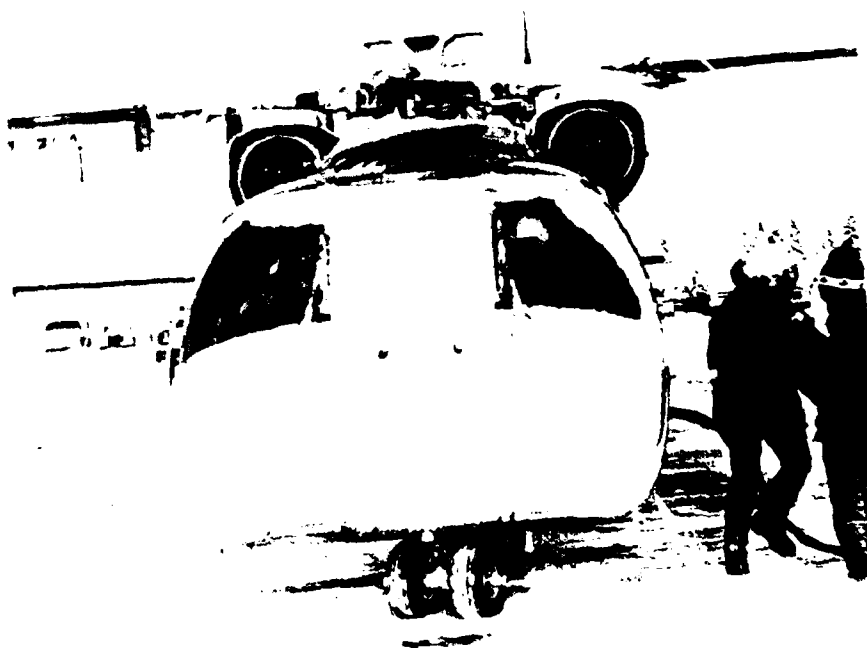
Photo D. Typical Accretion Pattern at  $16.5^{\circ}\text{C}$ .
