TECHNICAL REPORT M-297
November 1981

New Roofing Concepts in the Military Construction Process

EVALUATION OF SPRAYED POLYURETHANE FOAM ROOFING
AND PROTECTIVE COATINGS

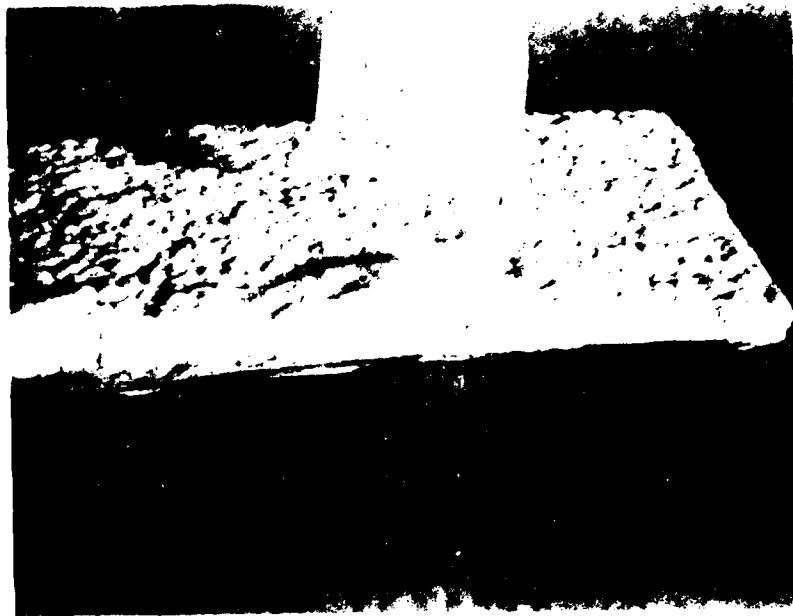
When water or moisture reacts with the isocyanate component, a by-product of the reaction is the formation of CO₂ (carbon dioxide) gas. This gassing causes the foam surface to exhibit high porosity where the reaction occurs. The severity of the condition described varies with the amount of moisture, but porosity does provide a way to visually check whether moisture was present when the foam was sprayed. Surface effects of foaming on a wet surface are shown in Figure 12.

Figure 12. Top view of the sample surface.
