ALEXANDER LAKE DAM

TIOGA COUNTY, NEW YORK

INVENTORY NO. N.Y. 936

PHASE I INSPECTION REPORT
NATIONAL DAM SAFETY PROGRAM
ALEXANDER LAKE DAM
S.Y. 936
REC I.D. NO. 000-1302
CHESAPEAKE RIVER BASIN
FINGER COUNTRY, NEW YORK

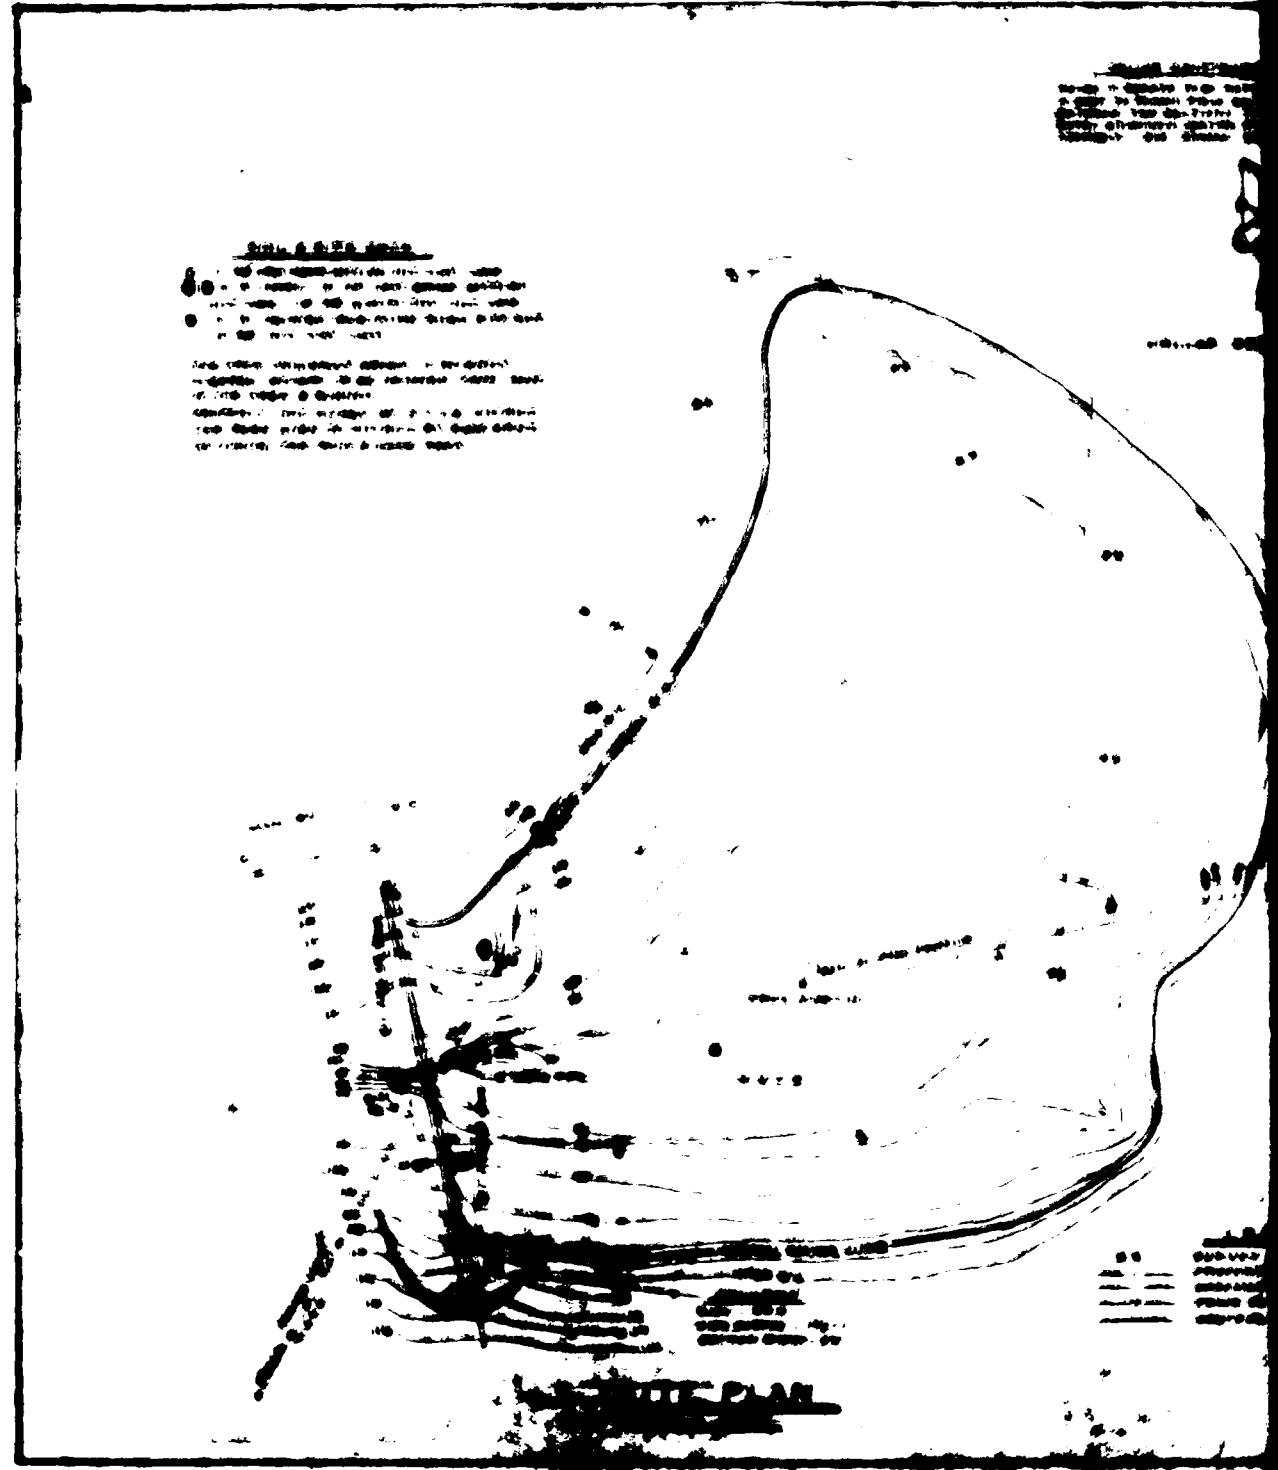
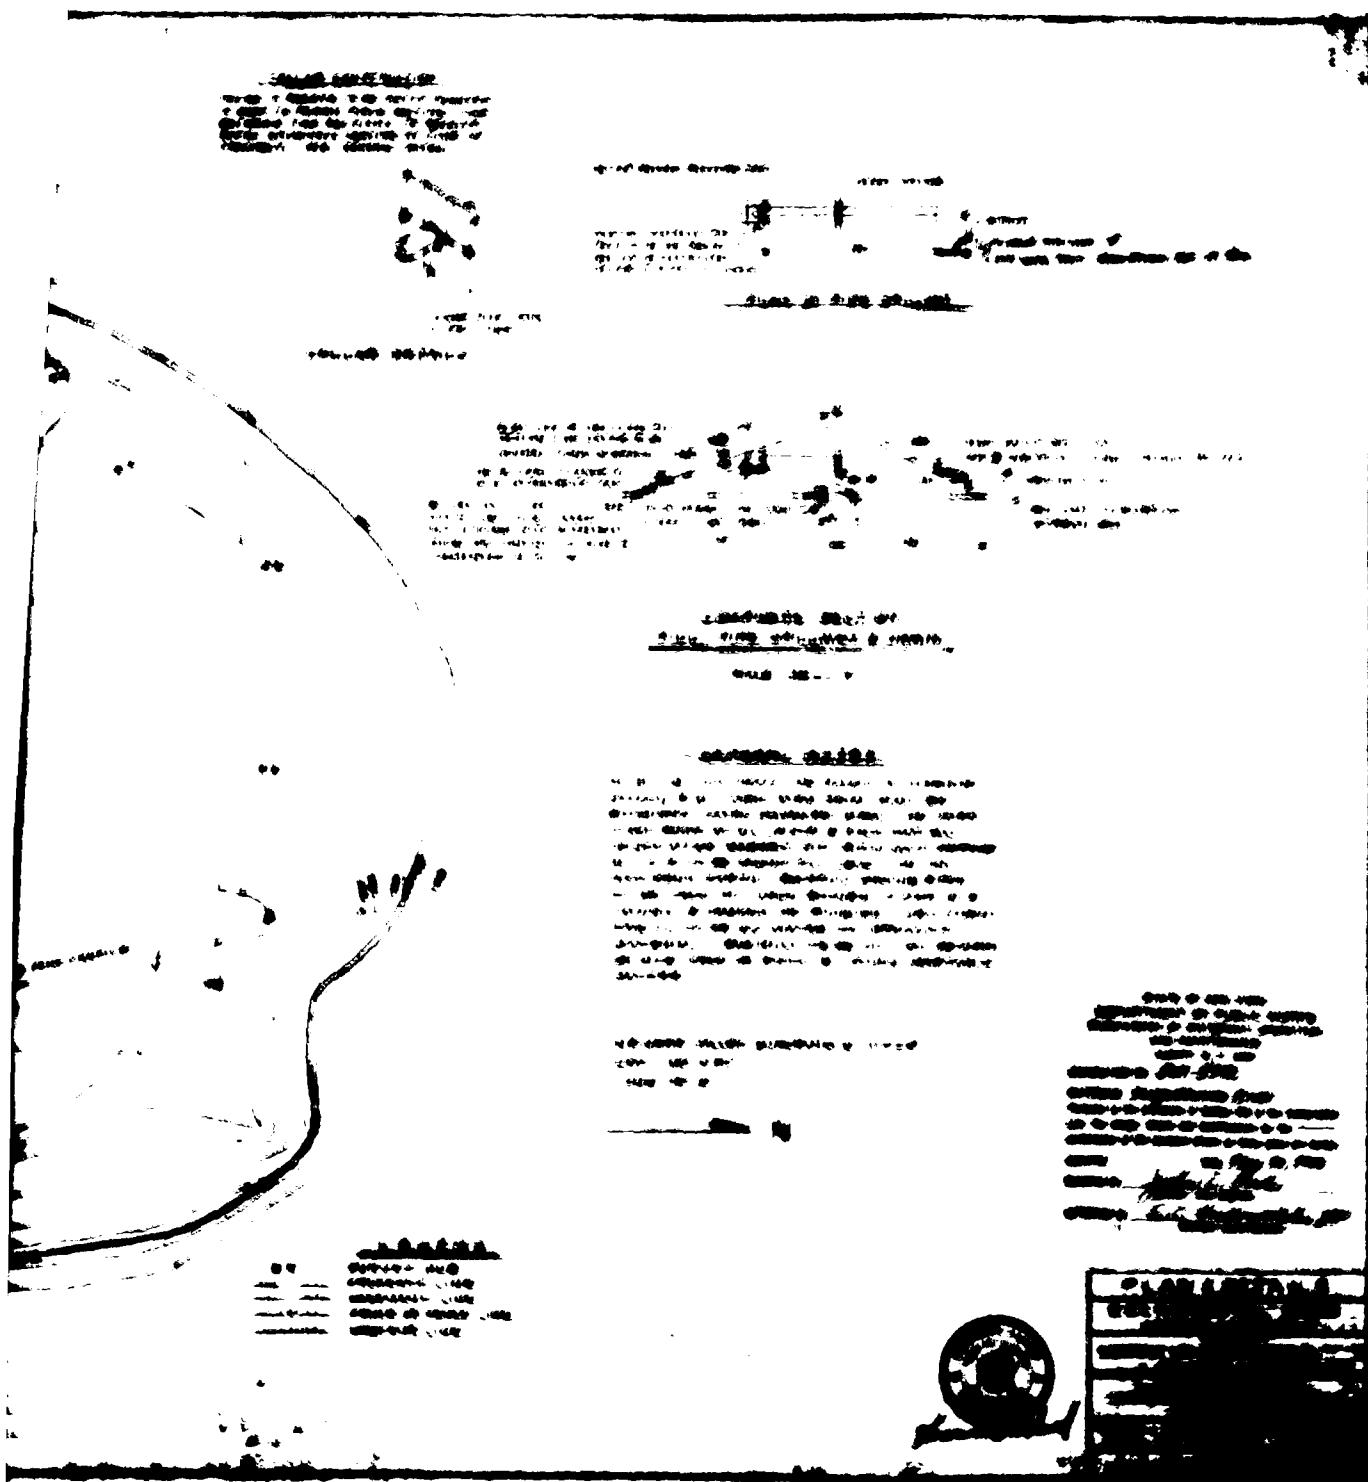
PLATE 2

No reference was found to indicate a subsurface investigation was conducted in conjunction with the design of the dam. A note included on the design drawing shown in Plate 2 suggests that some test pits may have been excavated to classify the soils in the area.

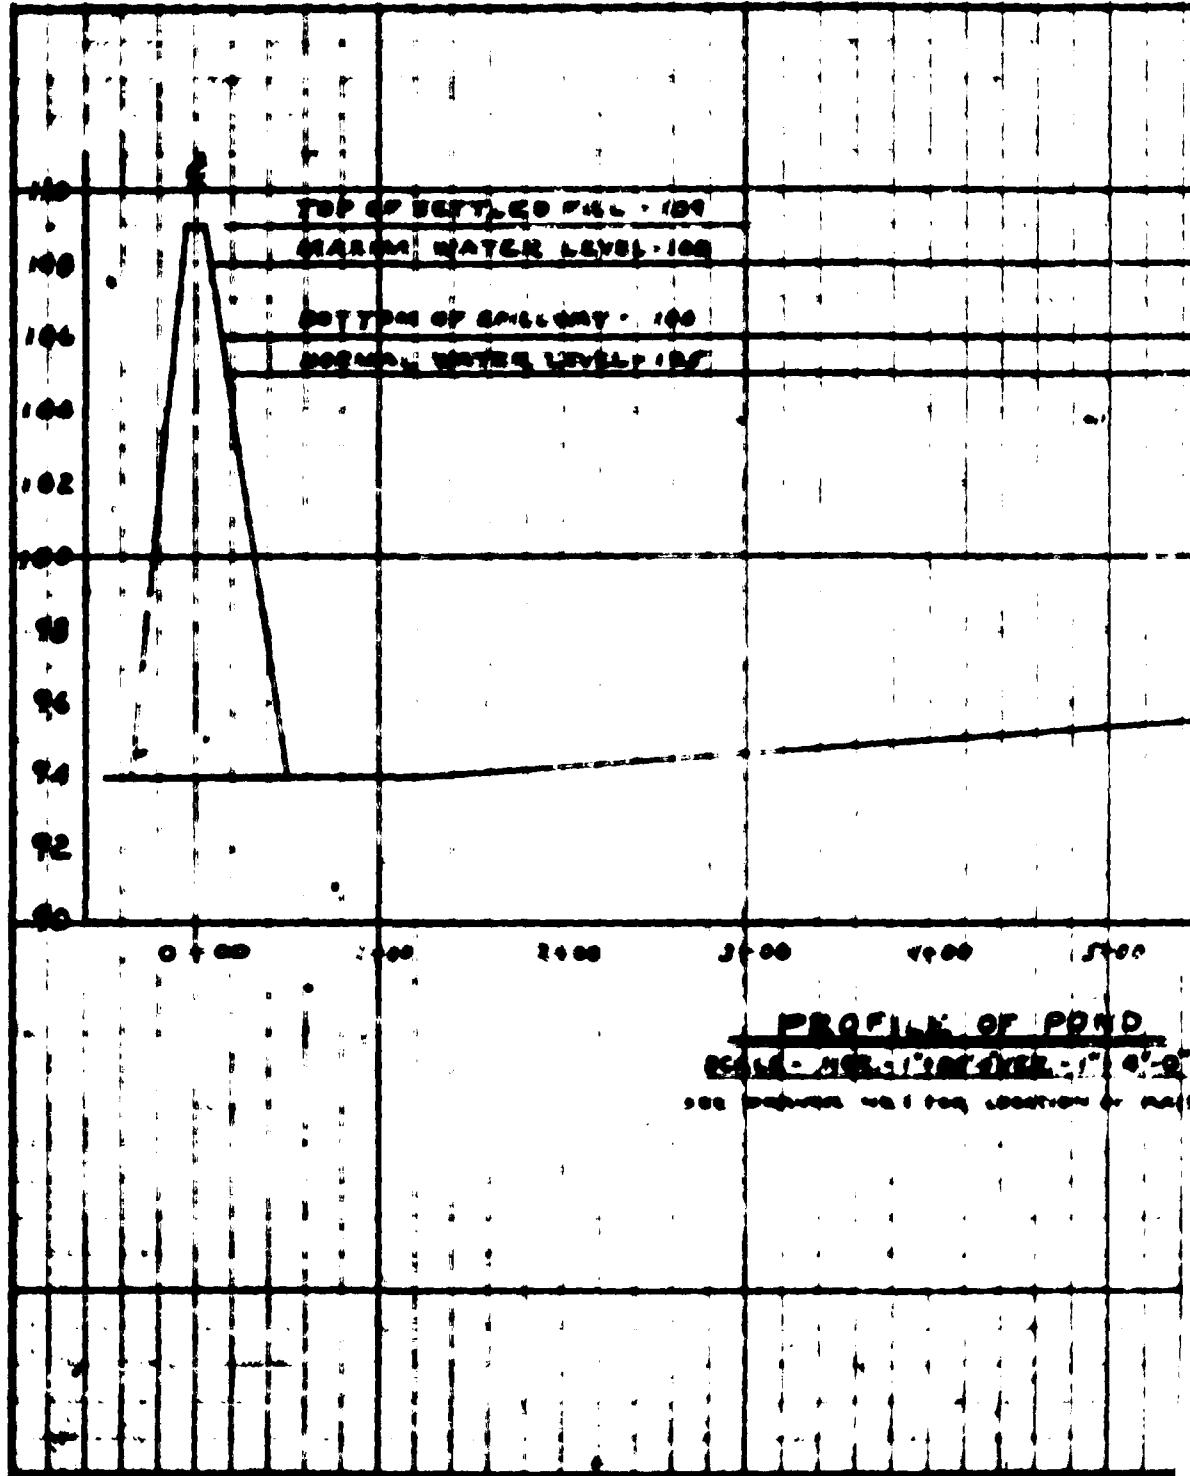
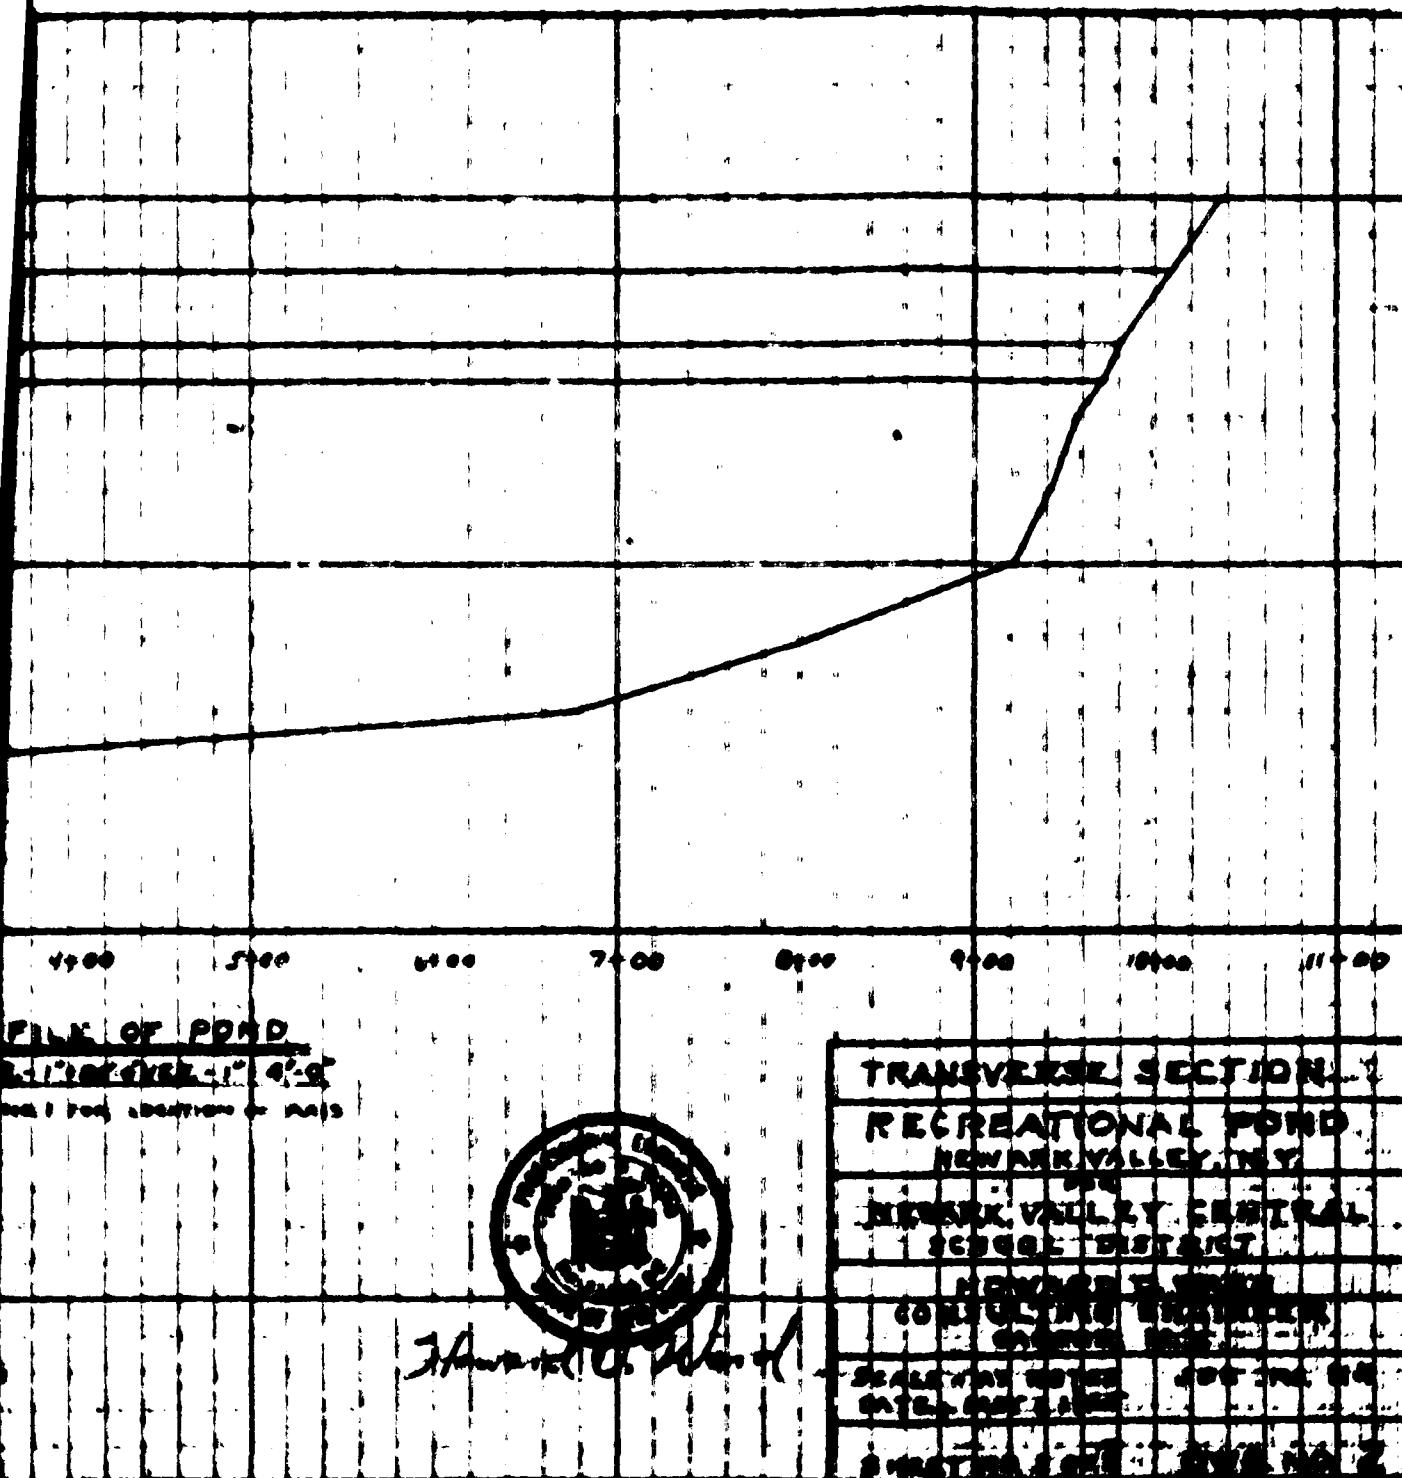
PLATE 4

The available information includes no hydrology and hydraulic analysis. Plate 4 shows the design maximum pool level. In the construction permit application to the state, the design capacity of the spillway is noted to be 454 cfs.
