MOHAWK RIVER BASIN

**LOCK 4 EMBANKMENT
WATERFORD FLIGHT DAM**

INVENTORY No. NY 968

**PHASE I INSPECTION REPORT^E
NATIONAL DAM SAFETY PROGRAM**

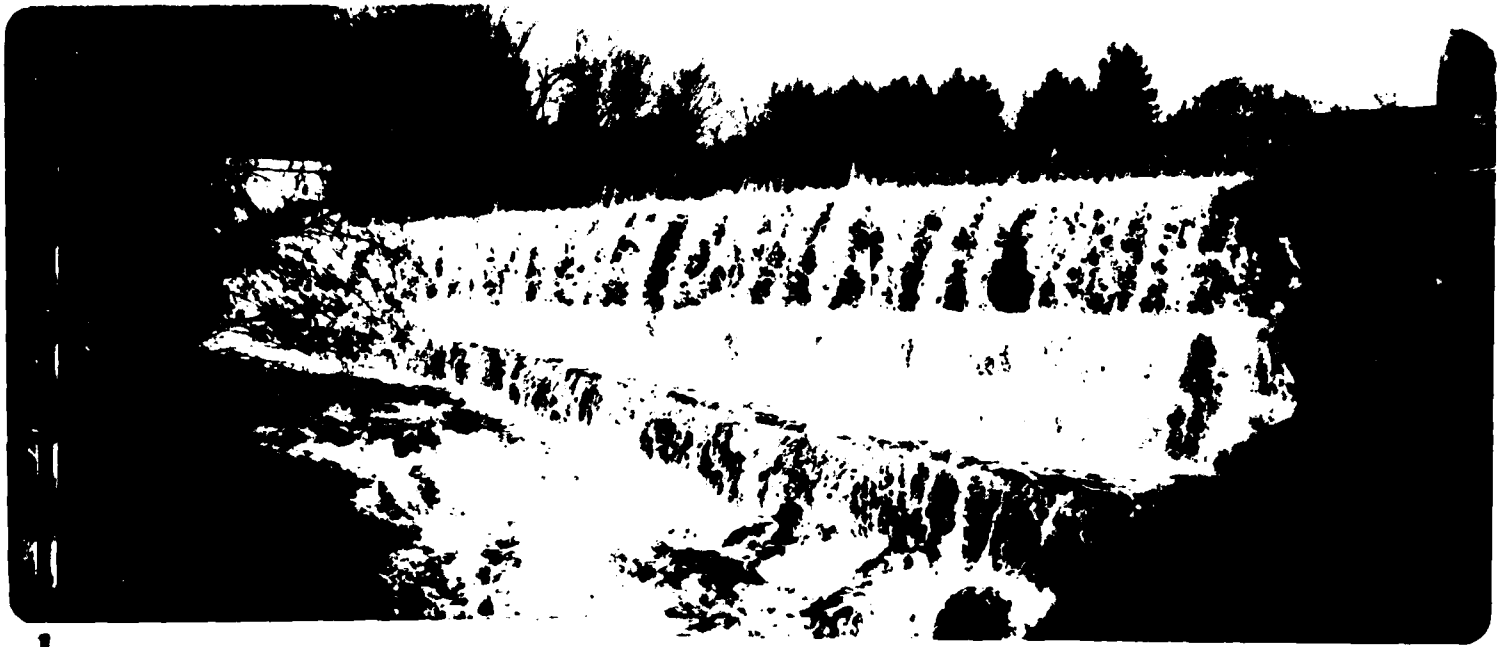
The spillway, located at the right abutment of the right embankment, was recently renovated and is in good condition. The spillway discharges through a rock channel into a bypass channel which carries the excess flow into the canal below Lock No. 4. This channel was in good condition and no signs of recent erosion were detected. Two outlet control structures are located on the left abutment of the spillway. These facilities consist of a 4 foot wide x 5 foot high sluice gate which may be used to drain the impoundment, and a 5 foot wide stop plank opening which may similarly be used to drain the facility. The operating mechanism on the

The spillway has a stepped downstream face. Rock is exposed in the down-stream channel immediately below the spillway and it appears that the spillway structure bears on rock. Flow was occurring over this spillway at the time of the inspection and the condition of the concrete in this structure could not be accurately evaluated. The spillway appears to be stable with no indications of misalignment or other structural movements, nor significant loss of section noted. The spillway abutments similarly appear structurally stable, although some deterioration of the surface concrete has occurred near the water line.

5. Spillway located at the end of right embankment.

Further investigation is recommended for the spillway structure, with the thought that methods to improve the stability of the spillway will have to be developed. Because of the influence on structural stability, additional studies should include evaluation of uplift pressures which act upon the base of the spillway. The engineering properties of the foundation rock should also be determined, in order to analyze resistance to displacement and obtain data relative to providing an anchorage system for the spillway section.
