**KINGSLEY BROOK RESERVOIR DAM**

**MADISON COUNTY, NEW YORK  
INVENTORY No. N.Y. 353**

**PHASE I INSPECTION REPORT  
NATIONAL DAM SAFETY PROGRAM**

NEW YORK DISTRICT, CORPS OF ENGINEERS  
JUNE 1981

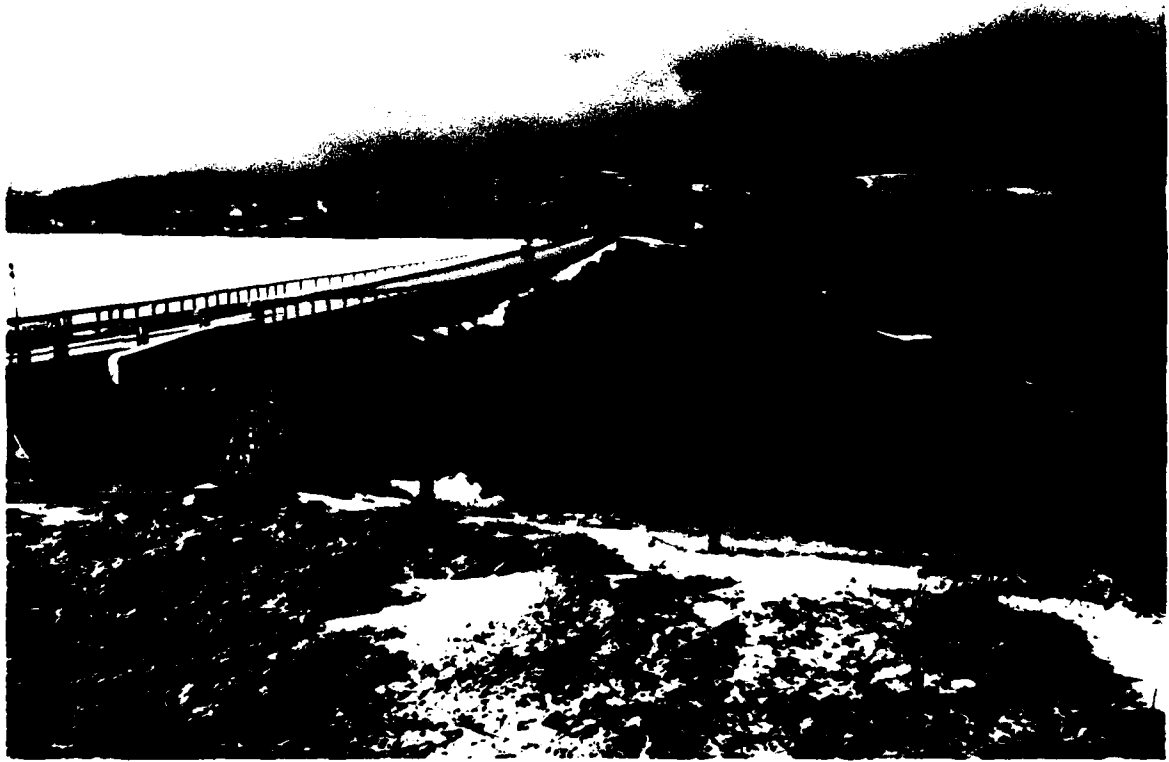
PHOTO #1: Overview of  
Kingsley Brook Reservoir Dam  
Inventory No. NY 353

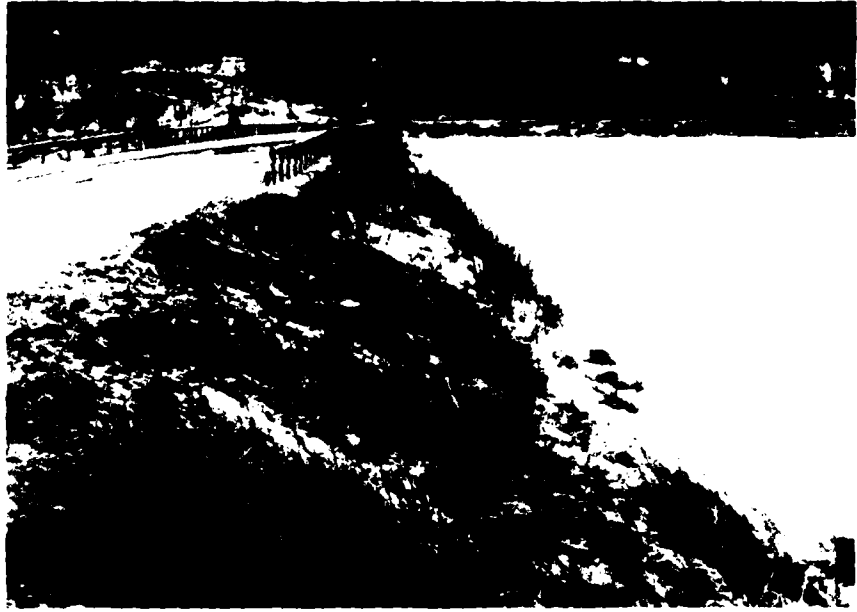
The earthfill embankment of the dam is generally in fair condition (See Photos No. 4, 5, 6 and 7). Reservoir Road runs along the dam crest which is in good condition (See Photo No. 3). There was no visible evidence of lateral movement, settlement, erosion or other serious defects. However, there is concern relative to seepage conditions at the downstream toe of slope.

4. The upstream riprapped slope was covered with grass and brush, and scattered 3 inch diameter tree or brush stumps were observed between the riprap (See Photos No. 4 and 6). These stumps had been cut off within the past several years.

PHOTO #4: Overview of upstream face of dam

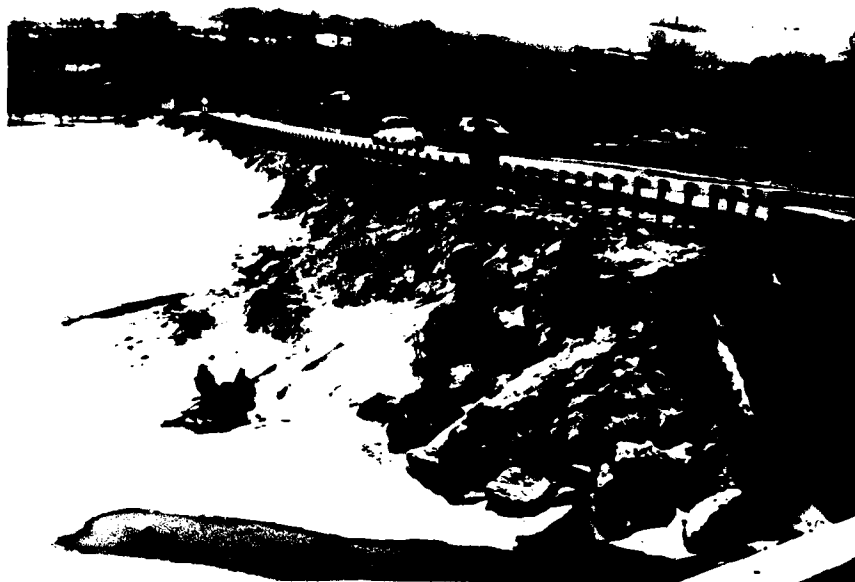
PHOTO #6: Upstream face of dam

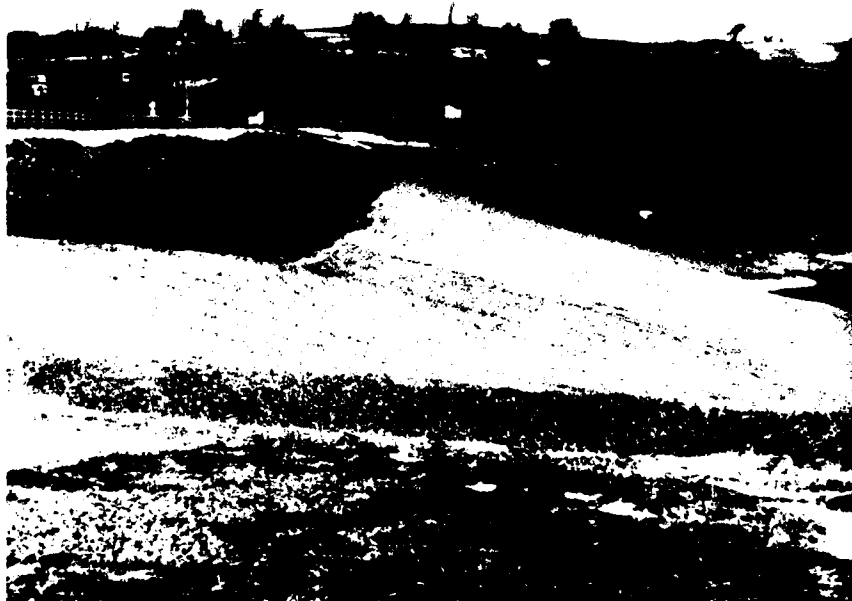
PHOTO #7: Downstream face of dam
