**LAKE LUDLOW CLUB DAM**

**CHENANGO COUNTY, NEW YORK  
INVENTORY No. NY 350**

**PHASE I INSPECTION REPORT  
NATIONAL DAM SAFETY PROGRAM**

**NEW YORK DISTRICT, CORPS OF ENGINEERS  
JULY 1981**

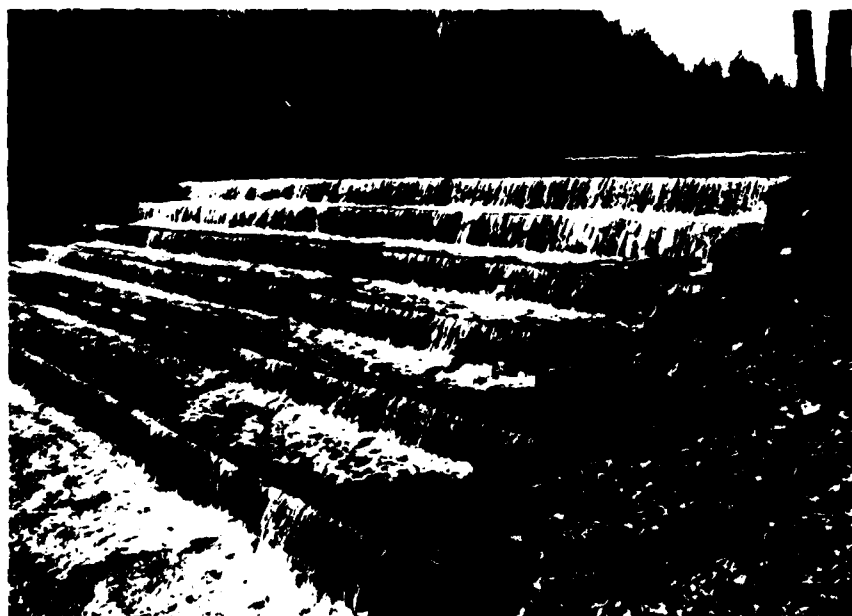
PHOTO #7: Downstream face of dam

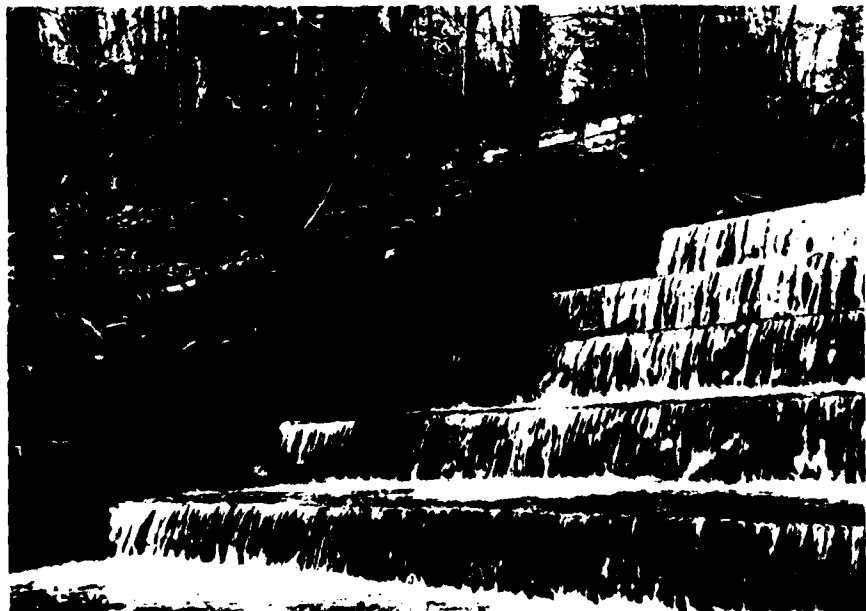
The dam has a short embankment section on each side of the overflow spillway (See Photos No. 8 and 9); these embankments are generally in fair condition. The irregular configuration tended to obscure any evidence of lateral movement or settlement, but there was some local erosion and possible seepage.

PHOTO #9: Stepped concrete retaining  
wall on right side of spillway

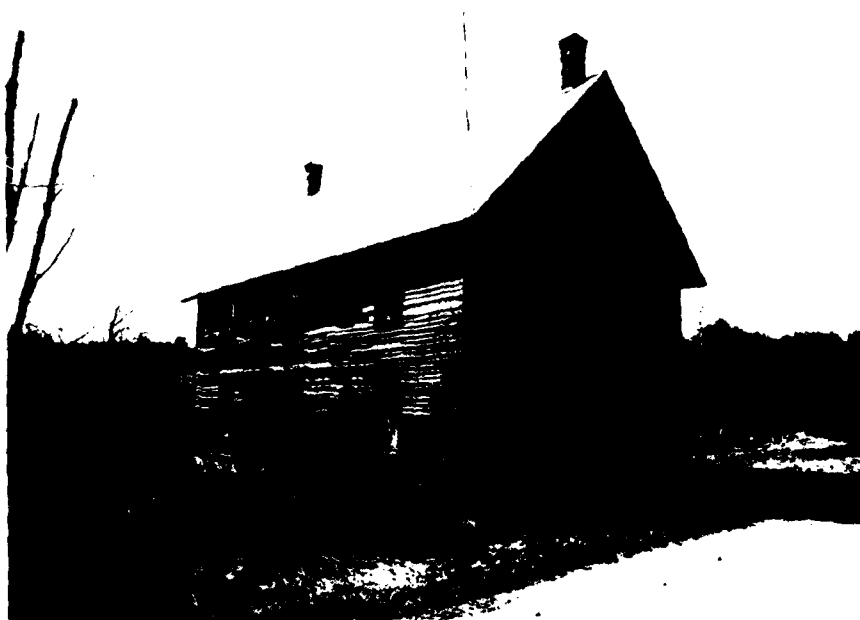
PHOTO #16: Reconstructed church in Tyner which was washed away by 1935 flood

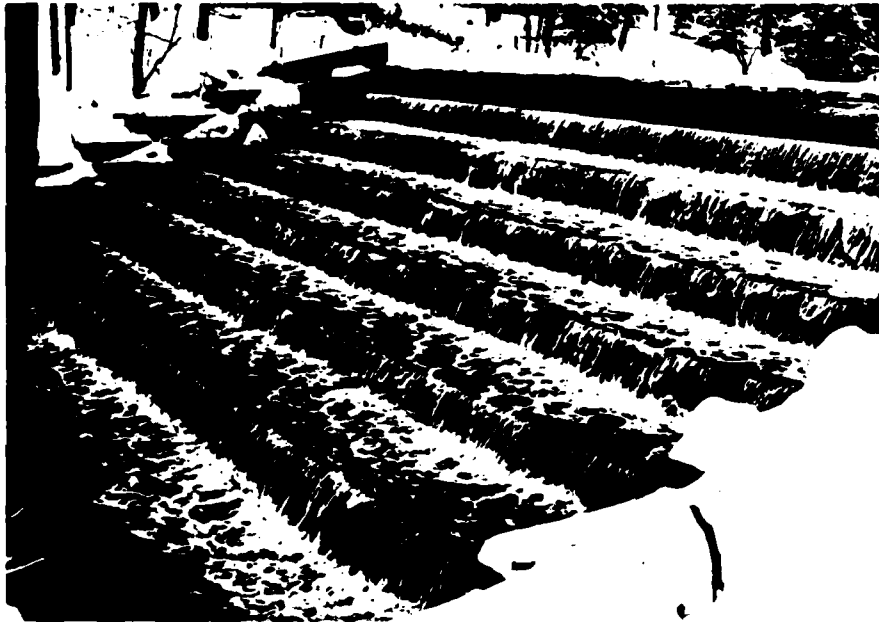
PHOTO #1: Downstream face of dam

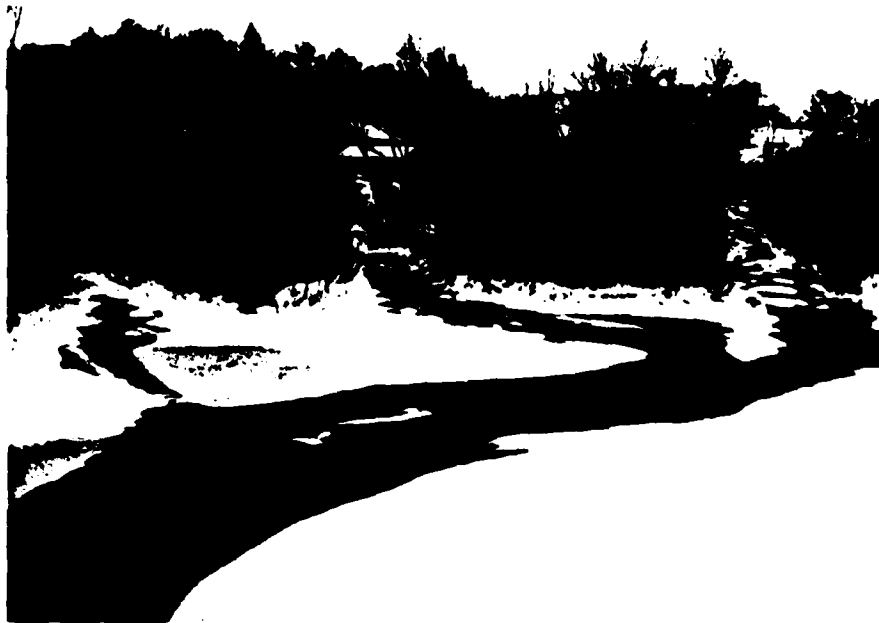
PHOTO #4: Upstream view from bridge (See  
Flood Impact Map - sheet 2 of 2)

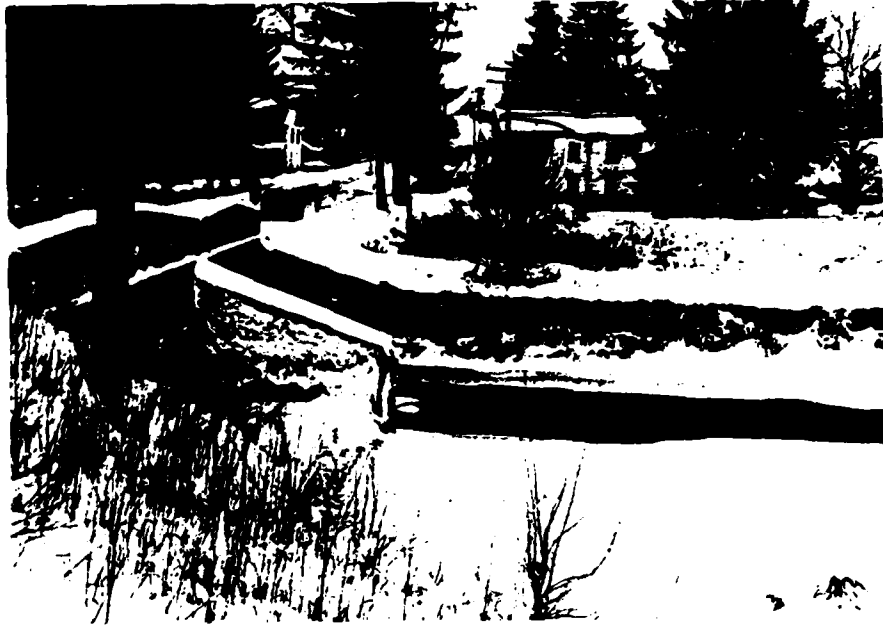
PHOTO #5: Upstream face of bridge (See Flood Impact Map - sheet 2 of 2)

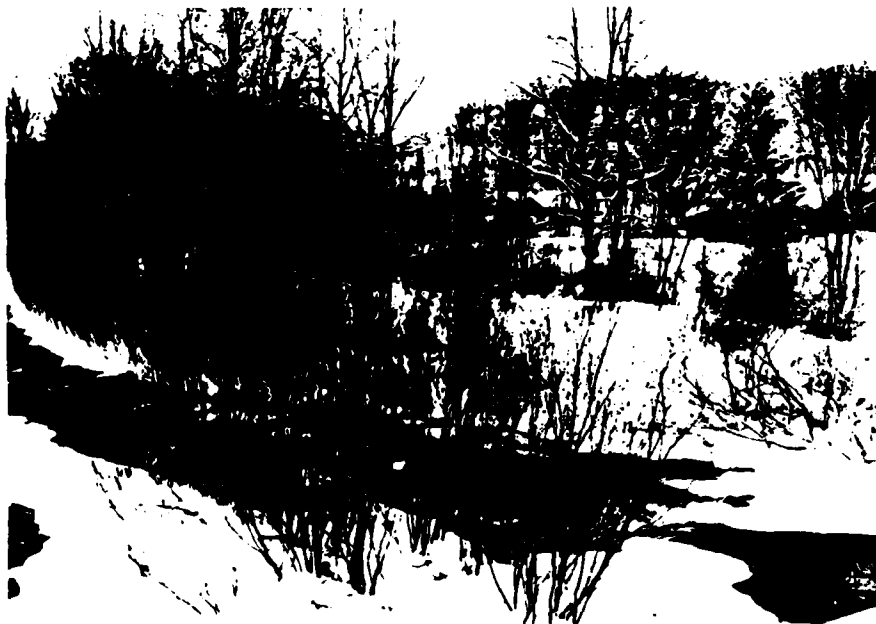
PHOTO #6: Downstream view from bridge (See Flood Impact Map - sheet 2 of 2)
