# WHETSTONE GULF STORAGE DAM

LEWIS COUNTY, NEW YORK  
INVENTORY No. NY. 544

## PHASE I INSPECTION REPORT NATIONAL DAM SAFETY PROGRAM

NEW YORK DISTRICT, CORPS OF ENGINEERS  
JULY 1981

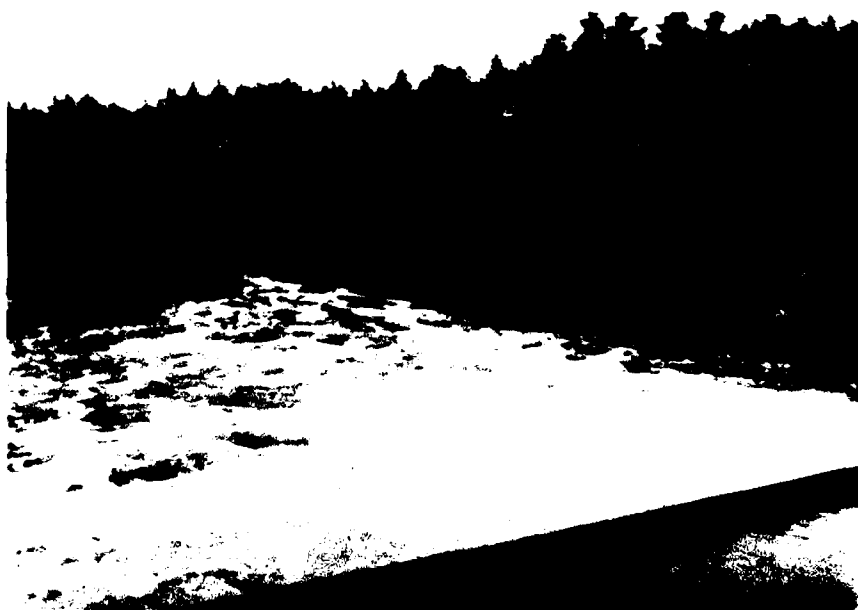
No data regarding flood levels was obtained for this dam; however, in the spring of 1972, heavy rains caused high discharge flows over the spillway (See Photos No. 9 and 11) and flooding downstream (See Photos No. 13 and 29).

PHOTO #13: Downstream channel conditions from spillway during flood in spring, 1972

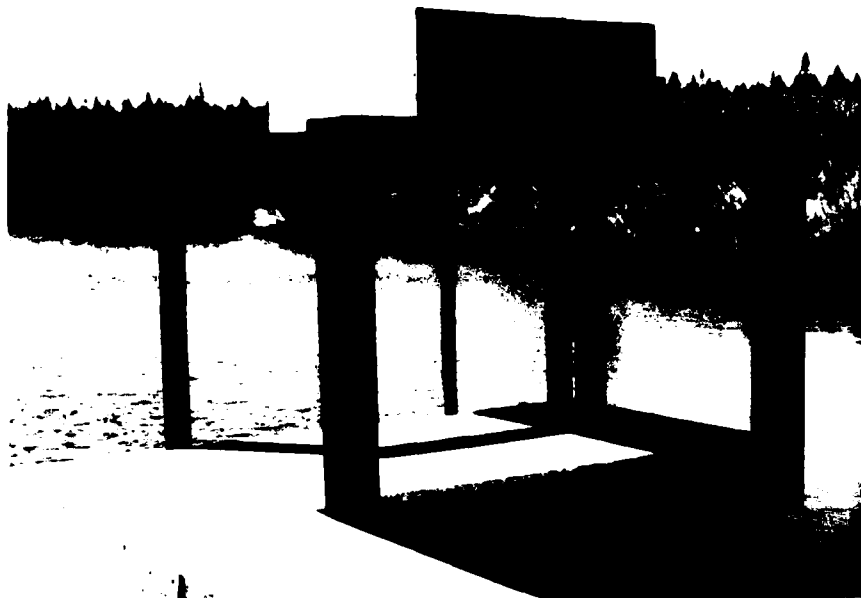
PHOTO #14: Hand wheel (under wooden housing)  
and operating platform for 36 inch  
high by 36 inch wide reservoir drain
