NATIONAL DAM SAFETY PROGRAM, CHAZY LAKE DAM (INVENTORY NUMBER N--ETC(U))

CHAZY LAKE DAM

PHASE I INSPECTION REPORT
NATIONAL DAM SAFETY PROGRAM

AUGUST 1981

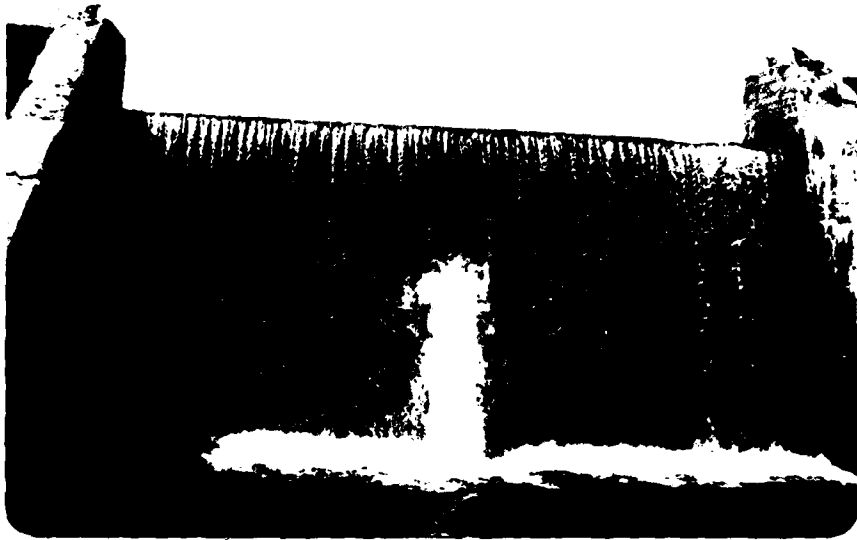
wing wall. This cracking again is not explained by the normal forces which would be expected on such a facility. The center buttress which supports the core wall near the center of the spillway also showed some signs of deterioration when viewed through the cascading water.

2. PRINCIPAL SPILLWAY.
TOP PORTION OF
CENTER BUTTRESS IS
DETERIORATED

1. Repair concrete surfaces on the spillway and repair the concrete buttress at the center of the spillway.
2. Replace rubble fill behind the face wall where this material has been displaced.
3. Re-align the facewall section where vertical displacement has taken place.
4. Remove trees and brush from all embankment sections.
5. Replace the slope protection on the upstream face of the core wall section of the embankment.
6. A formalized inspection system should be adopted to develop data on the conditions and maintenance operations of the facility.
7. A flood warning and emergency evacuation plan should be implemented to alert the public should conditions occur which could result in failure of the dam.

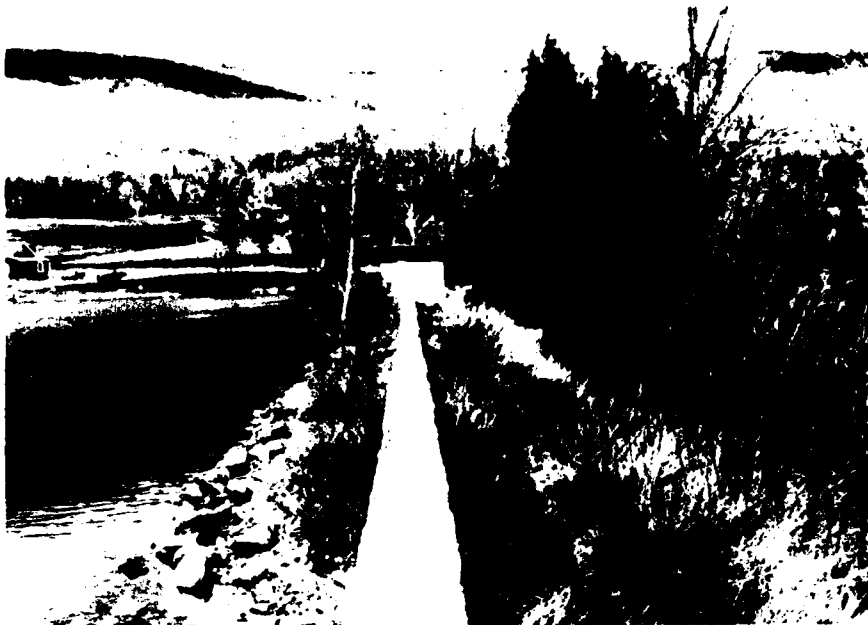
5. VIEW TOWARDS LEFT
ABUTMENT OF CORE WALL
SECTION. GATEHOUSE
CONTROLS RESERVOIR
DRAIN.

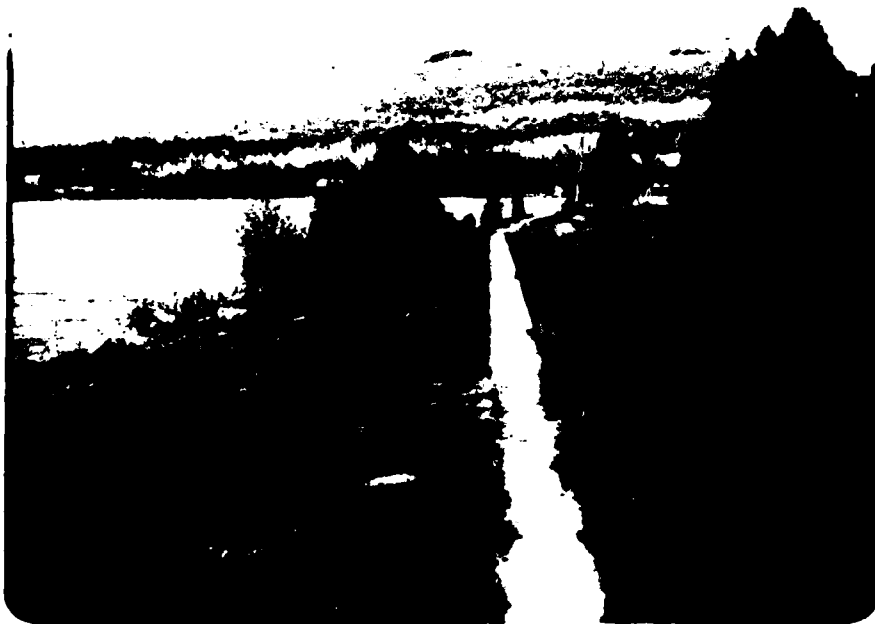
7. VIEW FROM RIGHT
ABUTMENT OF CORE WALL
SECTION. GRASSED AREA
IS PART OF TOWN PARK

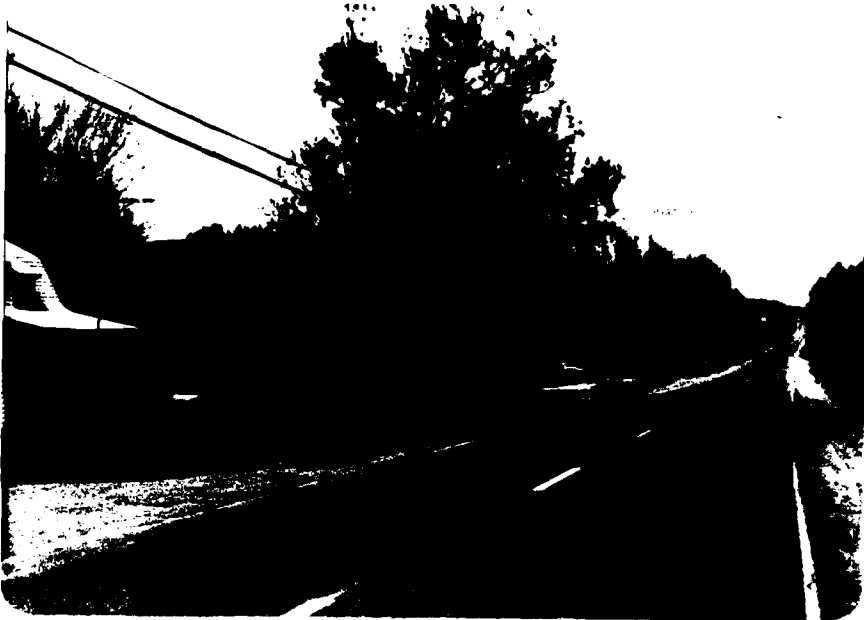
Three permanent residences and one mobile home residence are located near the Great Chazy River approximately 2 miles downstream from the facility. Therefore, the dam is in the high hazard classification as defined by the Recommended Guidelines for Safety Inspection of Dams.

15. DOWNSTREAM HAZARD.
BRIDGE OVER RECEIVING
STREAM IN BACKGROUND

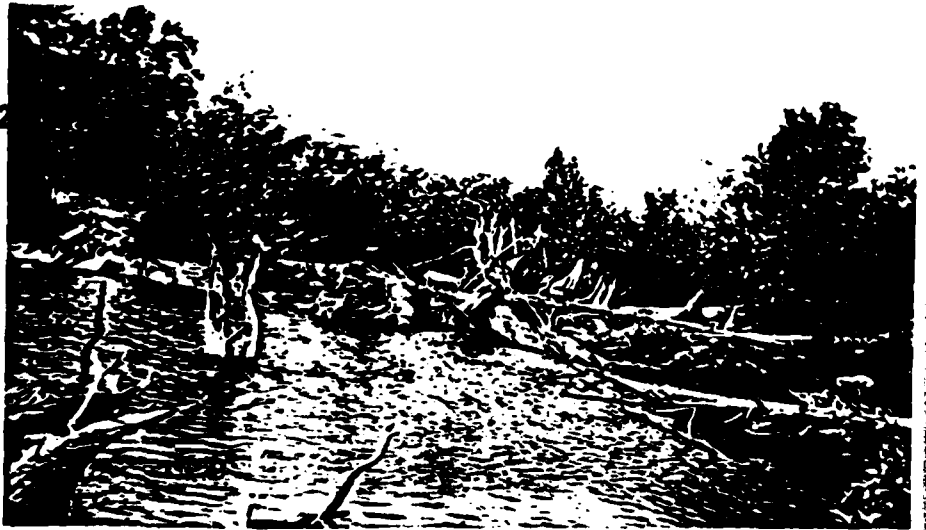
Chazy Lake Dam June 8, 1922

Chazy Lake Dam. The picture shows the spill way
destroyed by decay and ice.
This lake is the source of
The Big Chazy River.
May 1922
